AVIATION OCCURRENCE REPORT

LOSS OF WHEELS ON LANDING

INTER-CANADIEN FOKKER F-28 MK1000 C-FCRI
QUEBEC/JEAN LESAGE INTERNATIONAL AIRPORT,
QUEBEC
09 JUNE 1996

REPORT NUMBER A96Q0083

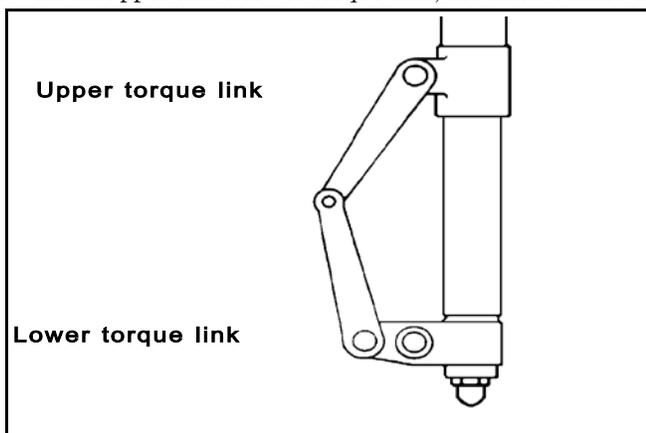
The TSB Engineering Branch examined the aircraft's right landing gear unit. The failure of the landing gear upper torque link was attributed to mechanical overload. The failure of the landing gear upper torque link was attributed to the overload extension of three small zones of precracking at a location known

to have been previously associated with fatigue crack formation. The zone between the precracking and overload revealed fine microstriations consistent with loading having occurred at higher-than-normal service loads. This indicates that the precracks only served to locate the initiation of the overstress fracture.
