AVIATION INVESTIGATION REPORT

A00Q0046

IN-FLIGHT BREAK-UP

BELL 206B-III (HELICOPTER) C-GFSE

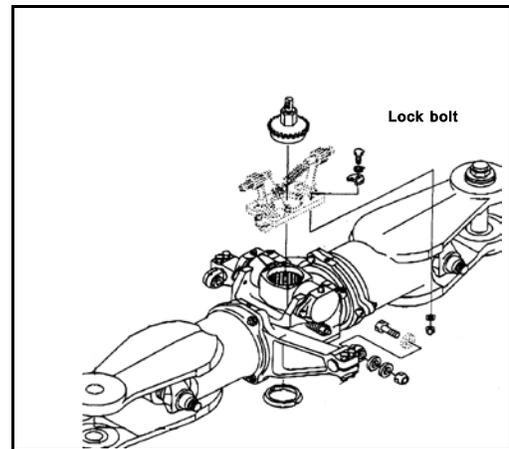
On April 25, the AME started to complete the work listed in the purchase service contract and to correct the deficiencies noted by the owner on pleasure flights on April 20 and 24. These deficiencies included the defective transponder, a leak in the ceiling, and corroded washers on the droop restrainers. A nut screwed onto the top of the mast secures the droop restrainers and the rotor head in place. A mechanical lock bolted to the droop restrainer plate is secured with a lock wire and prevents the mast nut from unscrewing in flight. After the mast nut is installed, an independent inspection is required. The work must also be entered in the aircraft logbook and signed off by either two AMEs or one AME and a qualified pilot.

Examination of the hub revealed that the mast nut, the droop restrainers, and the spacer that replaces the droop restrainers when they are not installed were all missing. The internal threads in the holes where the droop restrainers attach to the hub were intact, and the examination revealed no attachment bolt debris. Examination of the main-rotor mast and the head trunnion indicated that the damage was caused by a vertical movement of the hub. The two pitch control rods failed in overload. Shortly after the occurrence, the droop restrainers and the mast nut for C-GFSE were found in the S.C.G. Hélicoptère inc. hangar at the same location where they had been left the day before by the apprentice AME.

Examination of the rotor head and its components indicates that the main rotor separated from the aircraft because the mast nut was not in place. The possibility that another mast nut was installed before the take-off and came loose in flight was rejected because all the mast nuts in inventory were found in the S.C.G. Hélicoptère inc. hangar. Consequently, the aircraft took off with no mast nut.
