AVIATION INVESTIGATION REPORT
A02C0227

COCKPIT FIRE - PRECAUTIONARY LANDING

AIR FRANCE
BOEING 777-228ER F-GSPZ
CHURCHILL, MANITOBA 290 nm NE
17 OCTOBER 2002

Report Number A02C0227

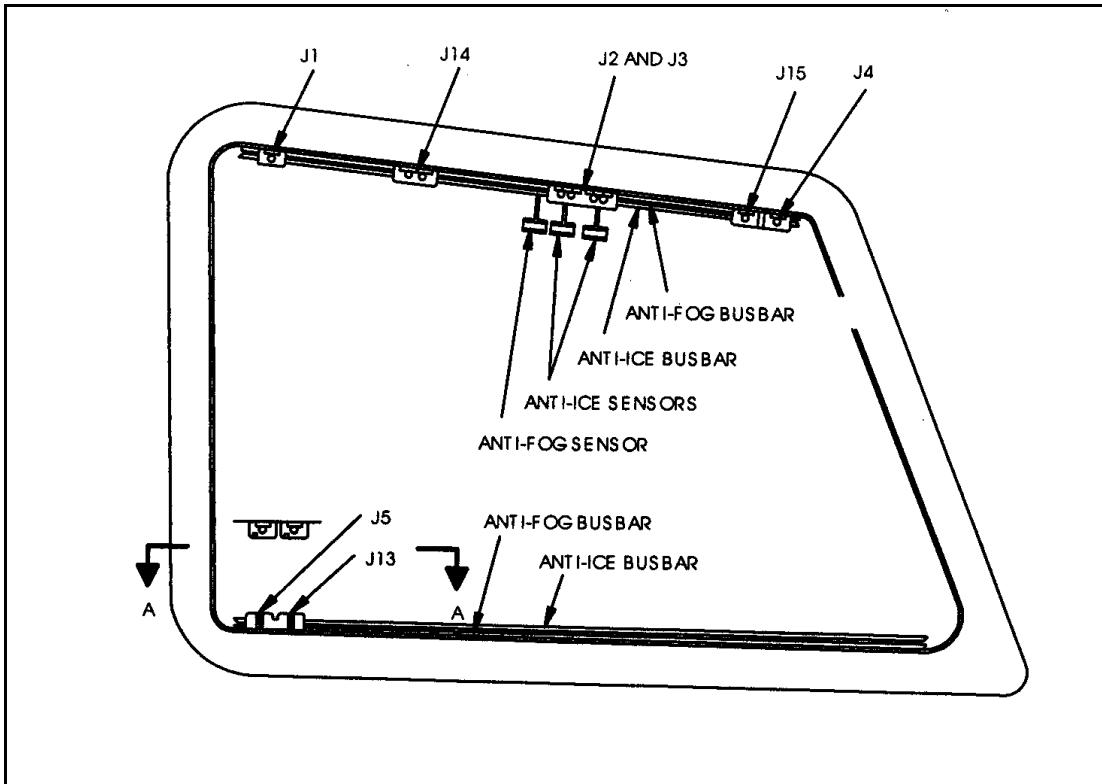
Prior to the removal of the damaged window, the power and sensor terminal connector screws were checked for proper torque as specified in the AMM (see Appendix A for a list of the recorded torque values). Three of the five power terminal connector screws were checked, and two of these were found to be well below the desired torque requirements. The torque on the remaining two power terminal connector screws, J5 and J13, was not checked in order to leave the burnt connectors undisturbed until laboratory examination. However, they were determined to be at least finger tight. One of the six sensor terminal connector screws was marginally below the required torque values.

The terminal connector screw torque on the undamaged right front cockpit window was checked and all five of the power terminal connector screws were found to be well below the desired torque requirements, with two of the five having no torque reading at all. Three of the six sensor terminal connector screws were marginally below the desired torque value.

J1, J4, J1, J13, J15: Power Terminals
J2, J3, J14: Sensor Terminals
Note: J13 and J15 are Anti-Fog (back-up) Power Terminals
