AVIATION INVESTIGATION REPORT

A03O0171

CONTROLLED FLIGHT INTO TERRAIN

BEECH 58TC BARON, N6058T

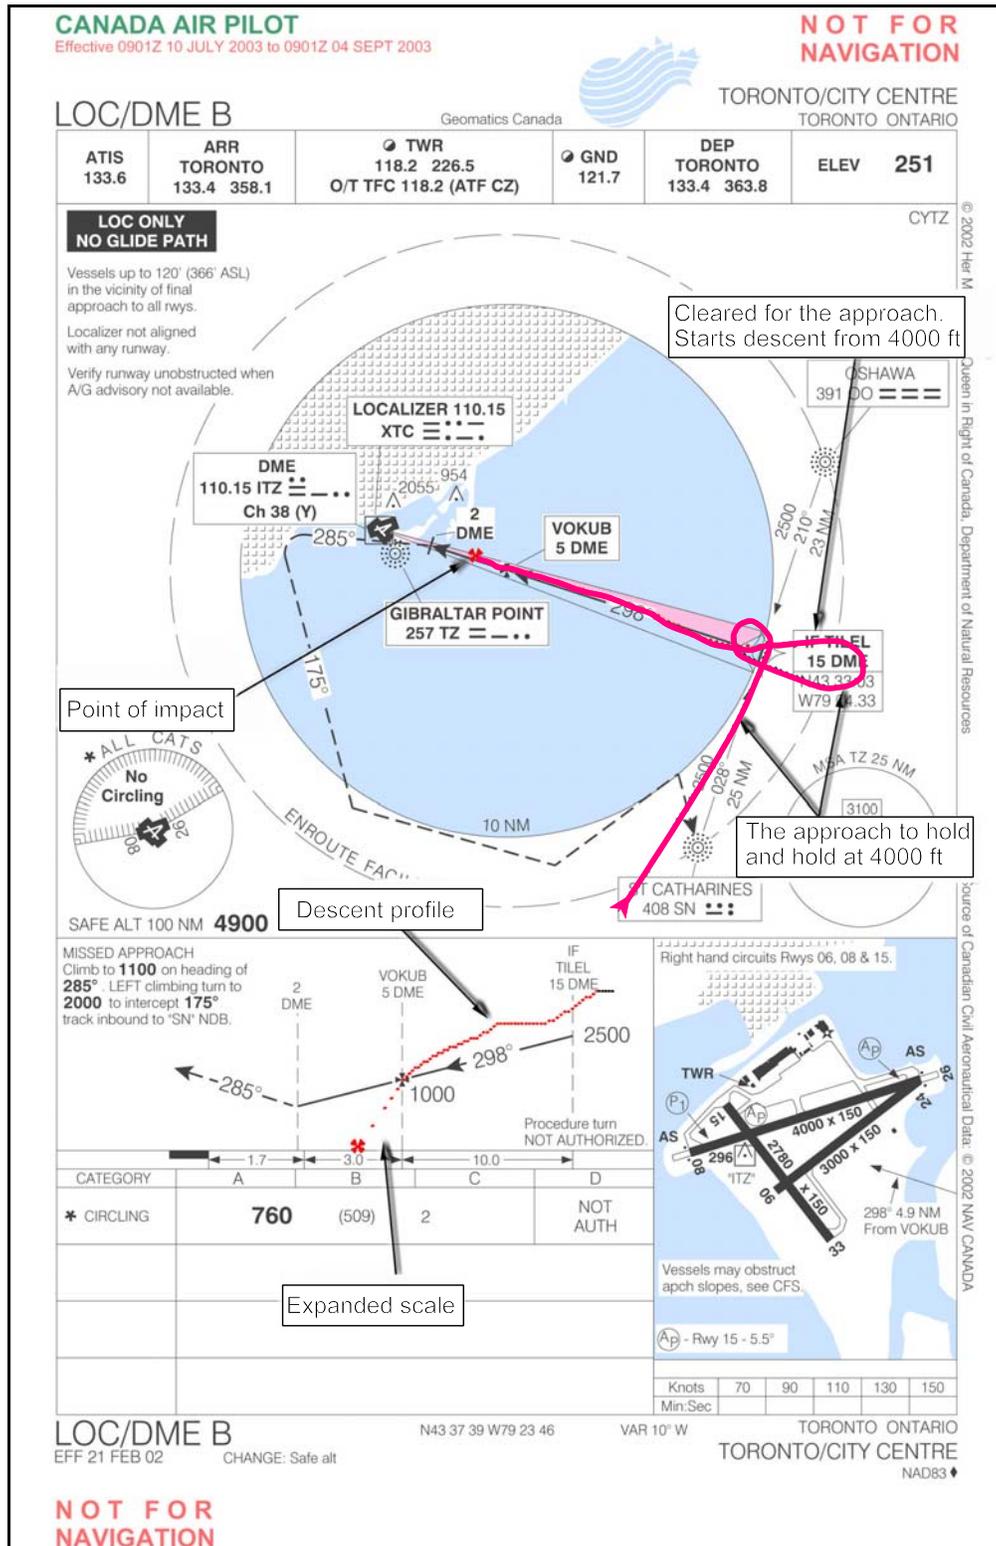
Appendix A – Flight Path Information

Data was obtained from a radar located at Toronto/Lester B. Pearson International Airport (LBPIA), 14 miles northwest of the TCCA. Track and altitude derived from the radar data is presented in Appendix A. The aircraft maintained an altitude of 4000 feet asl and an airspeed of approximately 140 knots⁴ while entering the hold. When cleared for the approach, the pilot began an immediate descent and airspeed increased to approximately 190 knots. The aircraft crossed TILEL, descending through approximately 3500 feet asl.

At 13.5 DME, the aircraft levelled at 2900 feet and the airspeed decreased to 150 knots. The aircraft resumed its descent at 11 DME, initially with a rate of descent of approximately 1000 feet per minute, then reducing to 600–700 feet per minute with an airspeed reduction to approximately 120 knots. At 6.5 DME, the rate of descent began to increase again and the airspeed increased to approximately 150 knots. According to radar, the aircraft passed the 5 DME fix at exactly 1000 feet. The last radar hit was at 500 feet asl, with a rate of descent of approximately 1200 feet per minute and an airspeed of 150 knots. The geographic position of impact was consistent with the radar data.

As the aircraft resumed its descent, airspeed and rate of descent were both initially high, but then decreased until they stabilized at approximately 120 knots and 700 feet per minute, normal values for an approach, for a duration of about one minute. Had the speed and rate of descent been maintained, the aircraft would have crossed the VOKUB 5 DME fix at 1300 feet and reached MDA at 3 DME, 1 mile before the missed approach point. This would have been an ideal location to permit transition either to manoeuvre for a landing if there was adequate visual reference, or to execute a missed approach if not.

Two miles before the VOKUB 5 DME fix, the rate of descent and airspeed both began to increase. The increased rate of descent resulted in N6058T crossing the VOKUB 5 DME fix at exactly the published 1000-foot minimum altitude, descending at 1200 feet per minute, a significantly greater rate of descent than necessary to reach MDA by the 2 DME missed approach point. This rate of descent continued until impact.
