AVIATION INVESTIGATION REPORT

A04O0020

AIRCRAFT PITCH-UP/STALL WARNING ON DEPARTURE

BOEING 767-233 C-GAUE

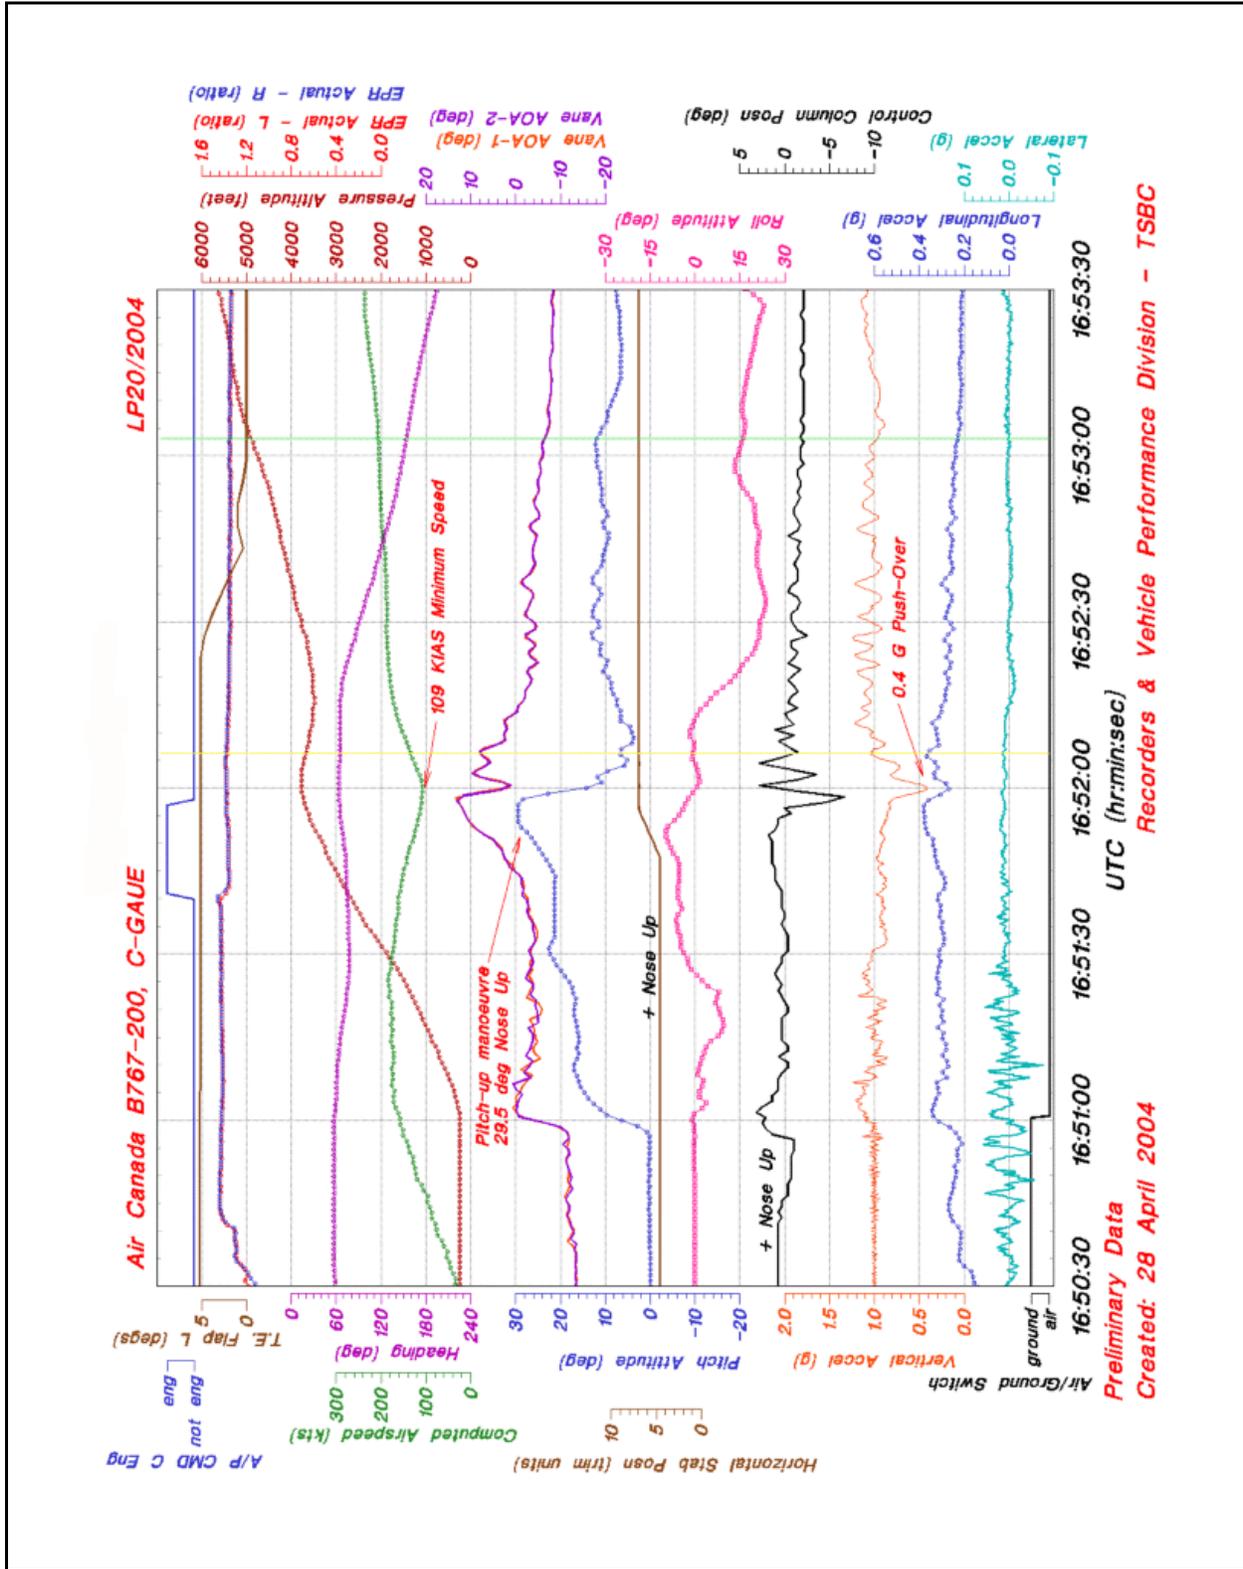
Appendix A – Flight Data Recorder Plot

The aircraft was equipped with a Honeywell Universal flight data recorder (FDR), model #980-4100-AXUN. The FDR was removed and downloaded by the operator. A copy of the raw data was sent to the TSB Engineering Laboratory for analysis. Appendix A is a plot of the FDR data from the beginning of the take-off run and shows the pitch up and near stall event. The data shows that, during the occurrence take-off, aircraft rotation started at 148 knots indicated airspeed (KIAS) and at 158 KIAS the aircraft lifted off. The calculated rotation and take-off safety speeds (V_r and V_2) were 141 and 145 KIAS. The aircraft accelerated through 170 KIAS about 3 seconds after lift-off, and continued to pitch up until a pitch attitude of approximately 16° was established. This pitch attitude was maintained and the aircraft continued to accelerate to approximately 185 KIAS during the next 20 seconds. The vertical speed was approximately 3000 feet per minute (fpm) during this time.

Approximately 25 seconds after lift-off, the pitch attitude began increasing over the next 10 seconds from 16° to 22° . The rate of climb increased to approximately 5100 fpm and the airspeed began to decrease. About 30 seconds after lift-off the flight director (FD) pitch mode changed from take-off to altitude capture (ALT CAP) mode. Approximately 10 seconds later, the centre autopilot was engaged. During this 10-second period (between ALT CAP mode annunciation and autopilot engagement), the airspeed decreased to approximately 160 KIAS. After the autopilot was engaged, the aircraft attitude remained at 22° up for about 4 seconds and then increased to 29.5° over the next 10 seconds. At the time the autopilot was engaged, the engine pressure ratio (EPR) was decreasing from 1.45 (take-off power) to 1.35 (climb power). The aircraft maintained 29.5° of pitch for about 3 seconds before the autopilot was disconnected and the flight crew began a 0.4g pushover to recover from the near stall. The autopilot was engaged for about 17 seconds, during which time the airspeed decreased from 160 KIAS to 109 KIAS. The vane angle of attack reached a maximum value of approximately 13° during the pitch-up; this corresponds to a body angle of attack of 17° . During the recovery the aircraft pitch attitude reduced to 3° nose up. The aircraft descended 300 feet during the recovery; the aircraft developed a momentary sink rate before re-establishing a positive rate of climb. Over the next 18 to 20 seconds, the airspeed increased to 180 KIAS and the pitch attitude increased to approximately 12° .
