**AVIATION INVESTIGATION REPORT
A05P0269**

IN-FLIGHT BREAK-UP

**HELIFOR INDUSTRIES LIMITED
BOEING VERTOL BV-107 II (HELICOPTER) C-GHFT
SOUTH BENTINCK ARM, BRITISH COLUMBIA
03 NOVEMBER 2005**

Report Number A05P0269

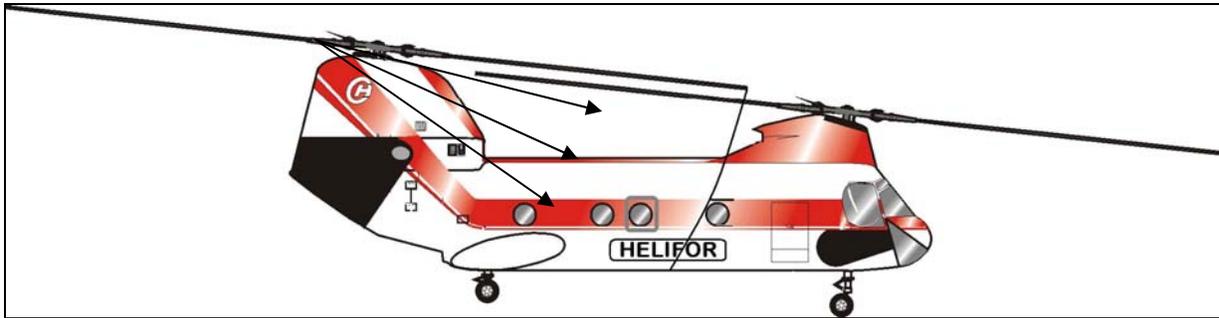
Figure 1. Blade strike area

Examination of the aft transmission revealed a fracture at the combining gearbox casing. Continuity of the aft transmission drive was confirmed, and the case fracture was consistent with ground impact forces. The three aft rotor blades exhibited signs of contact with the helicopter fuselage: fuselage paint transfer, scuffing, control cable marks, and spar fractures. There were significant impact marks on the leading edge of the three rotor blades. All aft rotor blade fragments were recovered with the exception of the outboard four feet of the red blade. The majority of the damage to the aft rotor blades was consistent with fuselage contact, with the remaining damage due to ground impact. Partial reconstruction of the fuselage revealed six blade strikes extending from the synchronizing drive shaft tunnel on the roof of the fuselage to the floor of the helicopter (see Figure 1 and Photo 1).

Partial reconstruction of the centre and forward fuselage sections clearly indicated that the aft rotor blades entered the cabin, severing the helicopter, synchronizing shafts, and control cables. A mechanical failure of the speed trim actuator rendered longitudinal pitch of the aft rotor system unstable and the helicopter became uncontrollable. Once the rod end separated from the speed trim actuator, the aft rotor head became unstable, allowing the aft rotor disk to tilt forward until the rotor blades contacted the fuselage. It is also possible in this type of failure that the aft rotor disk could tilt aft. Either scenario has catastrophic consequences for the helicopter.

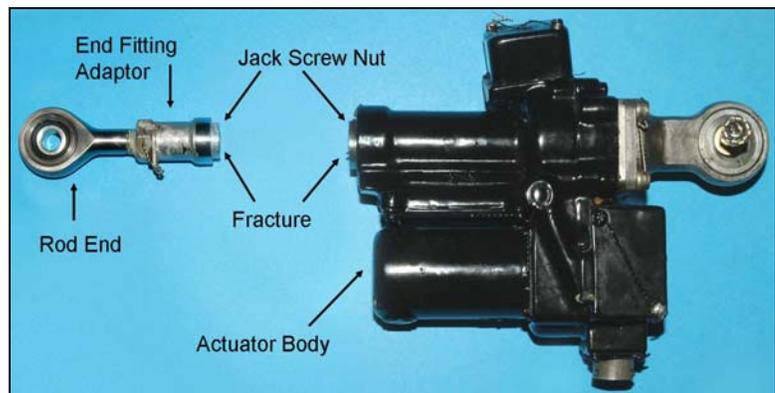
Photo 2. Failed speed trim actuator

All flight controls were visually examined, and continuity was verified to the extent possible. With one exception, all fractures of the flight control system were consistent with overload due to impact forces. A fracture of the jack screw nut on the longitudinal cyclic trim actuator exhibited signs of fatigue (see Photo 2). The jack screw nut was examined macroscopically and the fracture surface revealed features typical of a progressive failure.

The fracture surface intersected the last thread in the jack screw nut that accommodates the end fitting adaptor. The rod end, which screws into the end fitting adaptor, was found damaged to the extent that the rod end bearing would not move freely. Further examination of the aft pylon and swash-plate area revealed scoring on the underside of the aft rotor head rain shield. This damage was consistent with the rod end coming into contact with the swash plate and rain shield before ground impact.

SEM analysis of the jack screw nut revealed that numerous fatigue cracks had initiated at the inner diameter of the nut in the root of the last of five threads (inside actuator body). The cracks had propagated around the entire circumference of the fracture surface, suggesting a symmetrical tension load, an indication that the actuator was not misaligned during installation. The fatigue cracks had propagated toward the outer surface until the final 10 per cent of the material failed in an overload mode.

The deformed keyway on the shaft of the torsion bar and the cadmium material transfer residue on the face of the torsion bar are physical evidence that the retract limit switch did not activate and, therefore, was not stopping the retract motion. Continued motor operation caused the end fitting adapter to be driven into the face of the torsion bar, causing damage to the gear train by imposing a tensile load on the jack screw nut of over 1300 pounds. The stress concentration factor caused by the small thread-root radius, in combination with the high tensile load, resulted in a stress that was greater than the jack screw nut material endurance limit. Fatigue failure of the jack screw nut was inevitable once the endurance limit had been exceeded.

On 23 November 2005, Columbia Helicopters Incorporated issued an inter-office memorandum to all Boeing 107 helicopter crews, detailing recurrent procedures to check the operation and serviceability of the speed trim actuator switches. As a result of this memorandum, one other speed trim actuator was identified as having a non-functional extend limit switch.

On 23 November 2005, Boeing Aerospace Support-Philadelphia issued service bulletin 107-67-1001, requesting that all operators of Model 107 helicopters (BV and KV) and 107 derivatives inspect and functionally test the longitudinal cyclic trim actuator limit switches. Boeing recommended that this test be accomplished before the next flight, and before each subsequent flight until further notice.

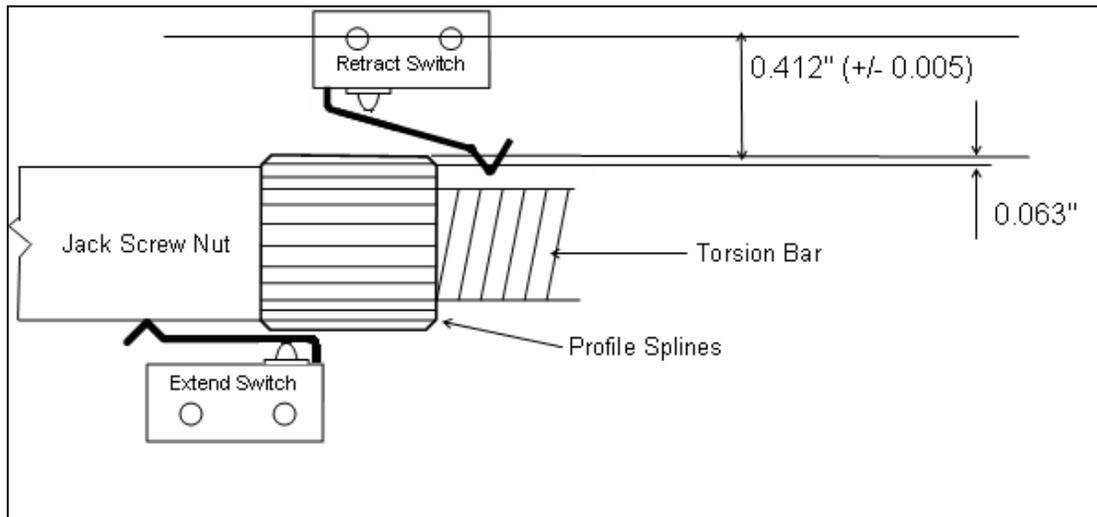
Figure 2. Dimensional analysis

The speed trim actuator incorporates two limit switches, one for retract and the other for extend (see Figure 2). The purpose of these switches is to stop the electric motor at the retract or extend limit of the actuator. The two limit switches are activated by profile splines, which are integral to the jack screw nut. The switches incorporate an arm that rides on the profile splines. When sufficiently compressed, the arm activates a plunger on the switch and interrupts the electricity to the motor.

Before disassembly (see Photo 3), the occurrence speed trim actuator was energized to establish the fully retracted and extended positions. These tests confirmed that the extension was in the normal range. In the retract direction, the actuator overran the normal stop, retracting beyond the normal limit. Both switches were then manually tested for electrical on/off function and found to be capable of on/off operation. Further testing revealed that the retract switch arm rode up the maximum height of the profile spline without depressing the switch plunger sufficiently to activate the internal electrical contacts of the switch. For testing purposes, the retract and extend switches were interchanged, and the actuator worked normally. Testing of the occurrence actuator with the limit switches interchanged revealed that the actuator stroke length was correctly adjusted at the time of overhaul, indicating correct adjustment of the switches in the horizontal axis. There is no adjustment available for the switches in the vertical axis – the distance between the switch and the splines.

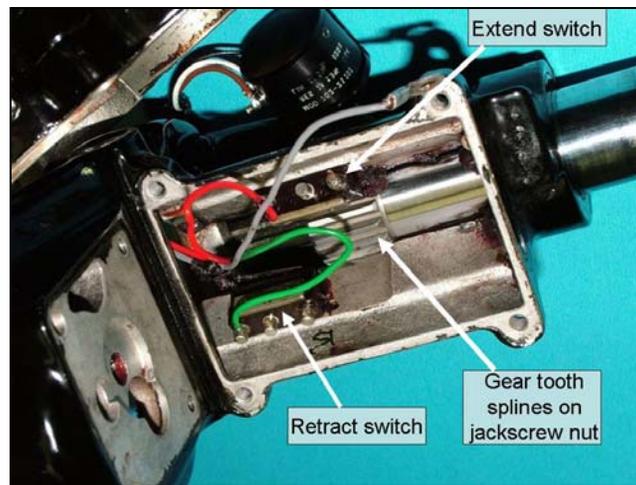
Photo 3. Interior of occurrence actuator

It was also noted that the retract switch arm had a groove worn where it contacts the profile spline. This wear was measured to be 0.003 inches. Switches from other actuators that had reached overhaul life exhibited wear on the arm, and on one switch, the arm was worn completely though yet continued to operate normally.

Examination of the torsion bar inside the jack screw nut revealed damage to the keyway in the shaft of the torsion bar. Damage to the keyway is consistent with the motor continuing to drive in the retract direction after it had reached the mechanical stop.

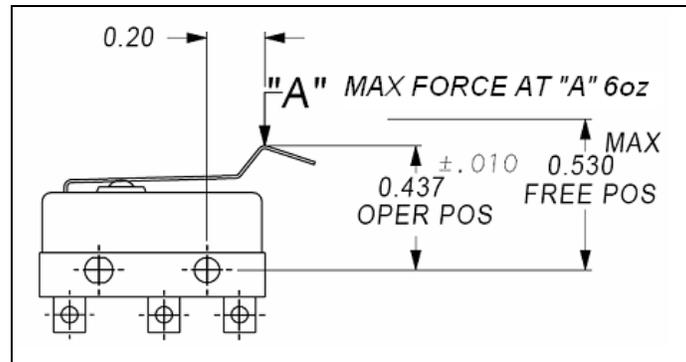
Figure 3. 2LML82E switch operating characteristics

Various examples of 2LML82E and USML117 switches were obtained by the TSB and examined. The results of testing are shown in Table 1. Tests confirmed that the occurrence limit switches did not meet manufacturer's specifications for arm travel (see Figure 3). Using the switch mounting holes as a reference, the arm of the 2LML82E switch should cause the switch to operate at 0.437 ± 0.010 inches. The retract switch and the extend switch from the occurrence actuator operated at 0.413 and 0.416 inches respectively - 0.014 and 0.011 inches beyond tolerance. This translates into a greater arm travel for switch activation.

The limit 2LML82E switches from the occurrence actuator did not meet the manufacturer's specification for switch arm travel. Given that there was no indication that the switch characteristics changed while in service, both switches were likely out of specification before installation and were operating with little margin for error. Since the switches cannot move in the vertical axis, it is likely that the 0.003-inch wear groove in the retract arm contributed to the failure of the retract switch to activate.
