AVIATION INVESTIGATION REPORT

A05W0176

CONTROLLED FLIGHT INTO TERRAIN

**CESSNA 180H C-FYIX
MOUNT BURNS, ALBERTA
22 AUGUST 2005**

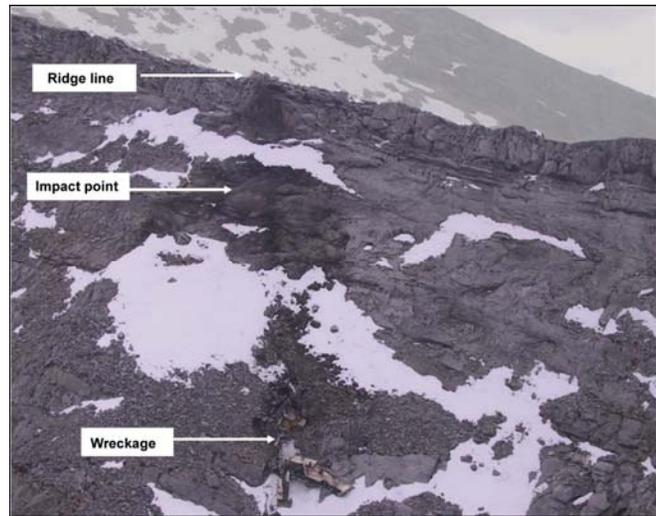
Photo 1. View of accident site

The aircraft contacted a near vertical cliff on the northeast face of a 9000-foot ridge. The point of impact was about 50 feet from the top of the ridge, which was oriented southeast to northwest. Damage to the aircraft indicated that it was in straight and level flight at the time of impact.

Most of the wreckage came to rest on a steep scree slope about 100 feet below the point of impact. Small pieces of wreckage were found on the other side of the ridge. A fuel-fed, post-impact fire consumed most of the aircraft. The pilot was found with the wreckage, and the passenger was found about 500 feet below. The propeller was not found; however, examination of the engine crankshaft indicated that the engine was delivering some power at impact. Higher terrain existed within one mile on an extension of the aircraft's track past the ridge (see Photo 1).

The occurrence fits the definition of CFIT. Since it does not appear that significant, timely evasive manoeuvres were attempted to avoid impact with the mountain, it is likely that the pilot did not have visual contact with the mountain top. The flight profile obtained from air traffic control (ATC) radar data and wreckage trail analysis suggests that, at the time of impact, the aircraft was under control and the engine was developing power. Since the aircraft struck the ridge at a relatively stable airspeed and heading (straight and level flight), it is likely that the pilot’s vision was obscured by cloud immediately before impact. It is also possible that, in attempting to cross the ridge, the aircraft entered a downdraft and was unable to out-climb the terrain. Had the aircraft successfully crossed the 9000-foot ridge, its track would have intercepted significantly higher terrain within one mile.

1. The aircraft was likely flown into cloud, which prevented the pilot from seeing and avoiding the high mountainous terrain.
