**AVIATION INVESTIGATION REPORT
A06Q0091**

ENGINE FAILURE

**HÉLI STAR INC.
BELL 206L-3 HELICOPTER C-GDTM
LA TUQUE, QUEBEC, 26 nm NE
07 JUNE 2006**

Report Number A06Q0091

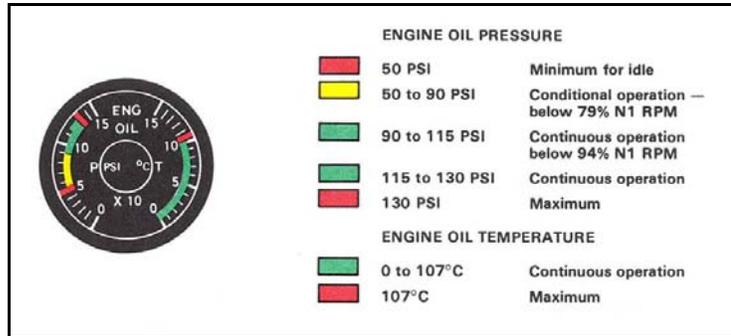
The Bell 206L-3 has a gauge that allows the pilot to determine the status of the engine oil system (see Figure 1). It shows the engine oil pressure and temperature. However, there is no caution light to warn of low engine oil pressure or high engine oil temperature. When an abnormal condition occurs, the pilot must determine how serious it is based on the engine oil temperature and pressure. The pilot must then follow the appropriate procedure recommended in the helicopter's flight manual. Engine oil pressure outside the prescribed limits indicates either a fault in the engine oil circulation system, a low engine oil level, or a system indication problem. Since the engine oil temperature sensor is located directly at the oil tank outlet, it is possible for the oil temperature to indicate normal even when the oil level is low. Three limiting ranges for engine oil pressure are defined according to the rpm of the engine's low-pressure compressor (N1 RPM), with N1 being proportional to the engine power delivered.

Figure 1. Engine oil pressure and temperature gauge (extract from the flight manual, section 1)
