AVIATION INVESTIGATION REPORT A10C0060

FUEL STARVATION AND FORCED LANDING

VENTURE AIR
BEECH 95-55 C-FBJA
PIKWITONEI, MANITOBA, 3 nm E
13 MAY 2010

Report Number A10C0060

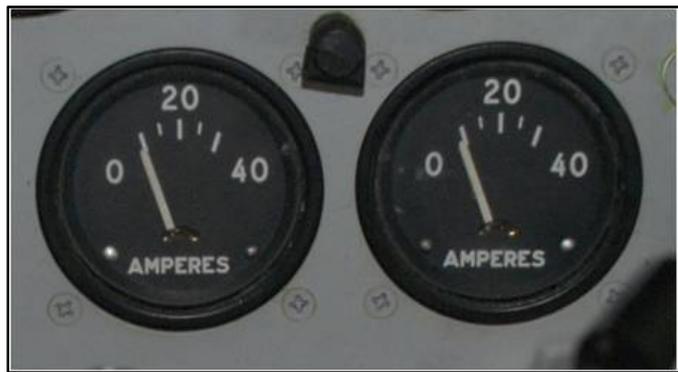
Photo 1. C-FBJA ammeter reading with Generators OFF

The generator output was indicated by 2 direct reading ammeters (as opposed to the charge-discharge type ammeter) mounted on the instrument panel behind the throttle quadrant (see Photo 1). The ammeter readings increase or decrease in direct proportion to the electrical load applied. While the scale starts at 0A and goes to 40A, the positioning of the 0 and the 40 do not align with the markings of the scale. This arrangement is such that a reading of zero could be misinterpreted as 10A.
