**AVIATION INVESTIGATION REPORT
A11A0101**

STUCK ELEVATOR CONTROL

**EXPLOITS VALLEY AIR SERVICES LIMITED
GANDER, NEWFOUNDLAND AND LABRADOR
HAWKER BEECHCRAFT 1900D, C-GLHO
10 DECEMBER 2011**

Report Number A11A0101

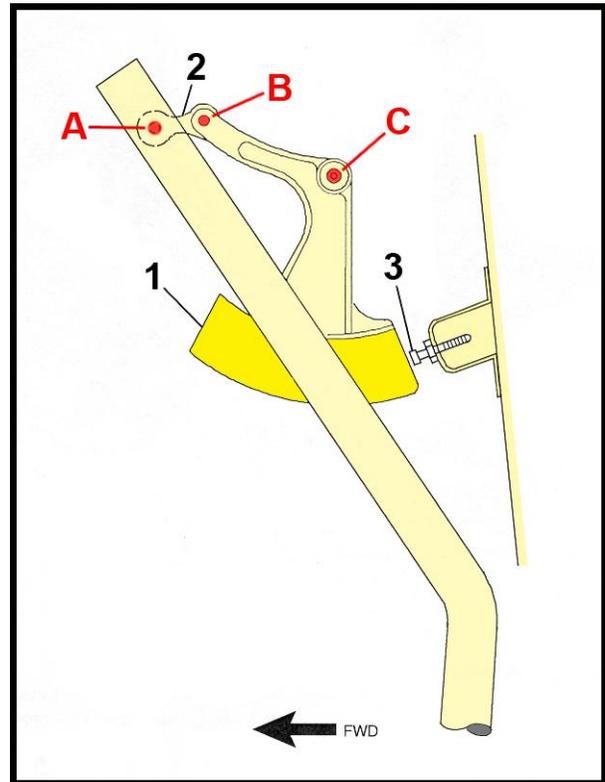
Figure 1. Control column and bob-weight

The bob-weight system (Figure 1) incorporates a bob-weight bellcrank assembly⁵ (item 1), which is connected to the co-pilot's portion of the control column through a link assembly (item 2).

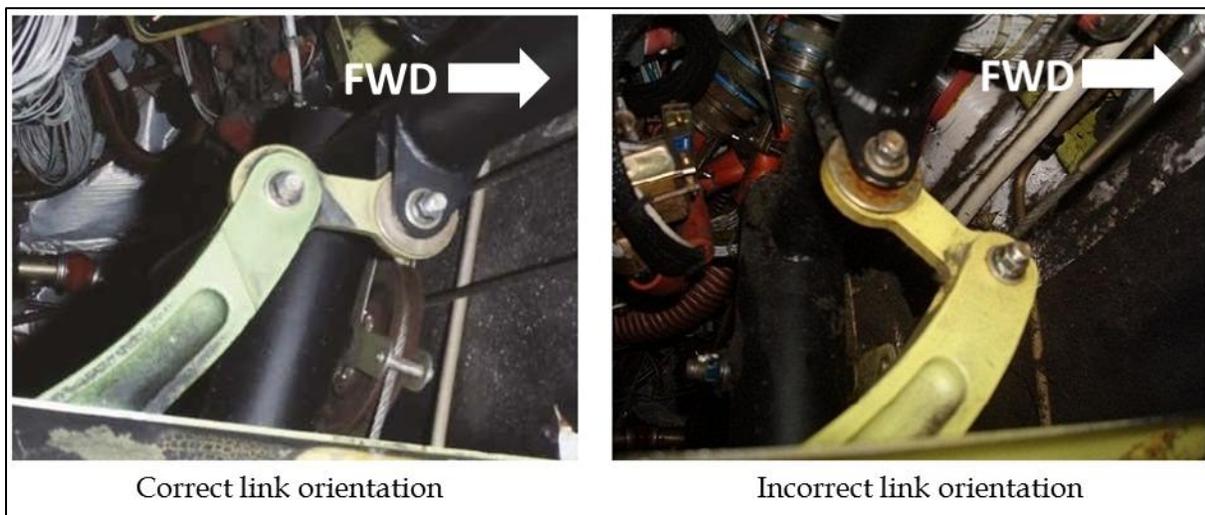
Photo 1. Bob-weight link assembly

EVAS's maintenance department examined the occurrence aircraft, and noted that the bob-weight system's link had gone over centre (Photo 1). Damage was noted on the bob-weight, the aft face of the bob-weight bellcrank mounting structure, and the stop-bolt bracket. The face of

the stop-bolt bracket was deformed rearward and to the right, causing the stop bolt to be deflected to the right. No damage was noted on the elevator primary or secondary control stops, or on any other component of the elevator control system.

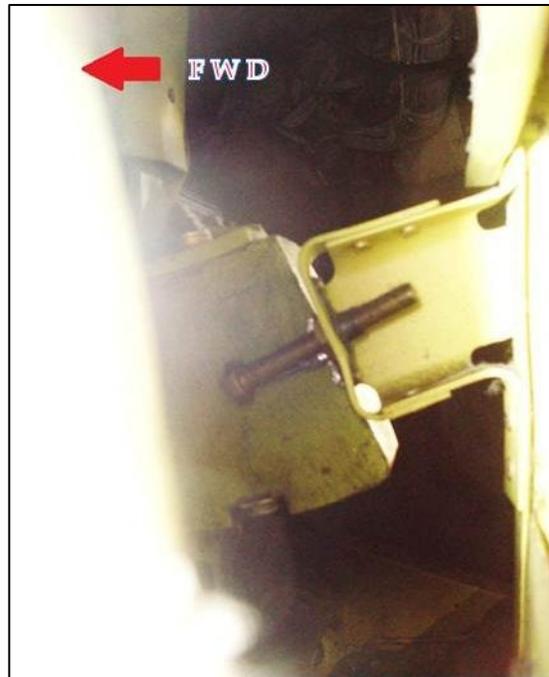
Photo 2. Bob-weight aligned with damaged area

EVAS repositioned the bob-weight by flexing the stop bolt to the left and moving the bob-weight rearward beyond its normal range of travel (Photo 2). Once aligned, the damage was noted to be consistent with the bob-weight scraping the side of the stop bolt.

When EVAS examined the aircraft after the occurrence, they had to push the stop bolt to the left to align the damage on the bob-weight with the stop bolt. Once the stop bolt was released, it would have exerted a sideways force on the bob-weight. This force would tend to hold the bob-weight in position. With the bob-weight held beyond its normal range of travel, the vertical portion of the T-shaped column would have been flexed forward. The design of the elevator position sensor system is such that it will read, and the flight data recorder (FDR) will record, movement beyond the normal range of travel. At the start of the occurrence flight, the elevator position indication was 1.1° beyond normal. This position is indicative of the control column travelling beyond its normal range of travel. The control column was stuck forward because the bob-weight became jammed on the stop bolt.

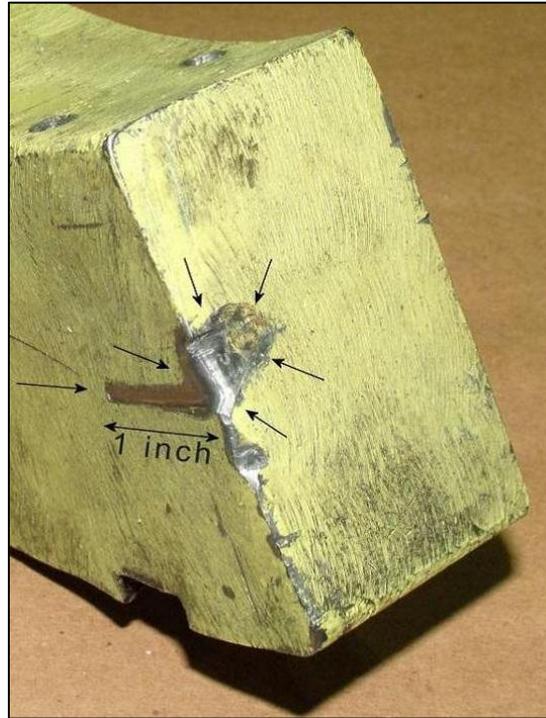
Photo 3. Occurrence aircraft bob-weight

Examination of the bob-weight showed that there were multiple imprints caused by the stop bolt, and these imprints exhibited progressive movement toward the left edge. When the stop bolt contacted the bob-weight at the edge, it was forced over and slid down the side of the bob-weight for approximately 1 inch (Photo 3).

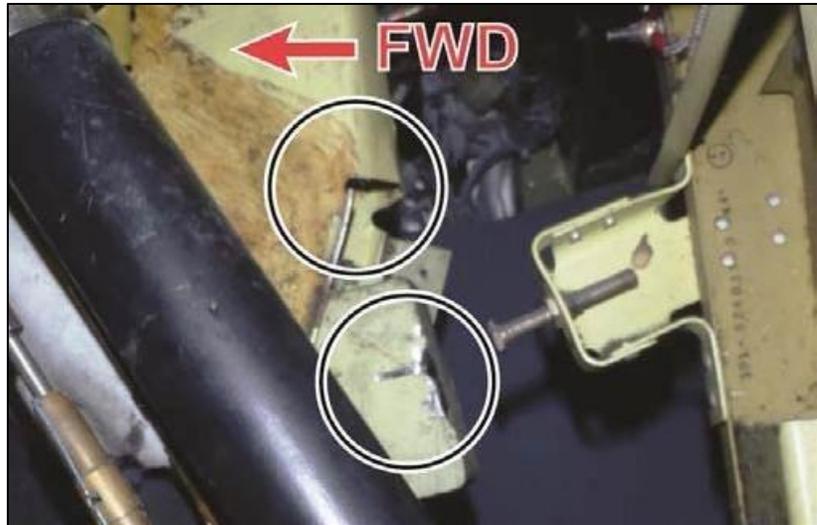
Photo 4. Damage to C-CPCY

When the company examined the aircraft's bob-weight system, it was noted that the left side of the weight had damage that was consistent with the stop bolt scraping along the surface. The aft surface of the bob-weight bellcrank support structure was deformed rearward, and the stop-bolt bracket had been deformed rearward, causing the stop bolt to align closer to the left edge of the bob-weight (Photo 4).

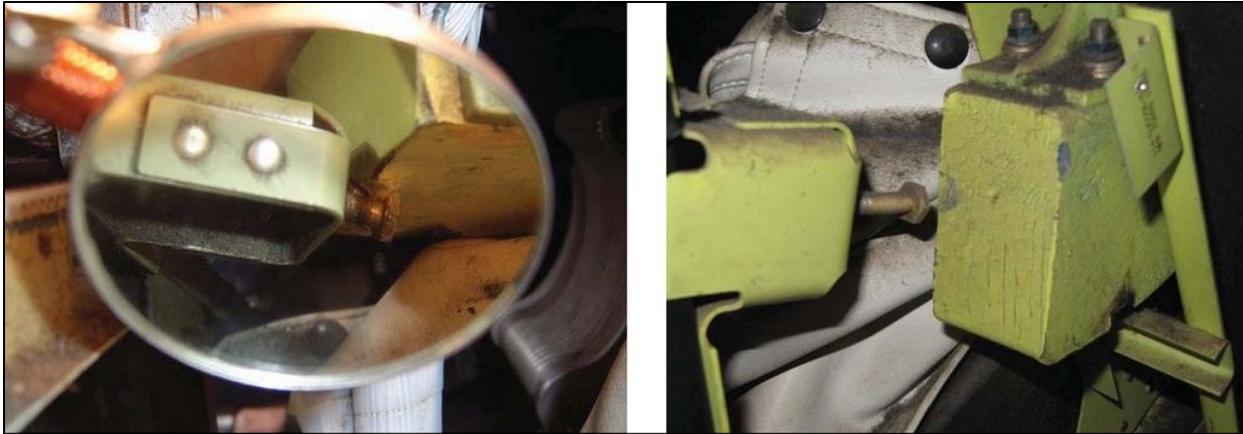
Photo 5. Model Communiqué #91 images

Model Communiqué #91 included 2 pictures: 1 showing the operator's bob-weight stuck on the stop bolt, and the other showing another bob-weight that had contacted the stop bolt on the left side of the weight (Photo 5). Model Communiqué #91 advised readers that the maintenance manual had numerous cautions advising that the control column should not be allowed to free-fall to the down position, as this free-fall could cause damage to the elevator system. HBC also reminded operators that an occurrence of this nature – the bob-weight becoming stuck on the

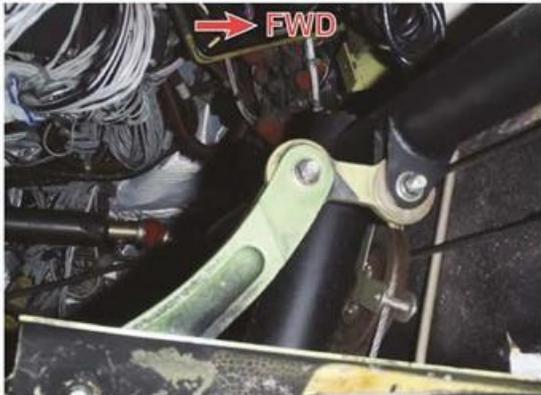
Correct Link Orientation

Hawker Beechcraft Corporation (HBC) has received two (2) reports of the elevator control system having limited nose-down control during takeoff. In this system, link assembly P/N 101-524112 connects the control column to the elevator bob-weight bellcrank. This link assembly, in each case, was reported to be overcenter, thereby restricting elevator travel.

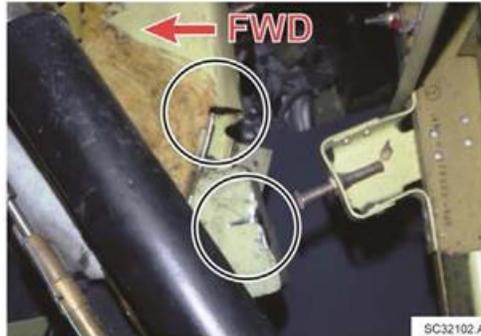
Bellcrank/Bob-Weight Damage

The overcenter condition may be facilitated by a misrigged secondary stop and/or excessively worn components in the elevator control system. One report revealed damage to the P/N 114-524061-21/-35 support structure containing the elevator bob-weight, allowing additional travel of the bob-weight.

The second report revealed an elongated bob-weight bellcrank pivot hole in the P/N 114-524061-35 support structure. Therefore, it is important to inspect all associated components for any abnormal wear or conditions per the requirements in the Maintenance Manual (MM), Chapter 5.
