**AVIATION INVESTIGATION REPORT
A11Q0052**

RUNWAY EXCURSION

**TRI MARINE MANAGEMENT COMPANY LLC
BOMBARDIER BD100-1A10, N818RC
IQALUIT, NUNAVUT
12 MARCH 2011**

Report Number A11Q0052

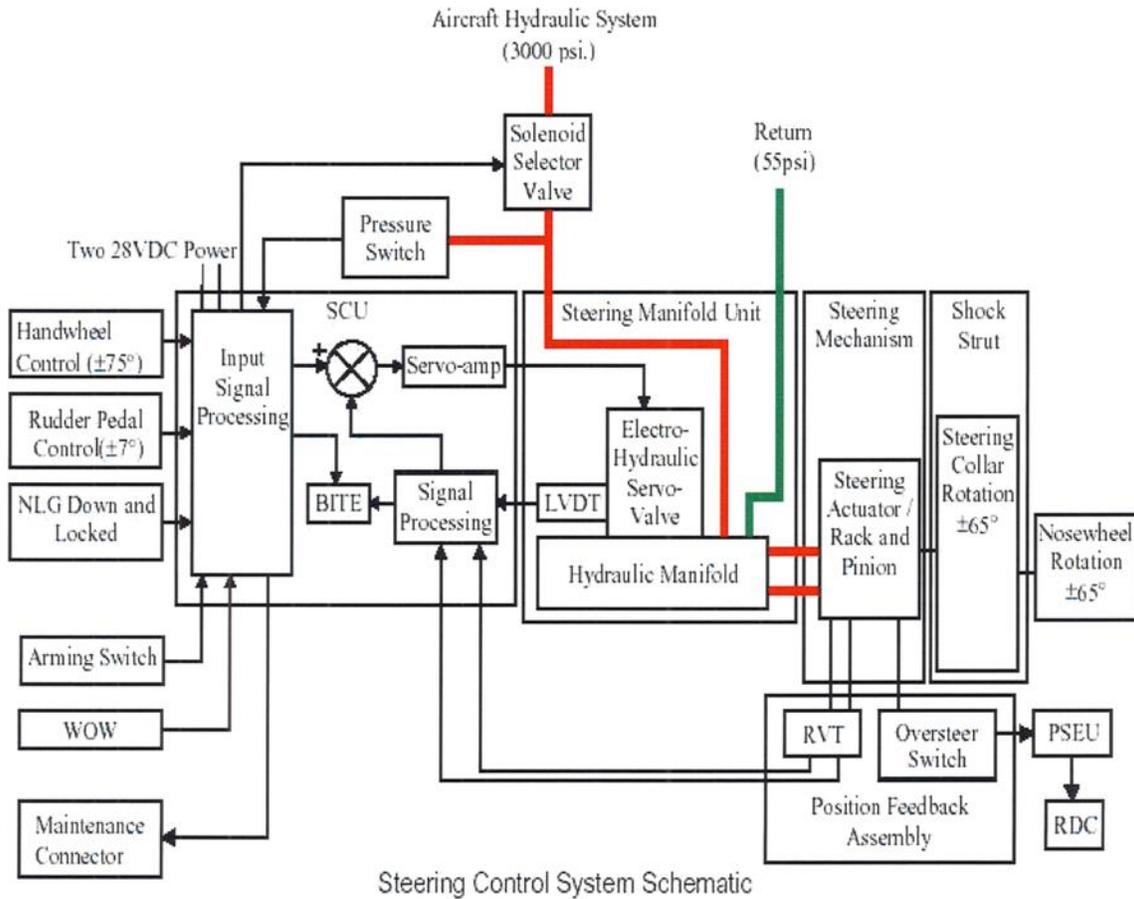
Appendix B: Nose-Wheel Steering System Operation

Following the analysis by MBD engineering of the SCU fault log entries of the non-volatile memory download, it was established that the un-commanded NWS action to the right could have been caused by 2 different parts that failed within milliseconds of each other. The EHSV⁹ did not respond to commanded current, and the SSV didn't close, which prevented the NWS system from free casting (Appendix B).

The presence of water in hydraulic fluid can have wide-ranging effects on system components, such as surface corrosion, which in turn can cause a valve to stick. The EHSV was found with internal corrosion, but this could not be explained. The EHSV did not respond to steering commands, and the steering control unit (SCU) logic commanded the SSV to close. The SSV did not close, and this condition prevented the NWS system from free casting with the steering pointing to the right.
