**AVIATION INVESTIGATION REPORT
A13O0098**

HARD LANDING AND TAIL STRIKE

**PORTER AIRLINES INC.
BOMBARDIER DHC-8-402 C-GLQO
SAULT STE. MARIE AIRPORT
SAULT STE. MARIE, ONTARIO
26 MAY 2013**

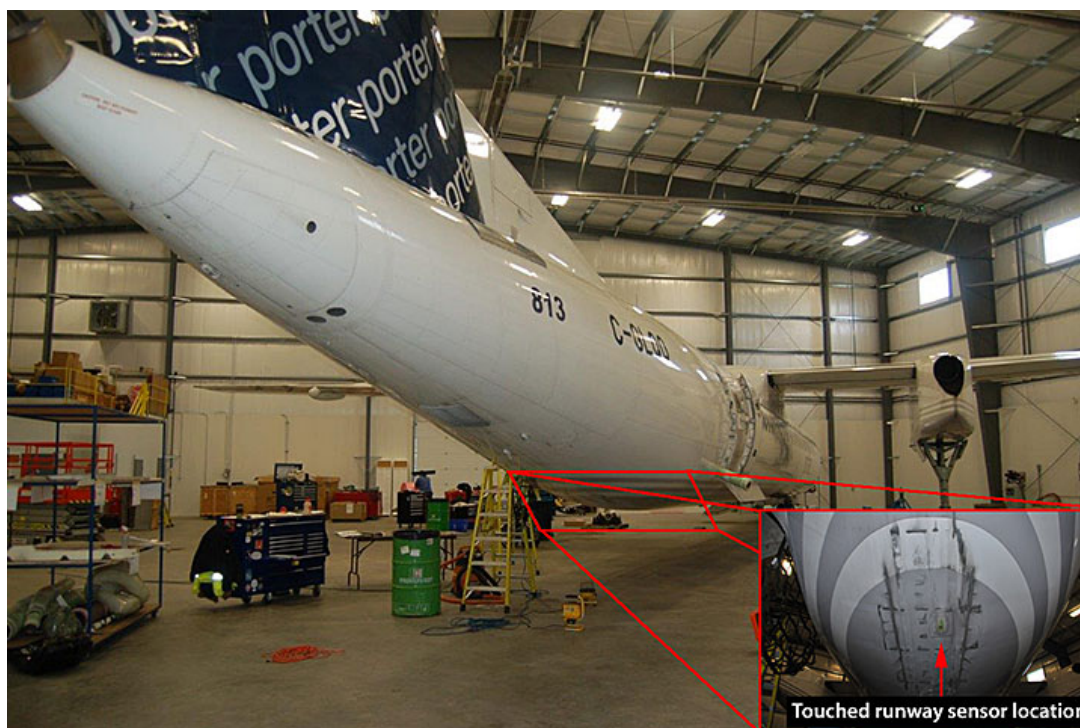
Photo 1. Damage to aircraft (Source: Altech Adjusters and TSB)

The underside of the aircraft tail section struck the surface of the runway during touchdown.

The maximum recorded pitch attitude during the landing was 7.3°. The peak value may not have been captured due to the interval of data sampling, so the pitch may have been higher than 7.3°. The recorded pitch value was consistent with the landing gear being at or near fully compressed at the time of the tail contact. The g -load⁴ on landing was 3.05.

The examination of the aircraft revealed impact and scuff marks on the skin, structural stiffeners and longerons of the lower part of the aft portion of the fuselage (Photo 1). Repairs to the aircraft included replacing the damaged fuselage skin along with the damaged structural stiffeners and longerons.

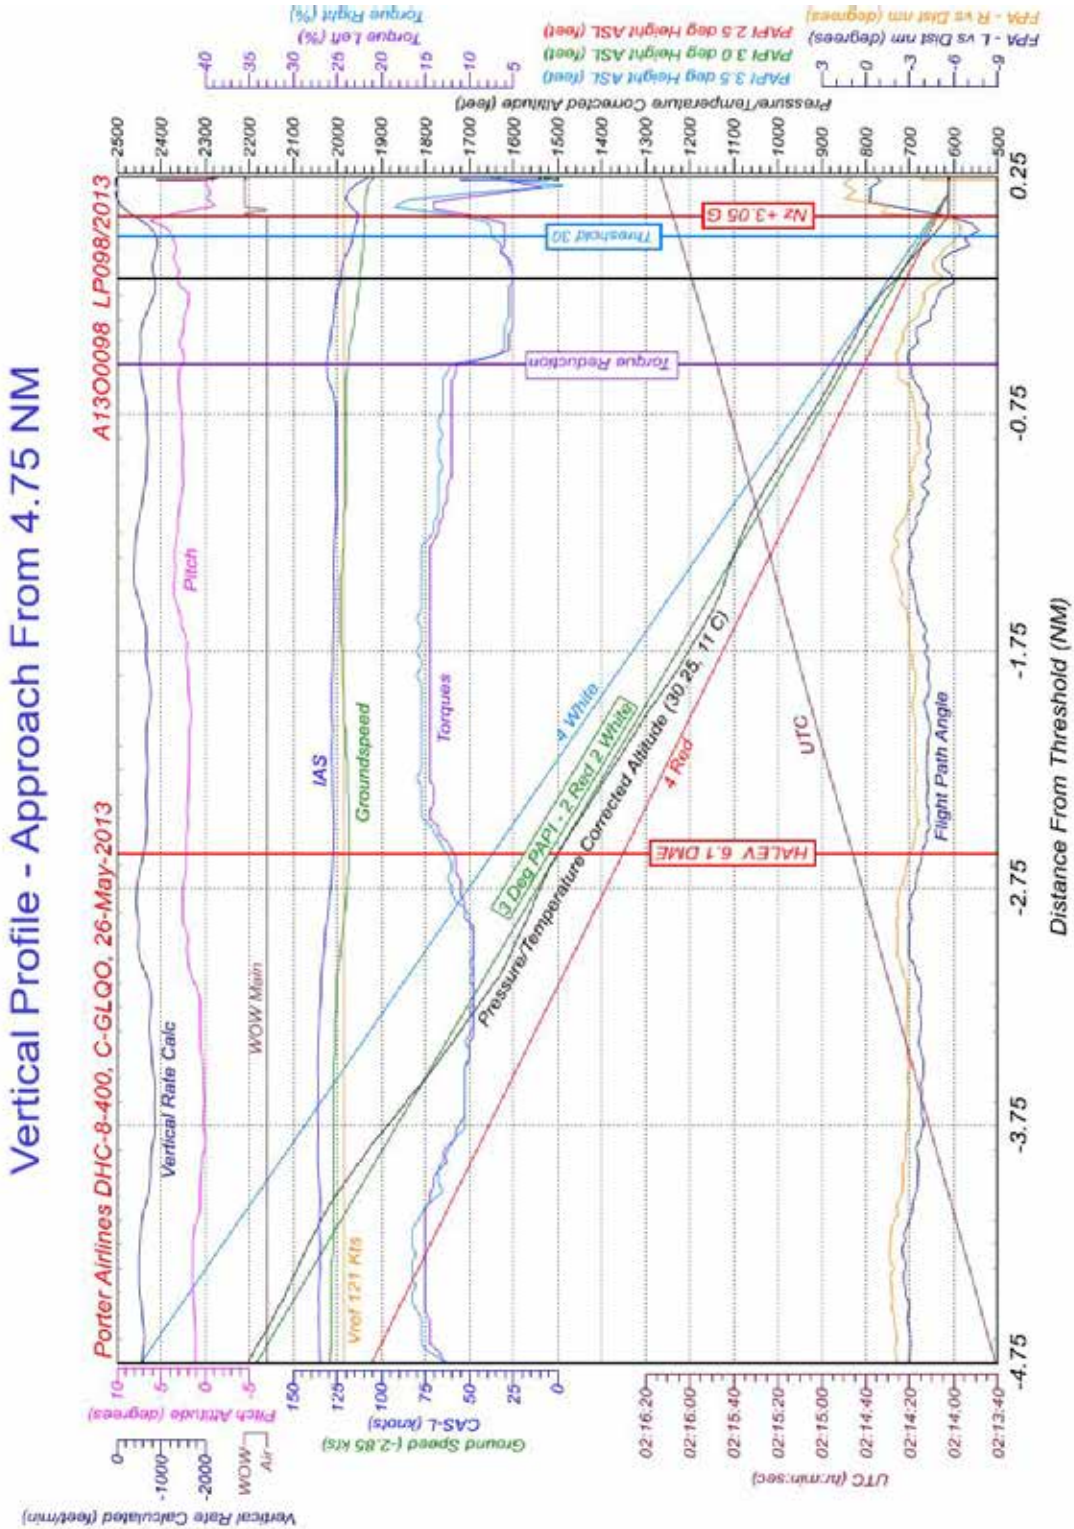
Appendix A – Vertical profile from 4.75 nautical miles

Flight data recorder information for the vertical profile of the aircraft, at 4.75 nautical miles (nm) and 1.5 nm from the threshold, is located in appendices A and B.
