**AVIATION INVESTIGATION REPORT  
A13P0163**

**ENGINE POWER LOSS, EMERGENCY LANDING, AND  
ROLLOVER**

**VIH HELICOPTERS LTD.  
KAMOV KA-32, C-GKHL  
BELLA COOLA, BRITISH COLUMBIA, 25 NM E  
04 AUGUST 2013**

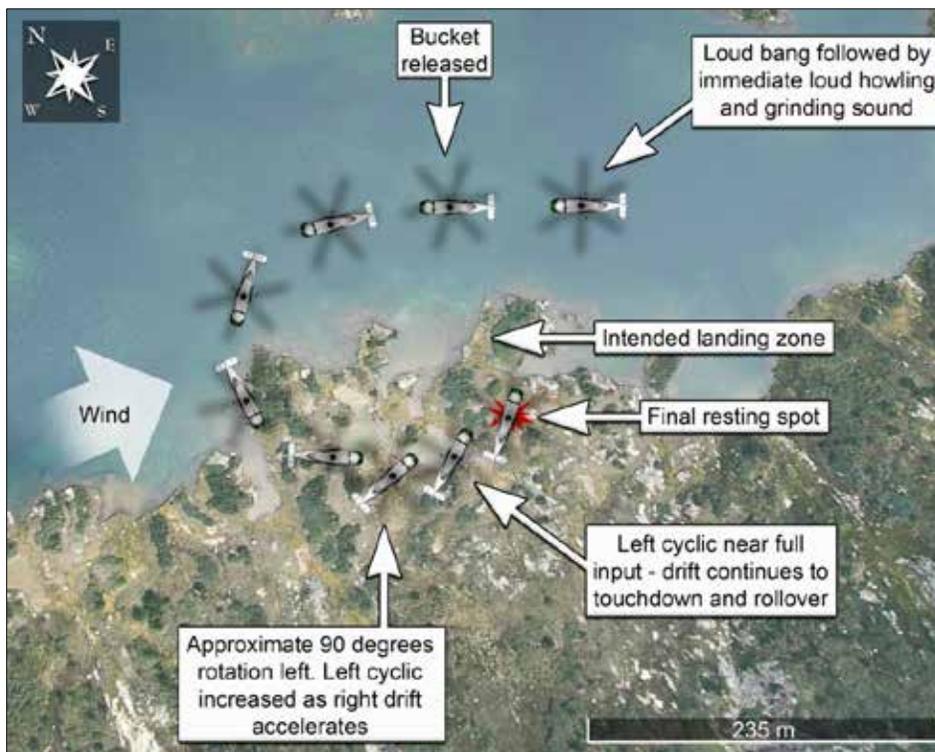
Figure 1. Sequence of events

On the second water pick-up during the third fuel cycle (Figure 1), the helicopter hovered into wind over the lake picking up water. As the crew lifted the bucket out of the lake, there was a loud bang and the helicopter began to shake excessively. The helicopter became difficult to control and descended towards the lake. The pilot not flying (PNF) released the water bucket, and the pilot flying (PF) was able to arrest the descent. The crew could not see the instruments due to the vibrations, and determined they had a problem with the rotor system. The PF flew the helicopter to the nearest place thought suitable for an emergency landing. The approach was down wind, the terrain was not level and the PF was not able to maintain the helicopter's heading constant. On touchdown, the helicopter bounced and landed on its right side (Photo 1). The rotors were turning at normal speed – about 270 revolutions per minute (rpm) – when the

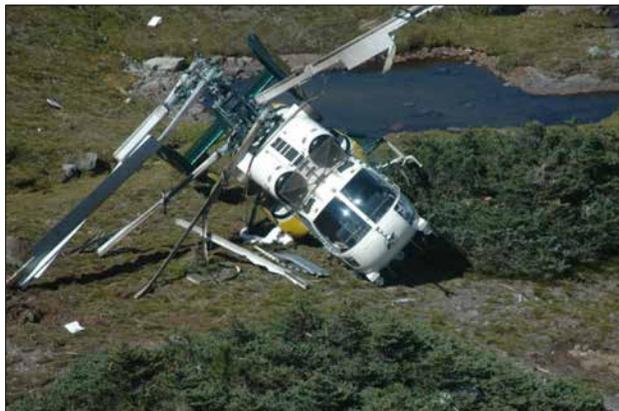
Photo 1. Damaged helicopter at the accident site

blades collided with the ground and broke. The energy in the broken blade pieces caused some of them to travel several meters from the main wreckage.

During the emergency landing, the crew had difficulty controlling the helicopter, particularly its heading. The landing surface was uneven, and the helicopter was still moving over the ground partially sideways upon touch down. This caused the helicopter to roll onto its side enough to allow the rotor blades to strike the ground.

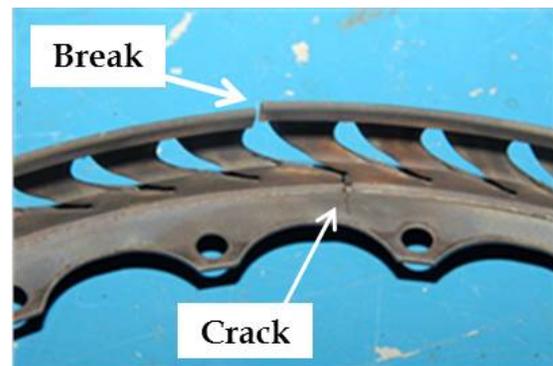
Photo 3. Guide vane retention ring failure

It was also apparent that the ring that retained the first stage guide vanes for the CT section had failed on its outer edge and cracked on the inner section of one of the guide vane slots (Photo 3). The fracture surface features were consistent with a fatigue break.

The material structure anomalies that were found are consistent with variations in the heat treatment during manufacture, and reduce resistance to failure. Additionally, the anomalies in the 1st stage guide vane retention ring would have allowed the guide vanes to move and warp, thereby causing unanticipated gas flow patterns within the compressor turbine. This likely caused the fatigue cracking and breaking of the retention ring. This, combined with the anomalies in the material structure of the CT blades, likely caused one or more of the CT blades to fail. Furthermore, the hole on the low pressure side of one of the guide vanes may have added to the gas flow pattern changes.

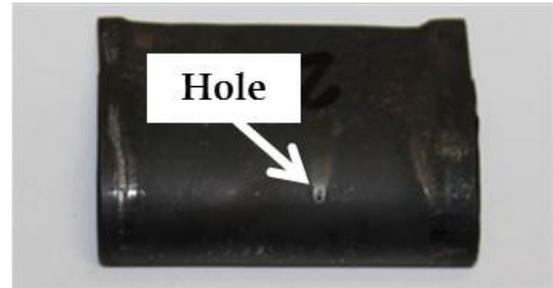
Photo 4. Guide vane with hole

All but one of the guide vanes demonstrated normal in-use wear (some erosion and material separation). The exceptional guide vane had a small hole on its low pressure side (Photo 4). Microscopic examinations revealed that the hole was not manufactured. These vanes are designed with holes on the high pressure side that allows charged air to exit on that side for temperature and airflow control. Air exiting on the low pressure side will cause unanticipated turbulence in that area of the engine.

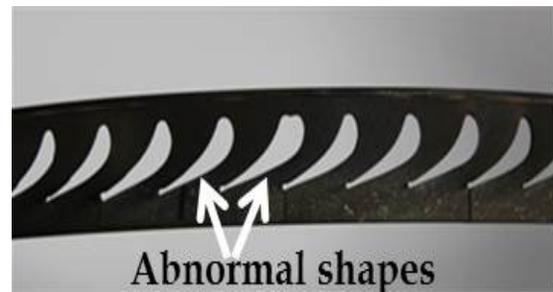
Photo 5. Retention ring manufacturing anomalies

The guide vane retention ring, which has slots the guide vanes fit into, showed anomalies in the size and shape of the slots (Photo 5). Microscopic examinations revealed that the slots had been machined to different shapes during manufacture, rather than worn into these different shapes.

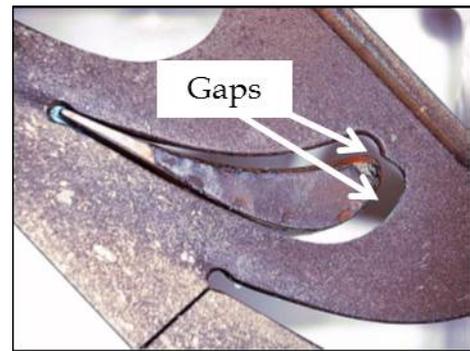
Photo 6. Guide vane in slot

The manufacturing anomalies in the guide vane retention ring slots were clearly visible to the naked eye. These anomalies, which show up as gaps, were even more evident when the guide vanes were installed (Photo 6). The guide vanes should fit in the slots tightly; there should be no visible gaps. The fact that obvious anomalies like these were missed during the manufacturing and assembly of the engine components may indicate a problem with quality control. If poor quality control in the manufacture and assembly of Klimov TV3-117 helicopter engine components is systemic, helicopters with these engines are at risk of failure, which can have serious consequences for aircraft, crew, and passengers.
