MARINE INVESTIGATION REPORT
M98L0139

FIRE ON BOARD

GENERAL CARGO SHIP "SOUTHGATE"
GRANDE-ANSE, QUEBEC

26 OCTOBER 1998

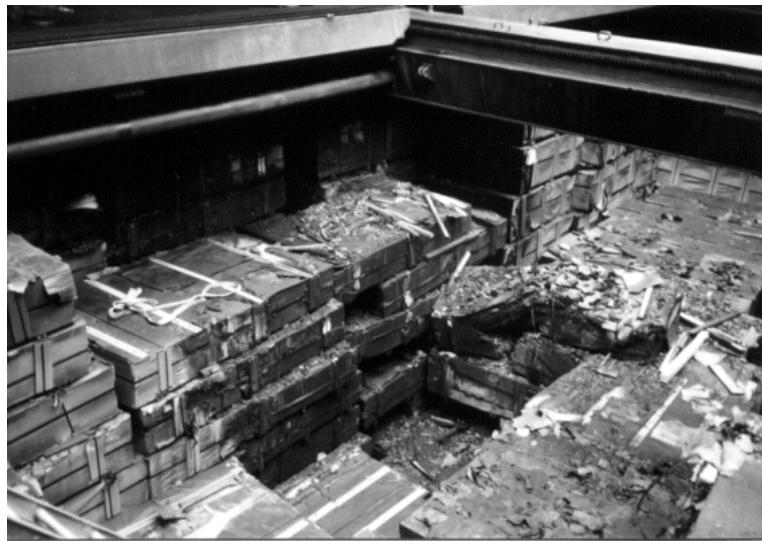
On November 3, hold No. 5 was opened again in the presence of the crew and firefighters from the fire department of the Ville de La Baie and the Canadian Forces Base at Alouette, Quebec. Environment Canada took samples of the atmosphere, which revealed no formation of hydrocyanic or formaldehyde gas. Upon issuance of a Tank Entry Permit by an independent chemist, the crew and firefighters descended into the hold and found that the fire was out.

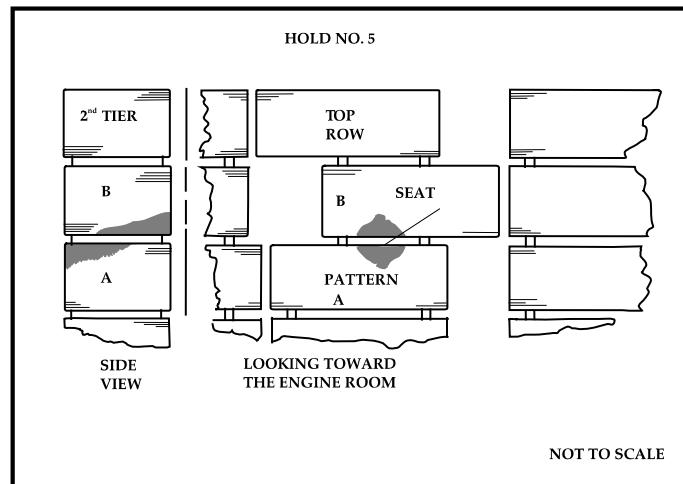
Observers of the fire agree that the first orange flames were noticed in the second bay from the aft bulkhead between the second and third tiers from the top. A centre of fire was found there. The second centre of fire was under the first centre of fire, but near the tank top. The second centre of fire near the tank top and the third centre of fire in the third bay were probably the result of secondary fires. The whitish-coloured smoke was probably actually light grey, and the subsequent black smoke was probably a dark-brown colour. These colours of smoke and flame are associated with burning wood.

1. It is probable that a cigarette end was discarded in the space between the bundles of MDF where orange flames were seen in what was later determined to be the seat of the primary fire.
