MARINE INVESTIGATION REPORT

M98M0061

COLLISION

YARMOUTH HARBOUR, NOVA SCOTIA

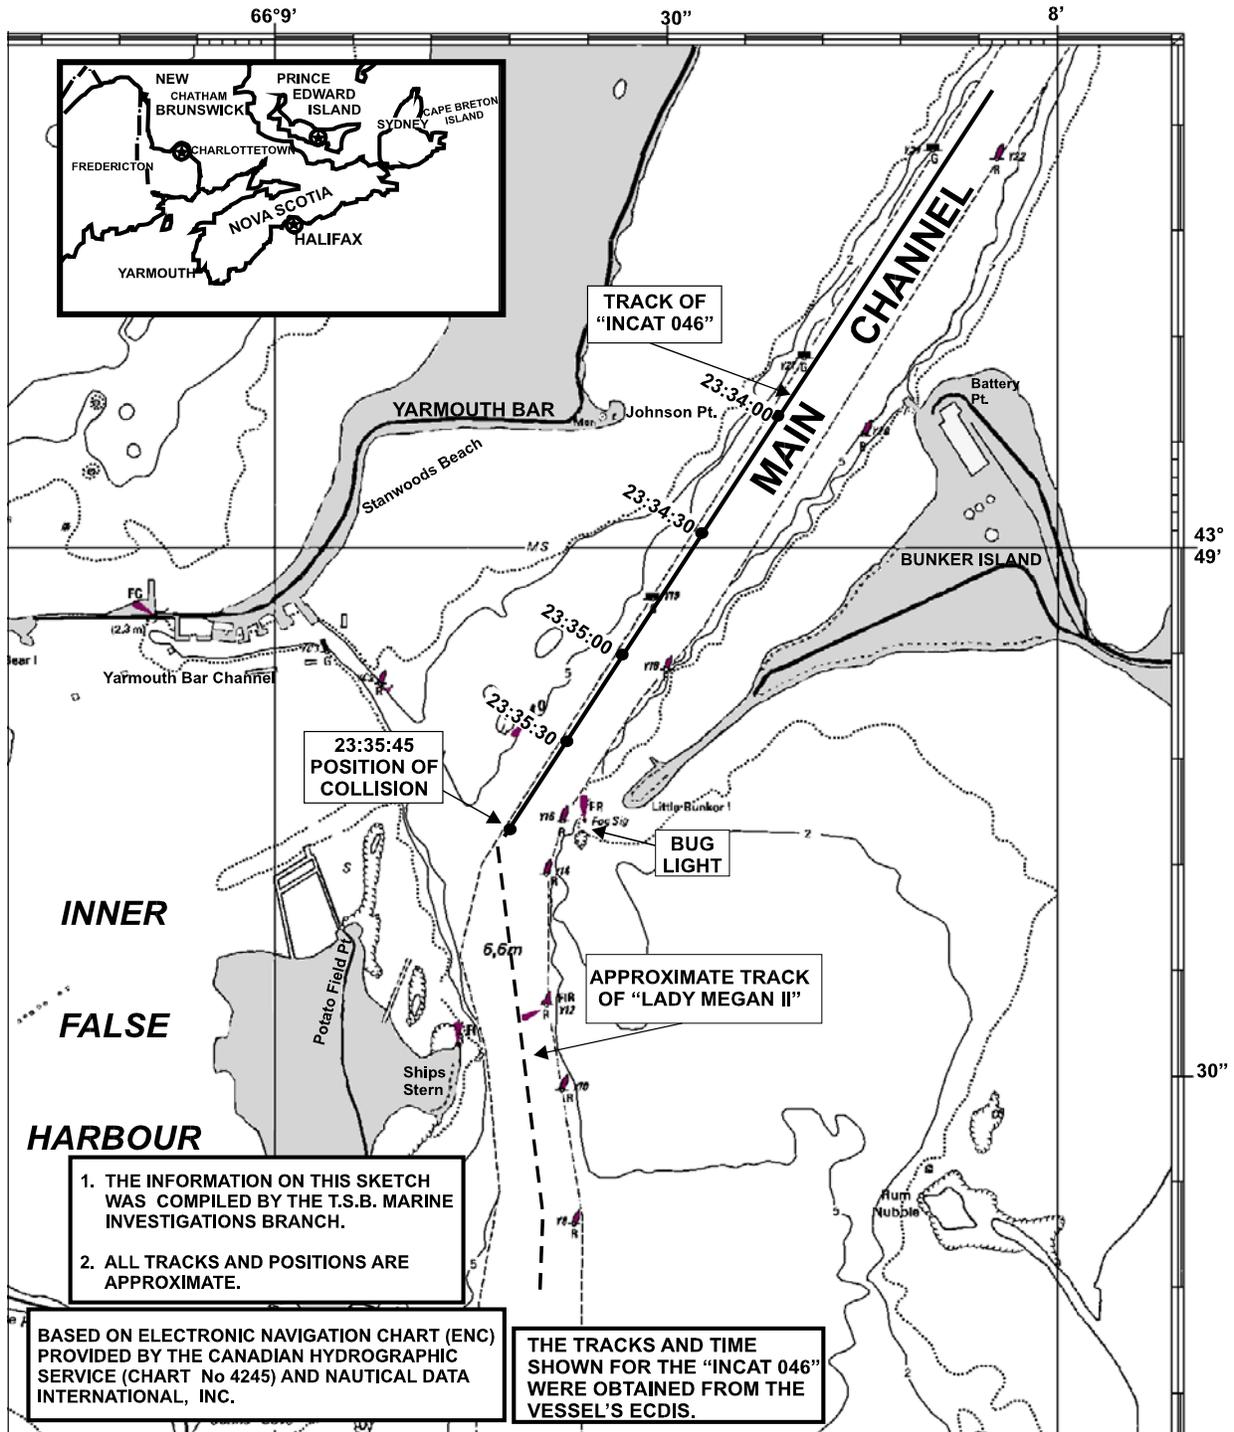
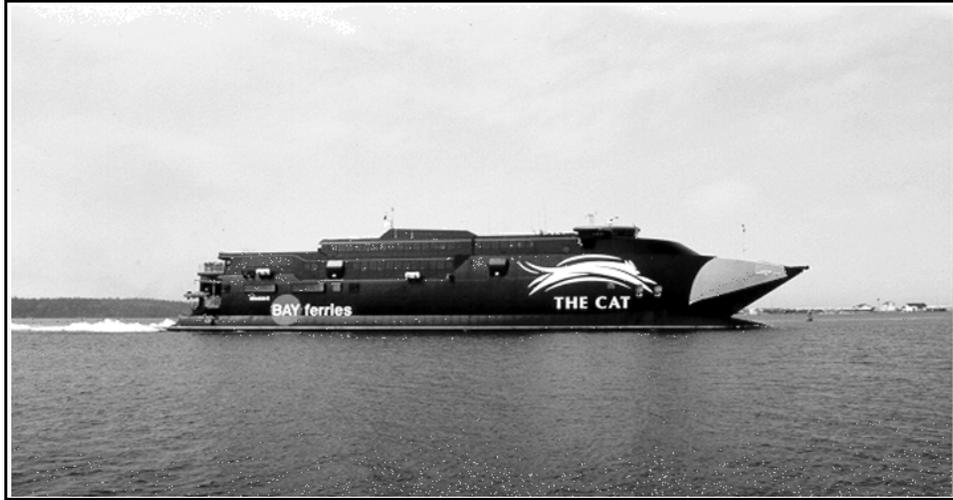
Appendix A - Sketch of the Occurrence Area

The collision occurred at about 2335:45, 111 m northwest of Bug Light on the western edge of the Main Channel at position 43°48.779' N, 066°08.665' W. Due to the design of the fast ferry catamaran, the fishing vessel did not glance off the hull, as commonly happens during a bow-on collision between a small and a large vessel. The fishing vessel's wheelhouse collapsed on impact with the underside of the weather deck, between the port pontoon and the centre hull of the "INCAT 046".

9. The “LADY MEGAN II” crossed over the 76 m wide channel and collided with the “INCAT 046” at the western edge of the Main Channel.
10. The crew of the “LADY MEGAN II” did not see the side lights of the “INCAT 046” at any time, initially because of the existing visibility and subsequently because the fishing vessel was close to the bow of the catamaran where her lights, positioned on the outside of each hull, were not visible.
