MARINE INVESTIGATION REPORT

M98M0078

CAPSIZING

A MUSSEL-HARVESTING PUNT
TRACADIE BAY, PRINCE EDWARD ISLAND
22 OCTOBER 1998

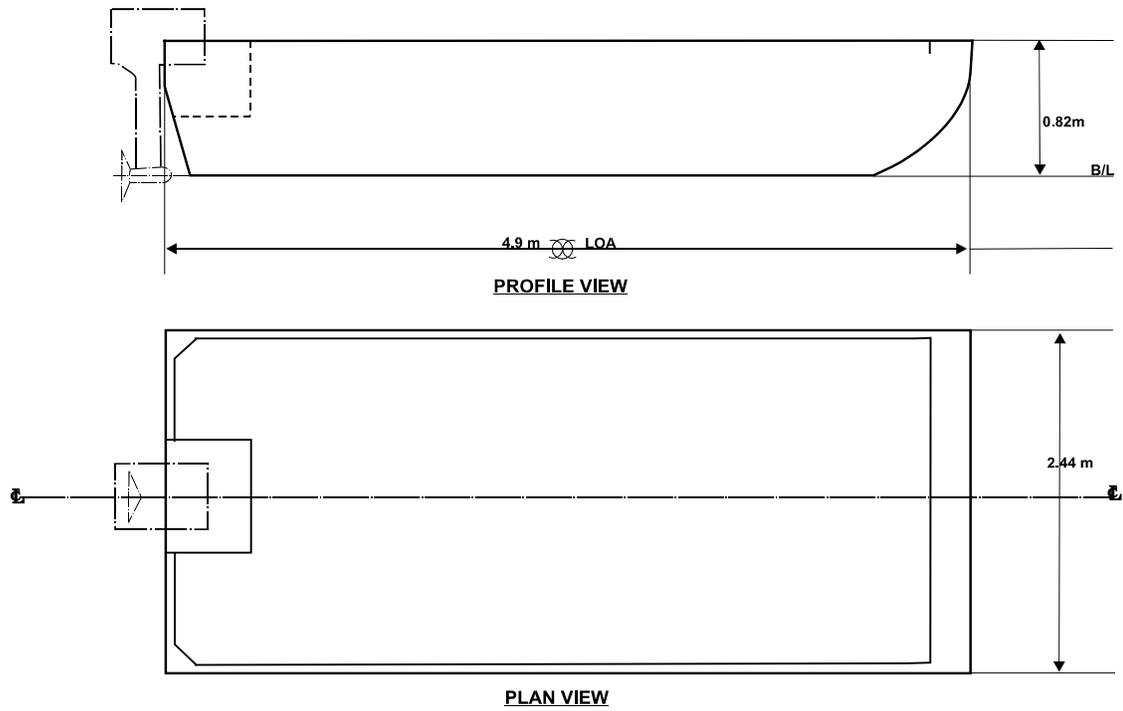
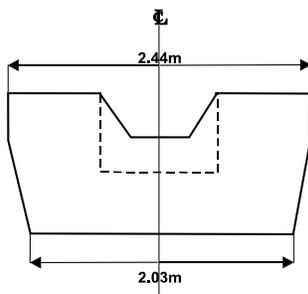
Appendix A - Outline General Arrangement of Mussel Punt

The mussel harvesting punt is an aluminum, open, flat-bottomed boat. The bow and stern are similar. The punt does not have a double bottom or accommodation, and no seating is provided for those on board. It is powered by a 60 horsepower outboard motor controlled and steered from a station at the bow on the starboard side. The vessel's basic layout is shown in Appendix A.

The outboard motor is mounted in a deep well at the centre of the transom. The punt is equipped with a hydraulic articulated hoist on the centreline near the bow. The hoist is powered by a pump driven by a portable gasoline engine mounted at the stern on the port side. The punt is also equipped with a non-automatic electric bilge pump with a capacity of about 1.57 L/s. The punt is not equipped with a radio.
