MARINE INVESTIGATION REPORT

M99L0098

GROUNDING

PASSENGER VESSEL *NORWEGIAN SKY*  
OFF ÎLE ROUGE, ST. LAWRENCE RIVER, QUEBEC

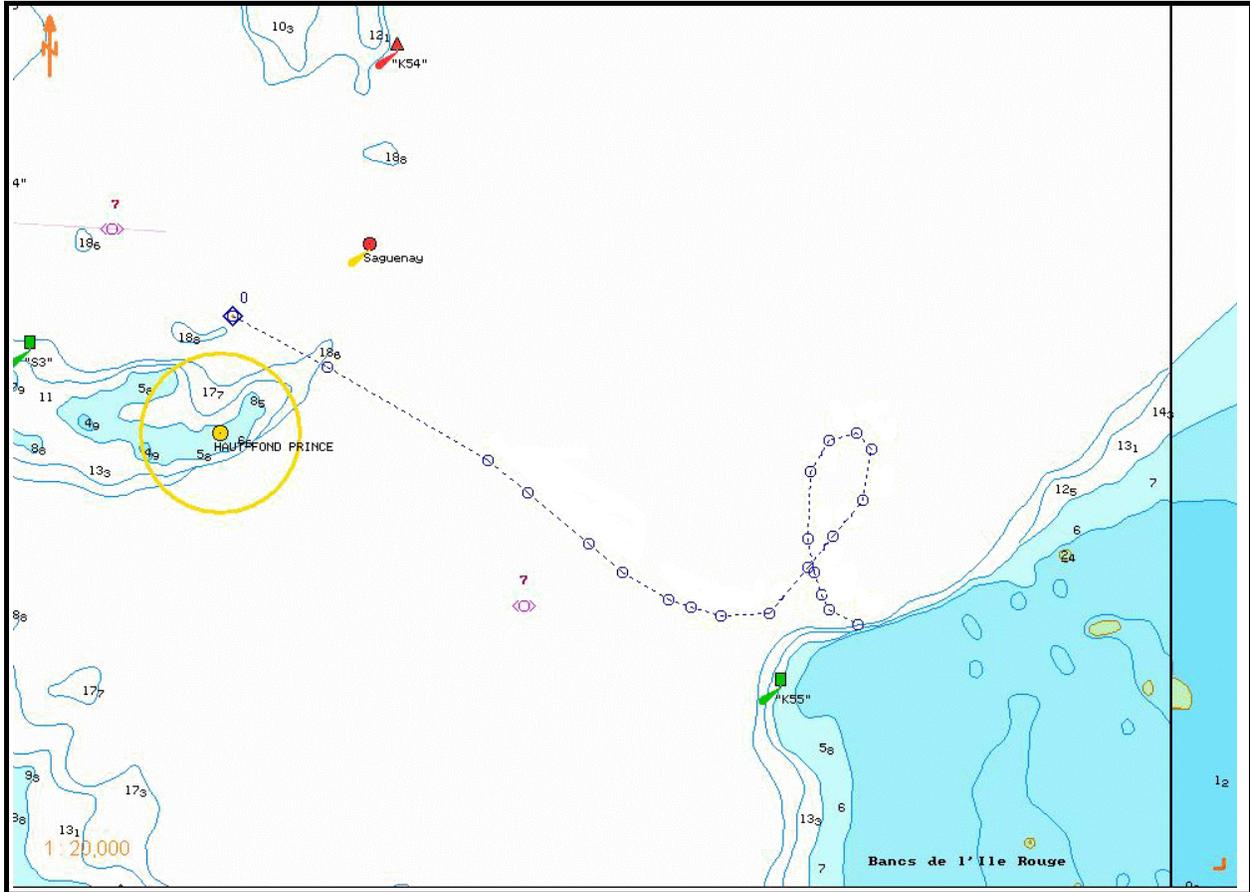
*Appendix A: Track of the Norwegian Sky*

Using the Pointe Noire range, the pilot conducted the vessel down the buoyed channel. At about 1120, near buoy S3, helm orders were given to steer a course of 115°G (the gyrocompass error was negligible) for buoy K55. The pilot adjusted the radar variable-range marker to two nautical miles (nm) and asked the master to gradually reduce the vessel's speed. The master moved the speed levers and oversaw progress of the vessel by visual observation. Near the Bancs de l'île Rouge (Rouge Island Banks), at about 1133, the pilot noticed that the target of Haut-fond Prince (Prince Shoal) light was nearing the variable-range marker and that whales were now grouped downriver of buoy K55. Consequently, he ordered the helmsman to turn the helm 20° to port to head toward Les Escoumins pilot station. At about 1141, the vessel settled on a course of approximately 030°T, heading toward the pilot station. At approximately 1148, the pilot realized that the whales were now abaft the port beam and, therefore, ordered 20° port helm (See Appendix A).

By 1204, with the heading about 076°G and decreasing, the rate of turn had increased to 47.1° per minute. The vessel's stern made bottom contact with the shoal. The vessel slowed and the stern came to rest on the Bancs de l'île Rouge. At 1206, the vessel was aground, listing 5.2° to port, heading 074°G, in position 48°05.8' N, 069°33.5' W. The electronic chart system (ECS) showed a speed of zero knots at 1206.52 (See Appendix B).

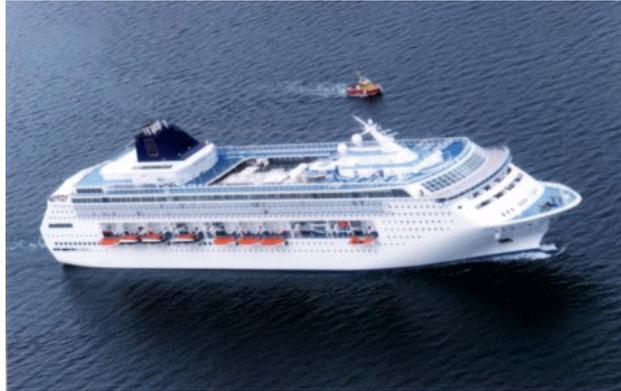
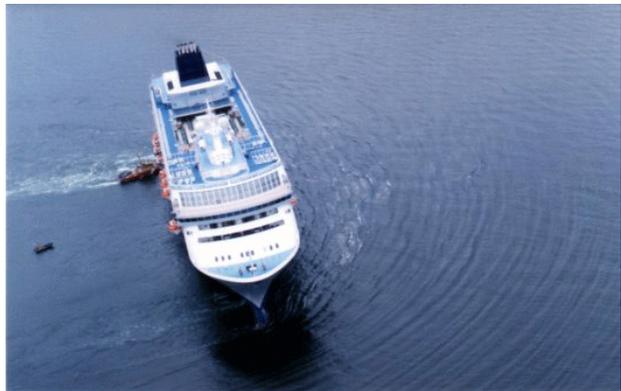
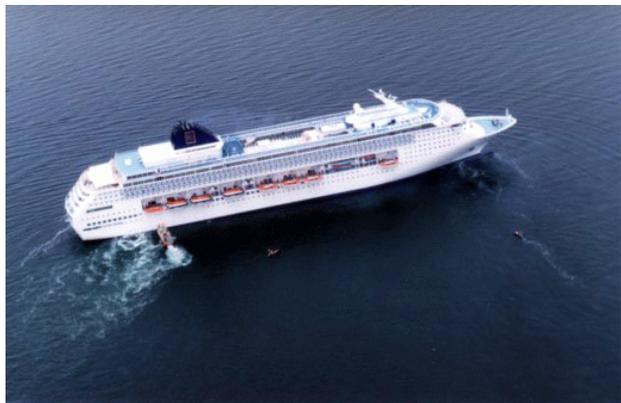
*Appendix B: Photographs*

At the dry dock in the port of Québec, the vessel was observed to have sustained extensive damage to the starboard rudder, both propellers, stern thruster No. 1, and the shell plating and adjacent internal structures. The starboard propeller hub was found to have sheared into two parts, and a void space in the bulbous bow section was also holed.

All damaged parts were replaced, and shell plating that sustained indentations more than 10 mm deep was cropped and renewed to restore the vessel to its original condition. As a result, the Certificate of Class remained valid without restrictions.
