MARINE INVESTIGATION REPORT

M99W0058

STRIKING BOTTOM

THE BULK CARRIER "CAPE ACACIA"  
WEST KINAHAN ISLAND, PRINCE RUPERT HARBOUR  
9 APRIL 1999

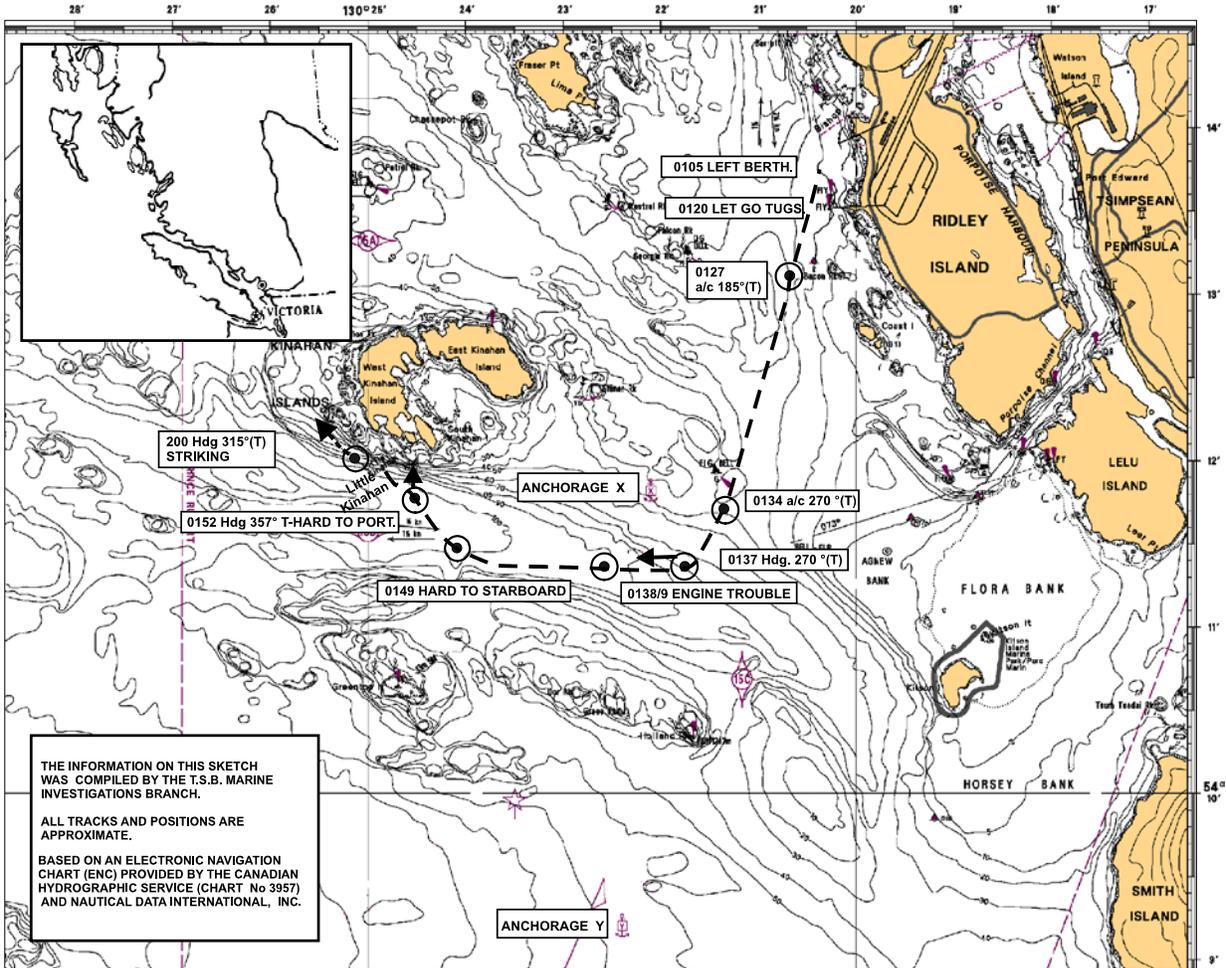
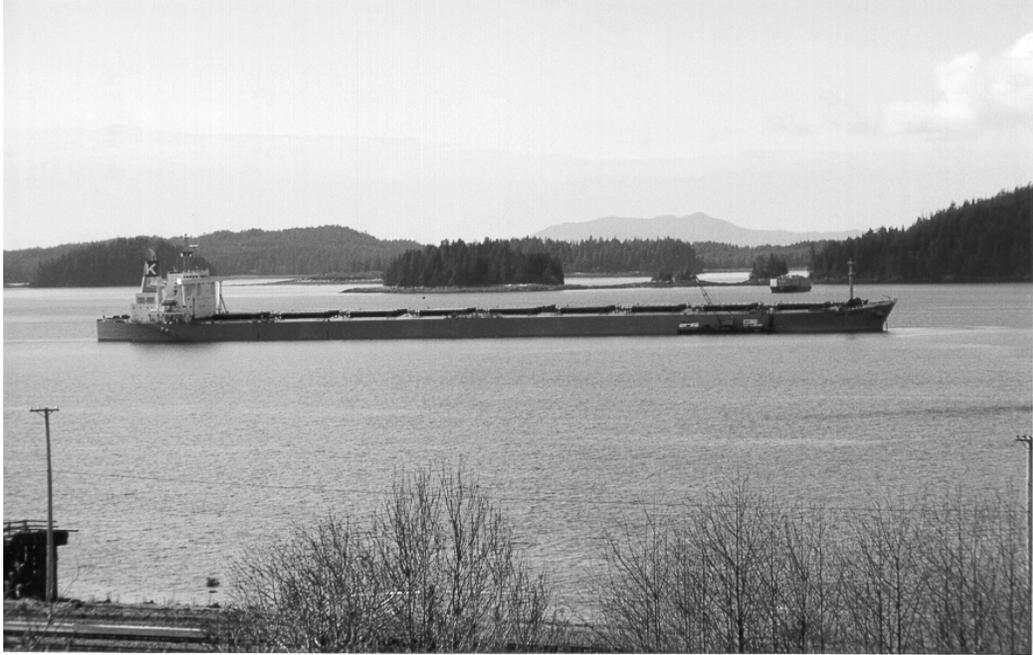
Appendix A - Sketch of the Occurrence Area

5. The "CAPE ACACIA" struck a rocky bottom south of West Kinahan Island, immediately inside the 20 m contour line, during darkness, in fine weather and clear visibility. The starboard underwater section of the bow was badly damaged.

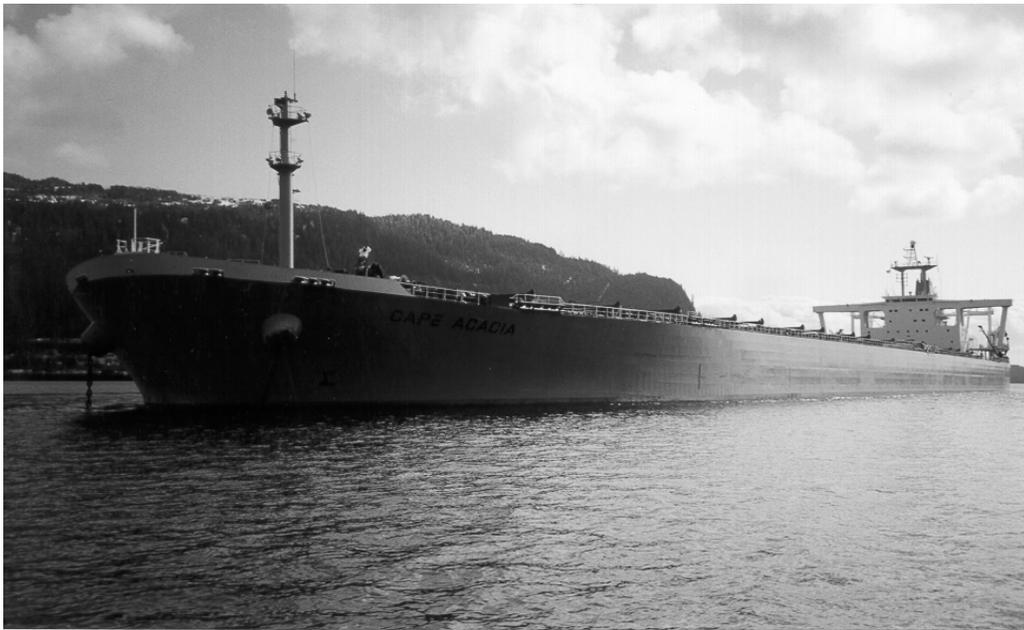
*Appendix B - Photographs*

Damage was limited to the forward underwater section of the vessel. The bottom shell plating in way of the forepeak tank (FPT) had a number of holes and tears, with a maximum size of approximately 5 m x 2 m. The bottom shell plating in way of No. 1 DBWBT had three holes with a maximum size of 700 mm x 150 mm. The collision bulkhead between the FPT and No. 1 starboard DBWBT had cracks at the connection to the bottom strake. Additional denting and scratching was found at the bow section.
