MARINE INVESTIGATION REPORT

M02L0021

HULL FRACTURE

BULK CARRIER *LAKE CARLING*
GULF OF ST. LAWRENCE, QUEBEC

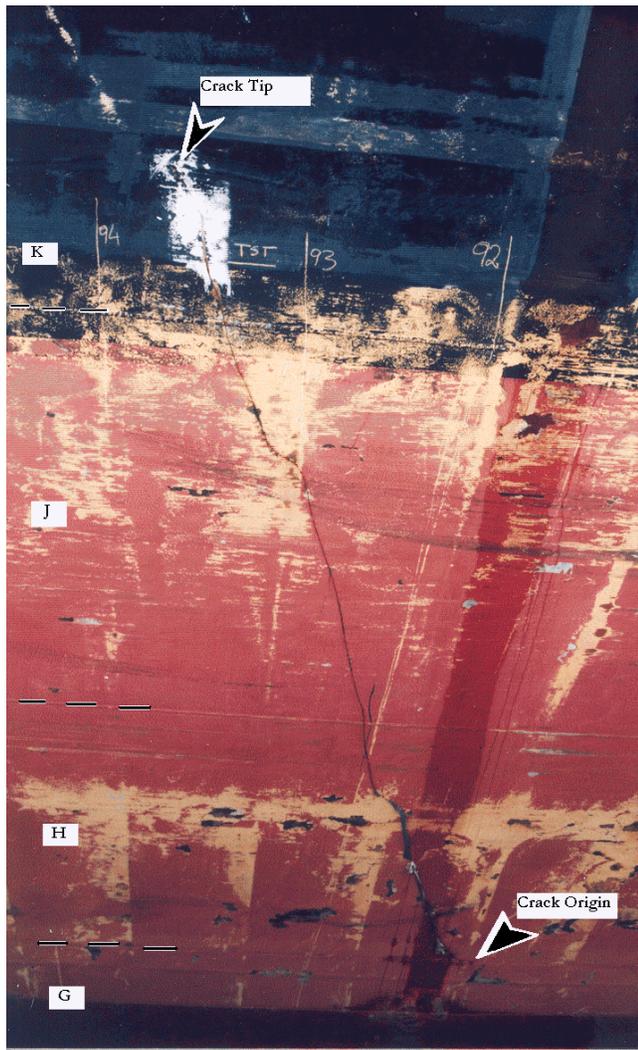
The fracture had not grown appreciably since the initial discovery, as a crack-arresting hole had been drilled at the crack tip to limit the growth of the fracture.

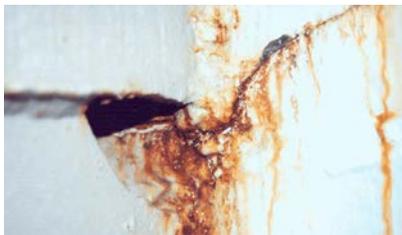
The principal side shell fracture was on the port side at frame 91, extending upwards and forward from the toe of the weld at the base of the side shell frame. The fracture traversed frames 92 and 93 through H and J strakes, terminating just short of frame 94 (K strake) in No. 4 upper water ballast tank, which was empty at the time. The shell fracture divided at the juncture of the ballast tank sloping plate; one branch continuing for 45 centimetres (cm) on the ballast tank sloping plate at approximately 90° from the juncture point—the other branch on the ship's side continuing up and forward for approximately 40 cm past the juncture point. The total length of the fracture at the ship's side was in the order of 6 m. Visual inspection and laboratory analysis indicates that the principal fracture originated at the base of frame 91 (at the toe of the weld).⁴ The fracture origin was located 1.3 m below the neutral axis of the vessel's midship section modulus.

The principal fracture was the forward half of a crack manifestation that presented itself on either side of the base of the frame. Five similar crack manifestations were found in No. 4 hold; on the port side, at frames 89 and 93, and on the starboard side, at frames 85, 91 and 96. All crack manifestations appeared to originate near the base of the frame at the toe of the weld, and giving rise to two cracks, one forward and one aft of the frame, each some 75 millimetres (mm) in length and generally in a characteristic "V" formation. Some typical examples found on the port side are shown below (See Photos 3, 4 and 5). All of these cracks were rusted and appeared to have been present for some time.

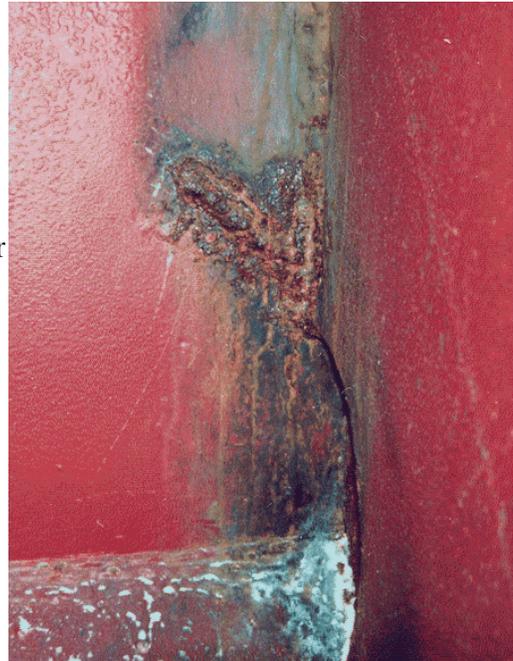
In No. 2 hold, four crack locations were also found; on the starboard side at frames 171½ (See Photo 6) and 172½, and on the port side at frames 144 and 145. In contrast to the cracks in No. 4 hold, all of the cracks in No. 2 hold had been covered with superficial weld repairs. The weld repairs had penetrated only a few millimetres into the thickness of the hull plate. It was not determined when, or by whom, these repairs were undertaken, nor is there any record held by DNV of these cracks or the repairs. In contrast to the crack manifestations in No. 4 hold, not all of these cracks were present both fore and aft of the frame, such as at frame 171½, where the crack was only forward of the frame.

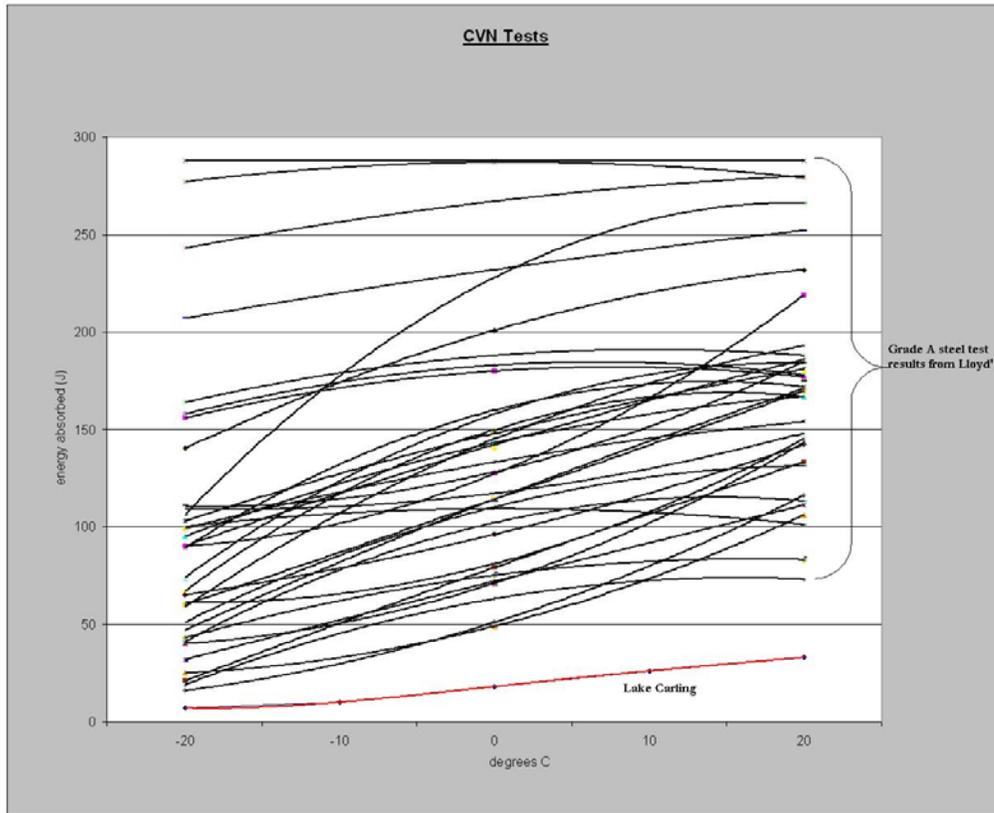
Appendix B - CVN and Grain Size Comparison

The *Lake Carling* metal samples demonstrated a FATT of 32° C. The ASTM grain size of the sample tested was found to be in the order of 5 to 6.

The grain size and CVN impact energy, and thus the corresponding fracture toughness, of the grade A steel used in the construction of the *Lake Carling* was well below the defacto standard when compared to average values of grade A steels available worldwide. This steel performed below expectations and did not provide a reasonable damage tolerance in all operational conditions.
