MARINE INVESTIGATION REPORT
M03W0265

COLLISION

BARGE *PACKMORE 4000* UNDER TOW BY TUG *TIGER SHAMAN*

FRASER RIVER NEAR MISSION, BRITISH COLUMBIA

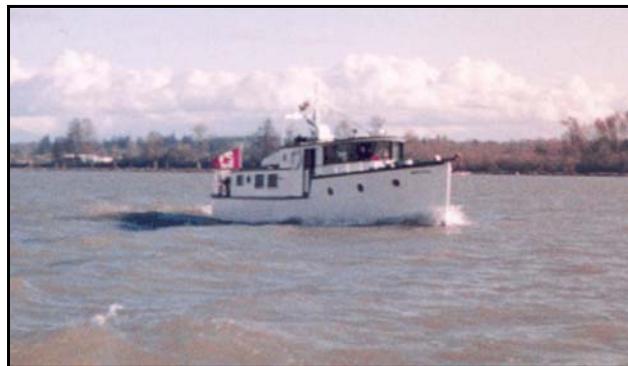
Photo 1. Pleasure craft *Mistral*

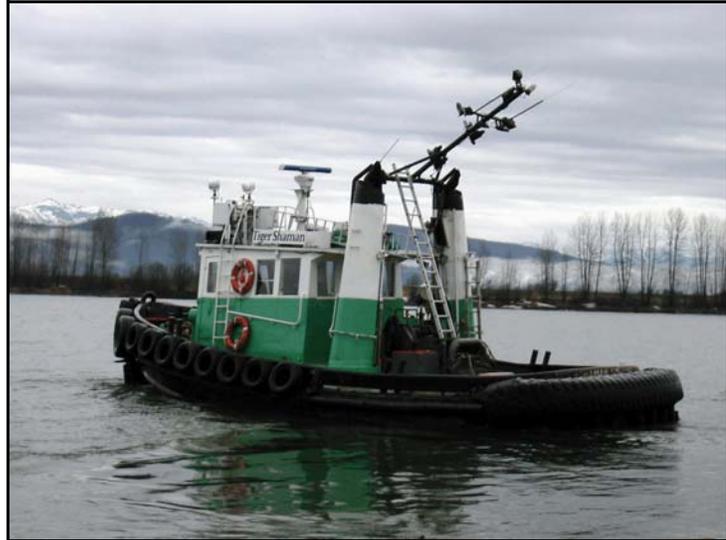
Photo 2. Tug *Tiger Shaman* with mast lowered 45 degrees

When the *Tiger Shaman* was approximately 1800 m west of the highway bridge, the tug's main mast was lowered by tilting it backwards about 45 degrees, the mast lights remaining lit. This was done to reduce the tug's air draft.

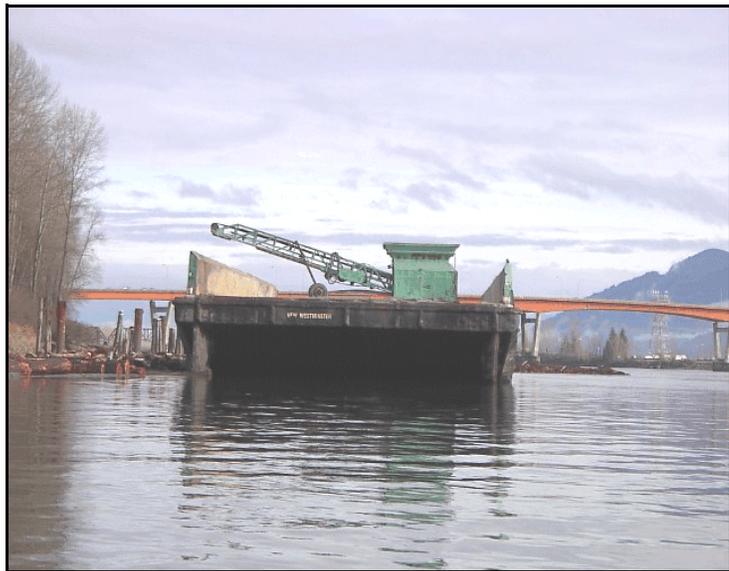
Photo 3. End view of barge *Packmore 4000*

The barge *Packmore 4000* had fresh paint scuffs on the starboard side of the bow.

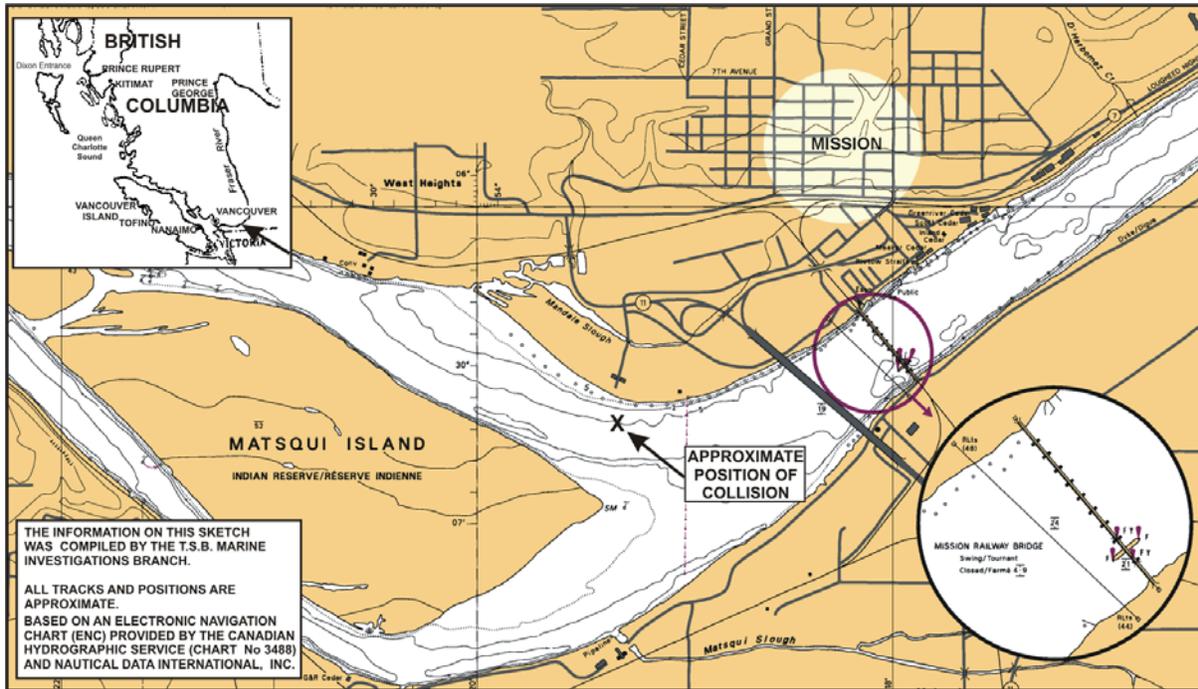
Figure 1. Fraser River, north of Matsqui Island, where collision occurred

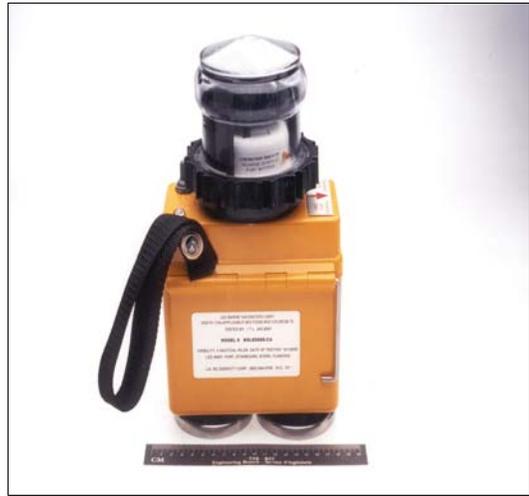
Photo 4. LED barge navigation lamp

However, the vertical sector of the emitted light from the lamp exceeding 12 candelas was approximately 1.8 degrees, and the vertical sector exceeding 7.2 candelas was 4.9 degrees.

- A potential exists to misalign the head and base assemblies of these lamps. This may result in a lamp's failure to meet the horizontal luminous intensity requirement. The manufacturer does not provide alignment documentation.

1. The misalignment of a Light Emitting Diode (LED) barge navigation lamp could significantly reduce its visible range, due to the narrow vertical sector of emitted light, and as the manufacturer does not provide alignment documentation.
2. The exemption of unmanned barges lamps from the vertical sector component requirements applicable to other commercial vessels makes any misalignment safety-critical and may deprive navigators on the approaching vessel from sighting the light in sufficient time to take collision-avoidance action.
