## MARINE INVESTIGATION REPORT

M04W0034

### CAPSIZING AND LOSS OF LIFE

SMALL FISHING VESSEL *HOPE BAY*  
QUEEN CHARLOTTE SOUND, BRITISH COLUMBIA  
26 FEBRUARY 2004

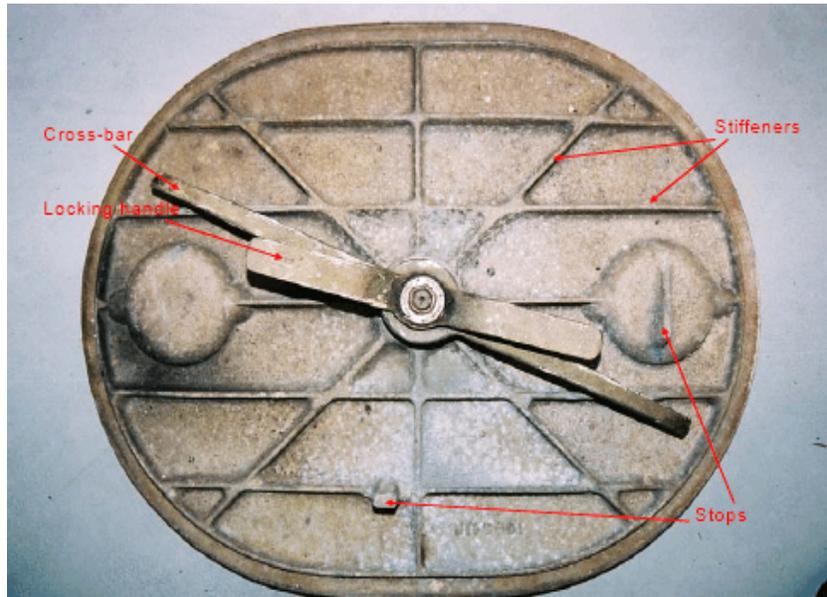
**Photo 2.** Underside of manhole cover similar to those on the working deck.

The TSB has carried out extensive testing to two manufacturers' designs of single cross-bar type manhole covers similar to those used on board the *Hope Bay*. This has revealed several inherent safety deficiencies:

- the operator is unable to see the cross bar when it is tightened from the deck of the vessel. There is a lack of visual and reliable tactile feedback that the cover has been correctly closed.

- an aluminum cover tends to warp under the influence of excessive loads and does not provide an effective seal.
- the short lever arm of the tee handle used for tightening does not allow sufficient torque to be created. In conjunction with the tubular nature of the O-ring, this creates a condition where the cross bar loses its initial pre-tension and becomes free.

- a combination of too-short cross bar stops and the large clearance between the spindle head and cover allows the cross bar to slip past the stops, leaving the cover inadequately secured.

- the design of the cover and the cross bar does not allow uniform distribution of the tightening force along the oval cover's long axis. Under an applied load, the cross bar acts as a fulcrum, allowing the opposite end of the cover to lift off the O-ring.

- the left-hand thread and consequent clockwise-to-open rotational direction of the spindle is counterintuitive, leading to incorrect operation.
- the manufacturers of the manhole covers do not provide their customers with operating or maintenance instructions.
- an unsecured manhole cover is vulnerable to being lifted off by wave action, leaving a compartment open to downflooding.

These deficiencies make the covers prone to water leakage.<sup>7</sup>

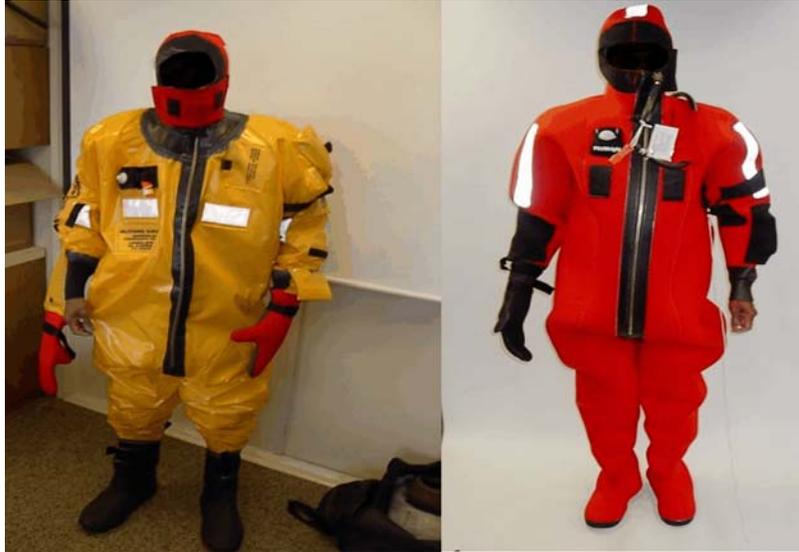
**Photo 3.** Typical universal size immersion suits used by personnel.

By comparison, cold water filled the suits of both crew members who succumbed to hypothermia. The immersion suits used by the two crew members were approximately 15 years old. One crew member's suit was found to be partially unzipped in the area of the neck and face seal. The second crew member's suit had a pinhole on the right biceps area. The design of these suits required the cuffs to be tucked inwards to prevent water from entering at the wrists. It is not known whether the cuffs of the crew members' suits were tucked in, but it is known that the manufacturer's instructions accompanying each suit at the time of purchase did not include this information.

A properly fitted and well-maintained immersion suit is essential to prolonging survival in the water. The death of two crew members who were wearing abandonment suits would suggest that excessive sea water entered the suits, reducing their thermal protection. The pinhole on the right biceps of one suit, combined with likely leakage at the untucked wrist seals, and the unfastened neck and face seal zipper on the other suit, would account for this.
