MARINE INVESTIGATION REPORT

M06C0061

BOTTOM CONTACT AND STRIKING

BULK CARRIER *SENECA*
ASSISTED BY TUGS *JERRY G* AND *ESCORTE*
OSHAWA, ONTARIO
13 OCTOBER 2006

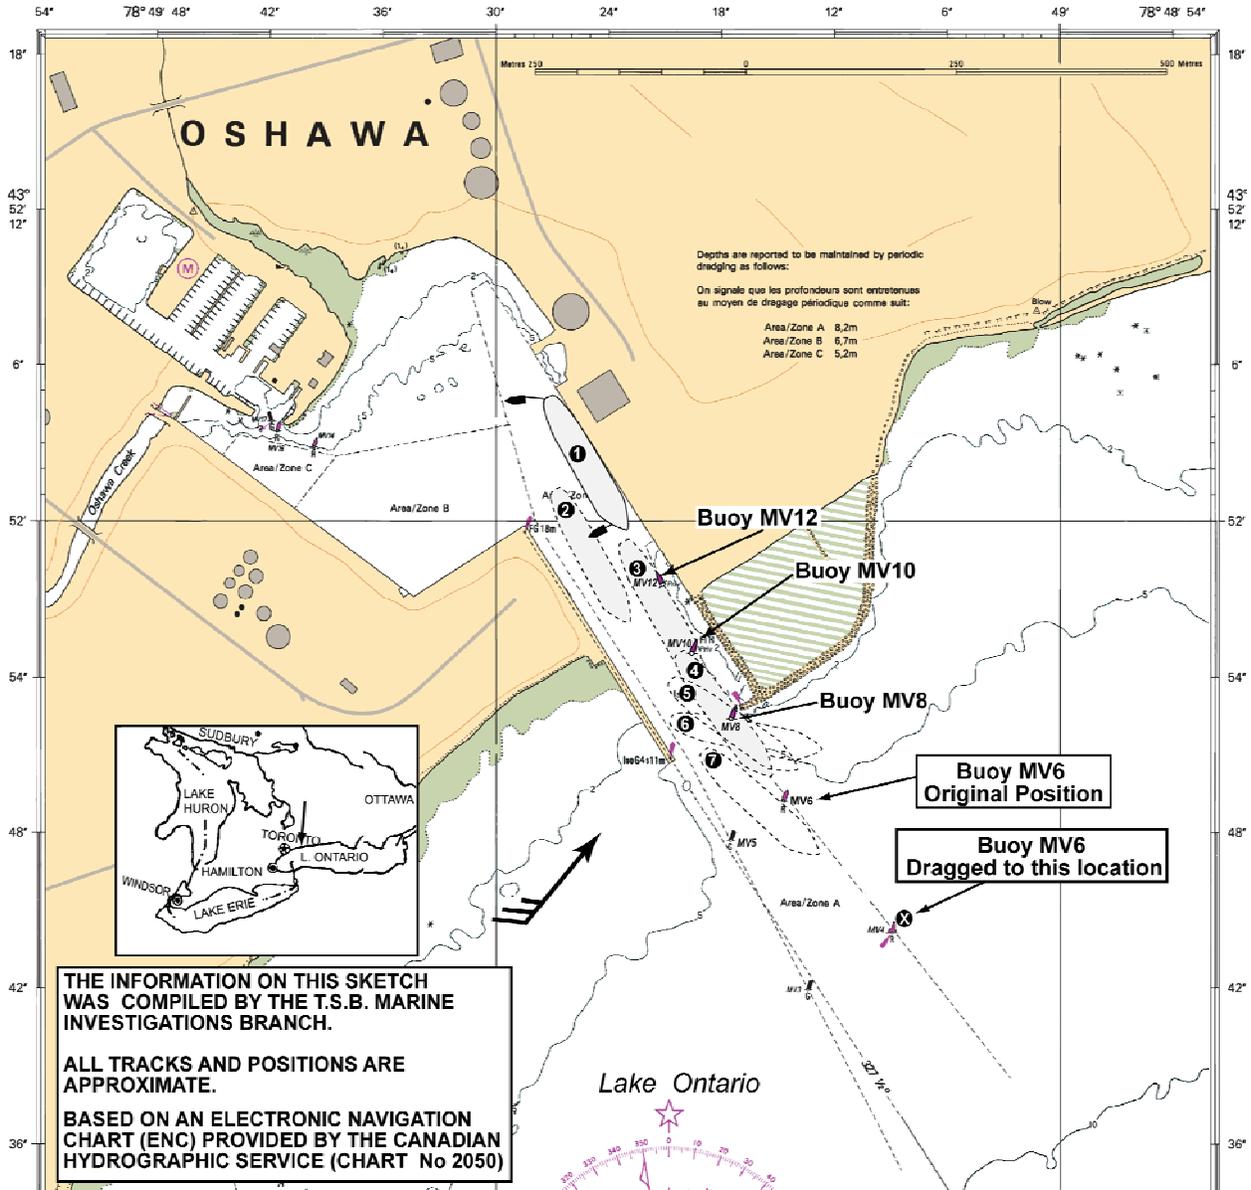
Figure 1. Seneca's movement (positions 1 to 7)

At 0729, buoys MV10 and MV08 disappeared under the *Seneca*'s port quarter and port forward area of the ship's side. The same buoys reappeared a short time later. At approximately the same time while transiting the harbour entrance, the *Seneca*'s port shoulder made bottom contact with the eastern side of the entrance. Simultaneously, the tug *Jerry G* was ordered to the port bow of *Seneca* to begin pushing at the port bow in an attempt to prevent the vessel from running aground. The remaining forward motion of the *Seneca* moved the vessel to a point about midway through the harbour entrance.

At 0732, the wind set the *Seneca* against the east harbour entrance where it made contact with the eastern seawall just aft of its midship's section. At this time, the tug *Escorte* reconnected a towline to the *Seneca*'s centre stern and began pulling, while the *Jerry G* continued to push on the port bow. The stern section swung into a position which blocked the harbour entrance for the next 6 to 7 minutes (see Figure 1).

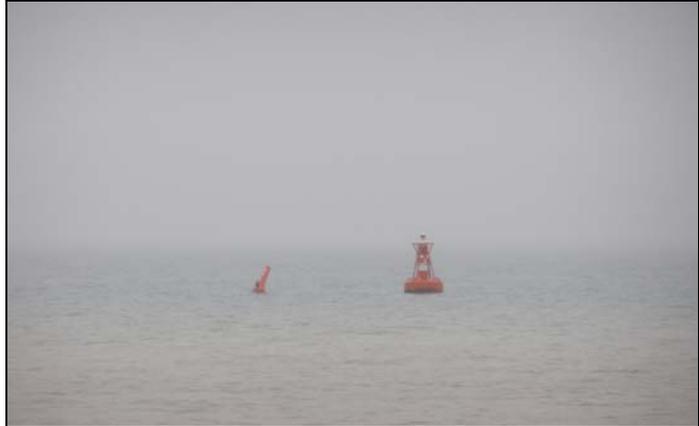
Photo 5. Spar buoy MV6, located near MV4

As the vessels progressed into the channel, buoy MV6 was dragged approximately 195 m and came to rest near outer buoy MV4. (see Photo 5). Buoy MV6 was significantly damaged.

The *Seneca* did not suffer any apparent damage. The *Jerry G* suffered some minor damage to its steering system electrical components. Spar buoy MV6 was significantly damaged and needed to be replaced.
