MARINE INVESTIGATION REPORT

M06N0074

SINKING WITH LOSS OF LIFE

SMALL FISHING VESSEL *LANNIE & SISTERS II*
NOTRE DAME BAY, NEWFOUNDLAND AND LABRADOR
17 SEPTEMBER 2006

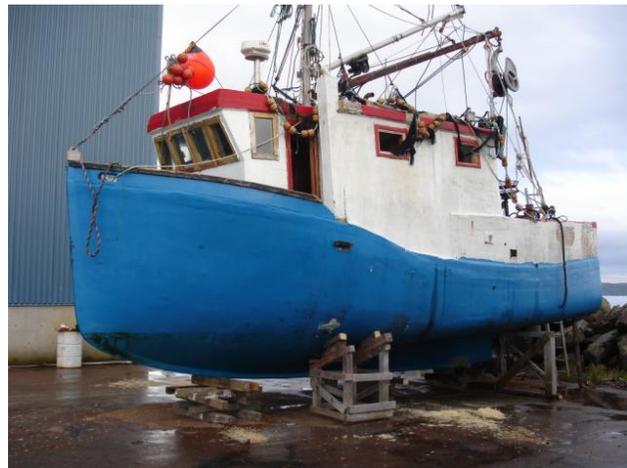
The *Lannie & Sisters II* was a small fishing vessel of the Cape Island design, constructed of moulded, glass-reinforced plastic, with the wheelhouse and accommodation forward, the engine room beneath the wheelhouse, and the work deck aft (see Photo 1). Access to the wheelhouse was through a hinged door on the port side. Access to the engine room was through a hatch located in the wheelhouse. A portable gasoline-powered generator was stowed on top of the wheelhouse.

Photo 1. The *Lannie & Sisters II*, post salvage

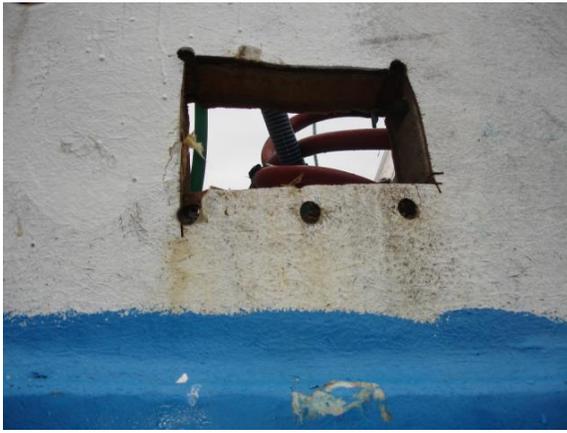
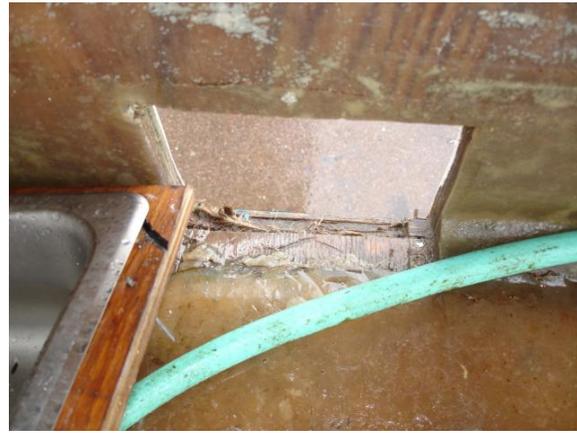
There was one freeing port at the forward end of the main deck on the starboard side. There were two freeing ports on the port side – one at the forward end of the main deck, and one on the forecastle. In all cases, the freeing ports were roughly cut by hand with the cut extending into the hull (see Photos 2 and 3).

Photo 2. A hand-cut freeing port

Photo 3. A hand-cut freeing port

Upon recovery, the vessel had no name, licence number, or port of registry displayed on its hull; water was observed pouring from the stuffing box (see Photo 4); the freeing ports were holes cut into the bulwark, with no flaps to prevent water ingress; and there was no freeing port on the starboard side aft.

- hand-cut freeing ports with irregular-shaped cuts that extended into the hull;
- scorched plywood surrounding the cooking stove, including an area that was burned through to the outside;
- instances of using household wiring and switches, rather than marine grade;
- flexible hoses for the bilge pump joined by a hose clamp without a proper connector between them;
- damaged propeller blades; and
- a transmission that was reported to be exhibiting signs of wear.

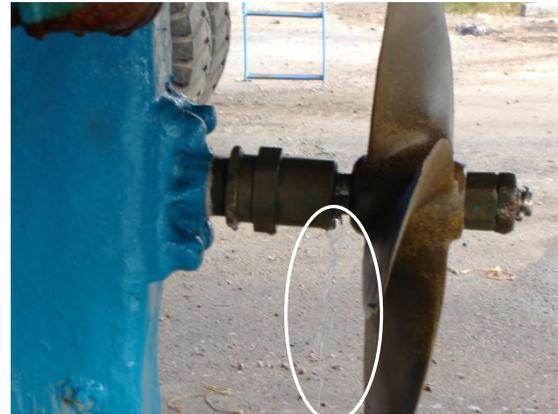
The *Lannie & Sisters II* had an external stuffing box for the propeller shaft that had been leaking for some time and getting progressively worse (see Photo 4). The crew members connected the vessel to shore power in Lushes Bight, so that the bilge pump would not drain the battery after they went home.

Photo 4. Leaking stuffing box after vessel recovery

In May 2006, the stuffing box, which was located on the exterior of the hull, developed a severe leak and the vessel went into drydock for repairs. The stuffing box began leaking again at some point after the drydock. The propeller had been in a damaged condition before the fishing crew took over the vessel in July 2006. The blades were distorted, which caused a vibration that made the leak progressively worse. The owner, the fishing crew, and the delivery crew were all aware that the *Lannie & Sisters II* was taking on water through the stuffing box.

1. Due to inadequate maintenance and upkeep of the stuffing box, the vessel likely experienced a steady ingress of water, and eventually foundered.
2. The lack of a high level bilge alarm deprived the delivery crew of an early warning that the bilge pump was not performing adequately.

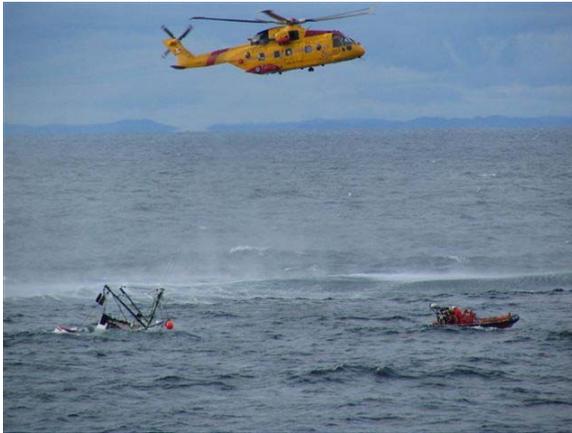
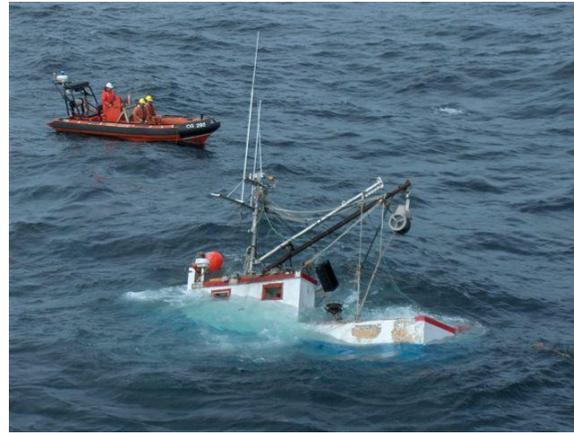
The vessel was discovered partially submerged at 0931 on 18 September 2006, in position 49°50'42" N, 055°16'00" W, by SAR resources (see Photos 5 and 6). A SAR fixed-wing aircraft spotted the body of the delivery captain at 1642 on September 18, and it was subsequently recovered by a SAR vessel. The other crew member is still missing and presumed drowned.

Photo 5. Search and rescue activities

Photo 6. *Lannie & Sisters II*
