**MARINE INVESTIGATION REPORT  
M14C0156**

**FIRE AND ABANDONMENT  
SMALL PASSENGER VESSEL *LA RELÈVE II*  
HAVRE-SAINT-PIERRE, QUEBEC  
11 AUGUST 2014**

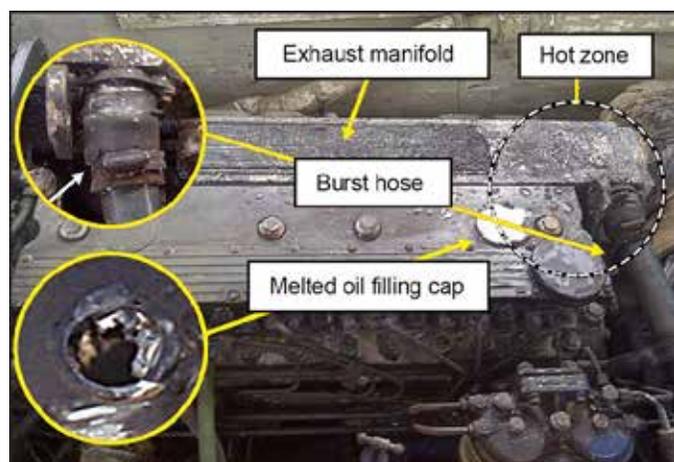
Photo 3. Damaged engine

The investigation determined that the engine lost coolant when the rubber hose connected to the exhaust manifold outlet burst (Photo 3), most likely due to wear. Without coolant, the engine became hotter, which eventually caused a crack to develop between the exhaust and water chambers in the exhaust manifold. The damaged hose and crack in the manifold directed the hot exhaust gases onto the underside of the engine compartment cover, which

had thermal-acoustic insulation installed on it.<sup>6</sup> The insulation consisted of 2 layers of polyurethane foam with a layer of vinyl between them, covered by a sheet of aluminized Mylar. This type of insulation provides some soundproofing and thermal protection, but it does not provide protection when it comes into direct contact with a heat source or when the reflective capability of the film is compromised. The hot gases damaged the film, exposing the foam layers. In addition, the engine oil filling cap melted, allowing the engine to spray oil onto the foam. The combination of the oil-soaked foam and heat from the leaking exhaust gases caused the fire.

The leaking exhaust gases, the steam generated from the leaking coolant, and the smoke from the burning foam insulation were drawn into the engine turbocharger, depriving the overheated engine of oxygen and causing it to slow down. The throttle was increased to compensate, and the engine stopped shortly afterwards.

The engine was extensively damaged due to overheating caused by the loss of coolant. The exhaust manifold, the turbocharger, and the cylinder head were rendered unusable. The insulation on the underside of the engine compartment cover was also damaged by the fire (Appendix C). Following the occurrence, the AR withdrew *La Relève II* from service.

1. *La Relève II*'s engine lost coolant when the rubber hose connected to the exhaust manifold outlet burst. The engine then overheated, causing a crack to develop in the exhaust manifold.
2. The damaged hose and crack in the manifold directed the hot exhaust gases onto the underside of the engine compartment cover, damaging the insulation and exposing the layer of polyurethane foam.
3. A fire started in the engine compartment after the foam became soaked in oil and exposed to the hot exhaust gases.

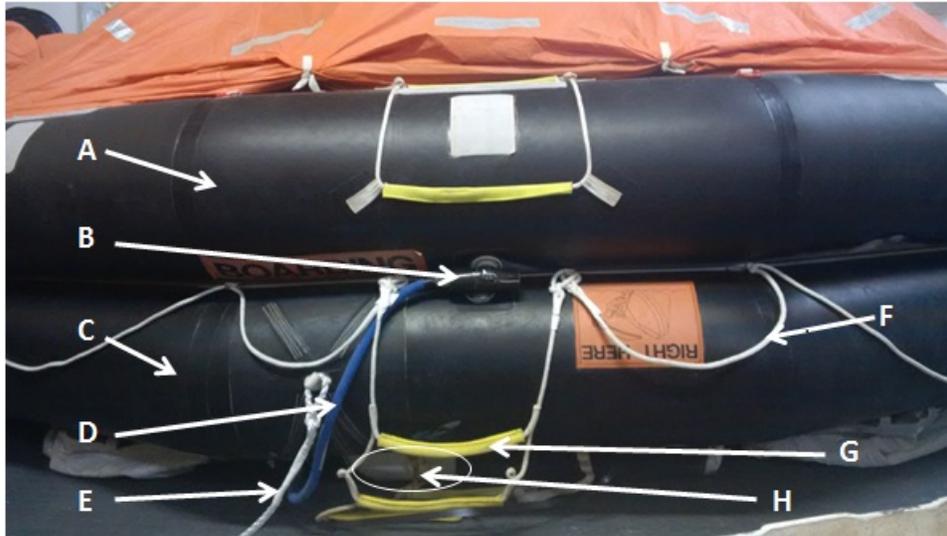
Photo 4. Life raft details

When the life rafts were launched at the time of the occurrence, 2 of the 3 did not inflate properly. They were examined by the TSB Laboratory (Photo 4) and the following was noted:

Aside from the areas around the inflation valves, the outer surface of the buoyancy tubes showed no signs of fraying, abrasion, cuts, or other pre-existing damage. The buoyancy tube material was tested for static tensile strength and met the current International Maritime Organization (IMO) specifications.<sup>9</sup> However, kinks in the lifeline near the inflation valves were observed on both life rafts (Appendix D). These kinks were permanent, meaning that, even after the lifeline was straightened and released, the kink reappeared in the same location. The painters and boarding ladders did not have kinks or show other signs of entanglement.

The master then initiated an evacuation of the vessel. However, only 2 of the life rafts were usable, as the third had immediately deflated. Kinks in the lifelines, deformation of the clamping plates, and the location of buoyancy tube ruptures indicate that the lifelines may have become entangled with the inflation valve assemblies. When the life rafts inflated, the entangled lifelines would have created localized strain around the clamping plates that held the inflation valves in the buoyancy tubes, tearing the inflation valves from the life raft. There was no information to indicate that the life raft had been opened other than for servicing in the previous month. Despite the life raft failure, the master and the deckhand were able to successfully evacuate all 33 passengers.

1. The insulation installed in the engine compartment contained polyurethane foam, which is prohibited for use on passenger vessels.
2. Two of the 3 life rafts failed to inflate fully due to buoyancy tube ruptures at the inflation valves. The ruptures may have been caused by the lifelines becoming entangled with the inflation valve assemblies and creating excessive strain in the tubes.

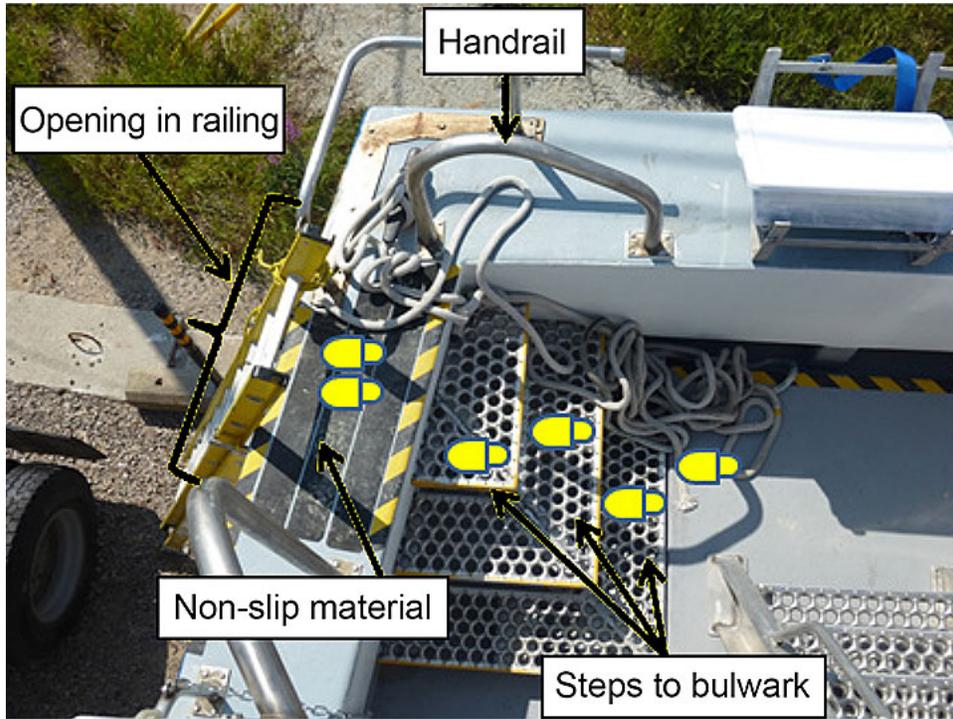
The master helped the passengers board the starboard life raft using the embarkation station. He also ordered the deckhand to take charge of the port life raft. The deckhand, assisted by one of the passengers, helped passengers board the port life raft. To do so, the passengers had to step onto a movable wooden bench, climb over the vessel's railing, and then descend about 1.5 m to reach the life raft (Appendix B).

Embarkation station on the starboard side of the vessel (ladder not present at time of occurrence)

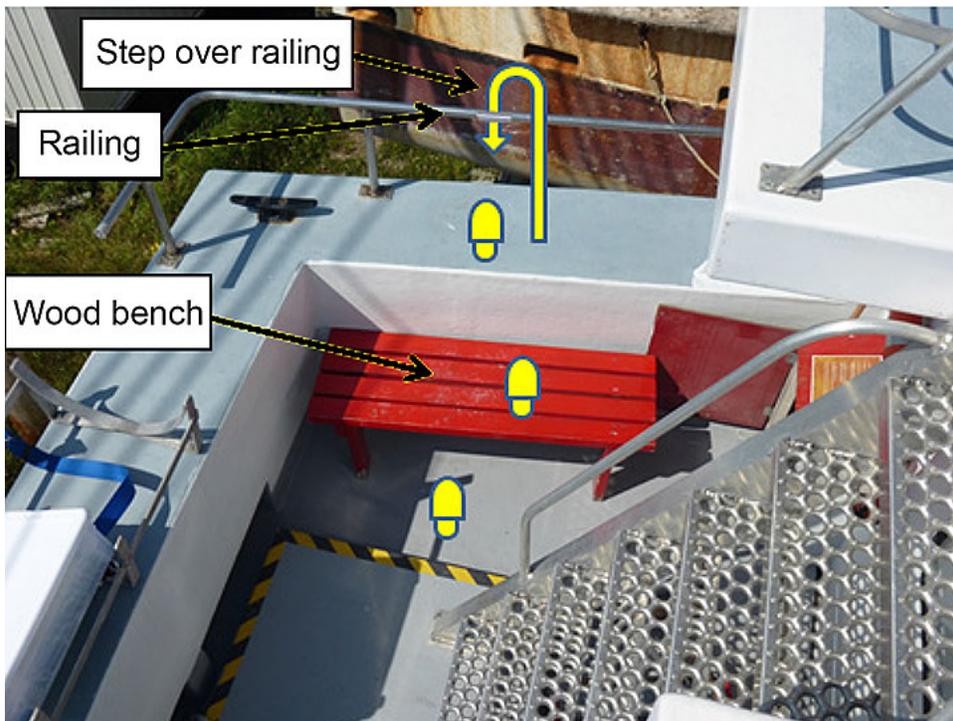
Location where passengers boarded the port life raft
