MARINE INVESTIGATION REPORT

M15P0347

Capsizing and loss of life

Leviathan II

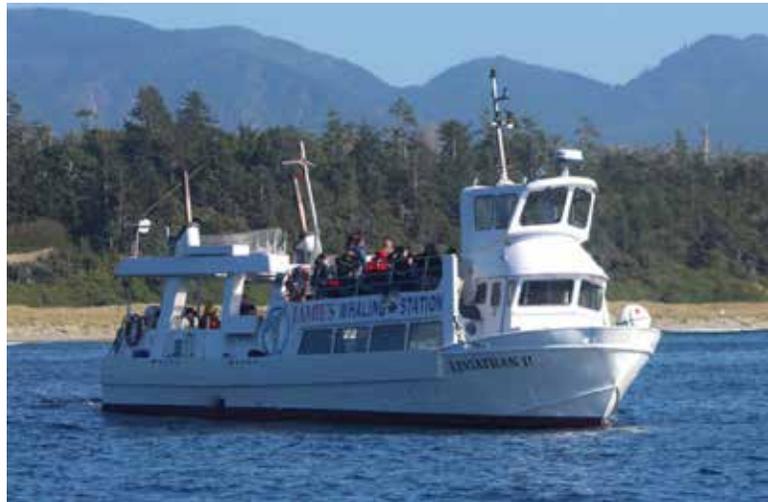
Figure 1. *Leviathan II* (Source: David Bly)

The *Leviathan II* (Figure 1) was an aluminum vessel with a shallow vee-shaped hull. It was originally constructed in 1981 as a crew boat. It was purchased by its current owner in 1995, and, in the following year, it was rebuilt in a British Columbia shipyard to operate as a passenger vessel for whale watching. As part of the rebuild, the hull was lengthened by approximately 4.8 m at the stern. The top of the original cabin was also strengthened to provide a passenger seating area on the top deck and a flying bridge; navigation equipment was relocated from the wheelhouse to the flying bridge. As a result, the wheelhouse was no longer in active use.

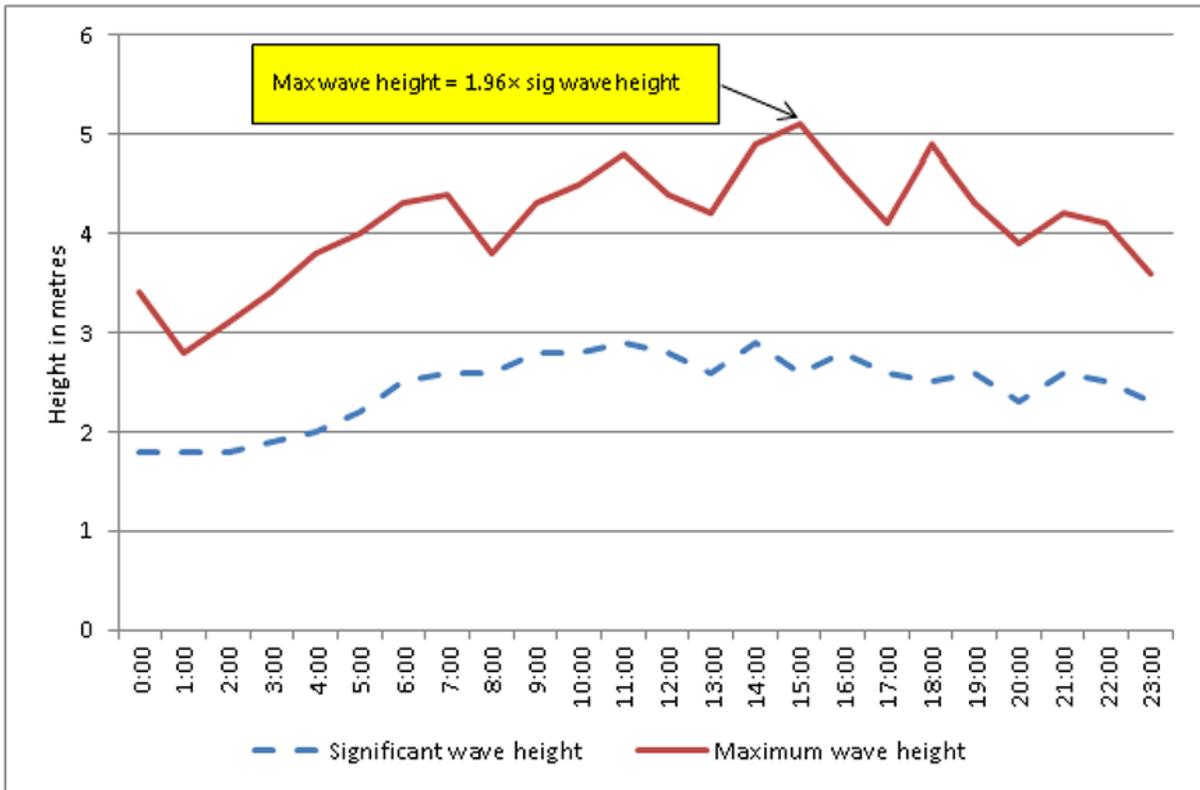
Figure 2. Significant and maximum wave height at La Perouse Bank on 25 October 2015

At the time and location of the occurrence, the wind was estimated to be 10 knots from the southeast, and wave conditions were a 2 m swell from the same direction. Conditions were overcast, the sea water temperature was 14 °C, and the tide was ebbing. The previous observed¹⁵ high water was at 1131, with a water level of 3.86 m. The subsequent low water was at 1755, with an observed water level of 0.84 m.

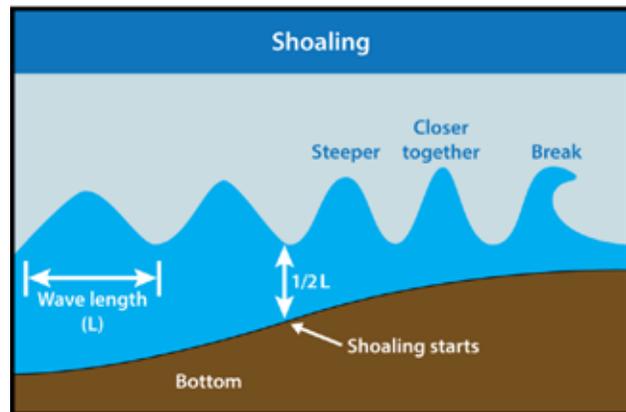
Figure 3. Physical changes to a wave as it approaches a shallow area (Source: Environment and Climate Change Canada, National Marine Weather Guide, Chapter 3)

A breaking wave is a type of wave that rises up, pitches forward, and breaks into surf. Breaking waves can be caused by shoaling, which occurs when deep-water waves approach a shallow area or “shoal.” In this situation, the waves slow down as they encounter water depths that are less than half their wave length (L) (Figure 3). As the waves slow down, their crests become closer together, and the waves become higher and steeper. When these waves are about as high as the water is deep, they pitch forward and break (Figure 3).

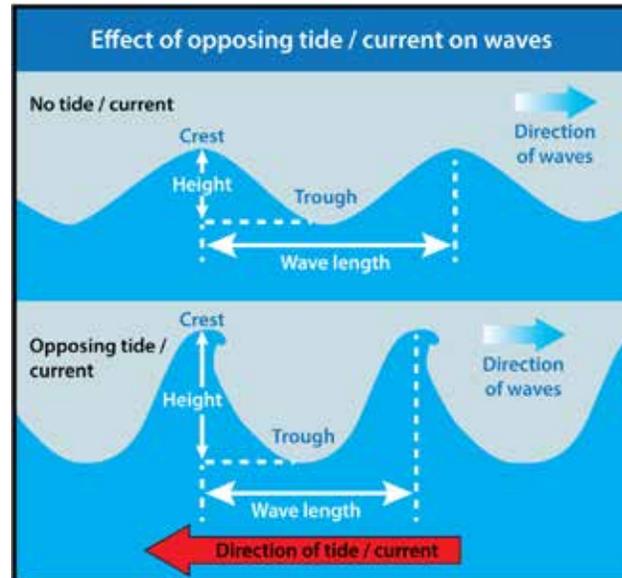
Figure 4. Effect of opposing tides on waves (Source: Environment and Climate Change Canada, National Marine Weather Guide, Chapter 3)

Opposing tides and currents flowing against waves are other factors that cause wave length to decrease and wave height to increase (Figure 4). In these conditions, waves rapidly become steeper, increasing the likelihood that they will break.

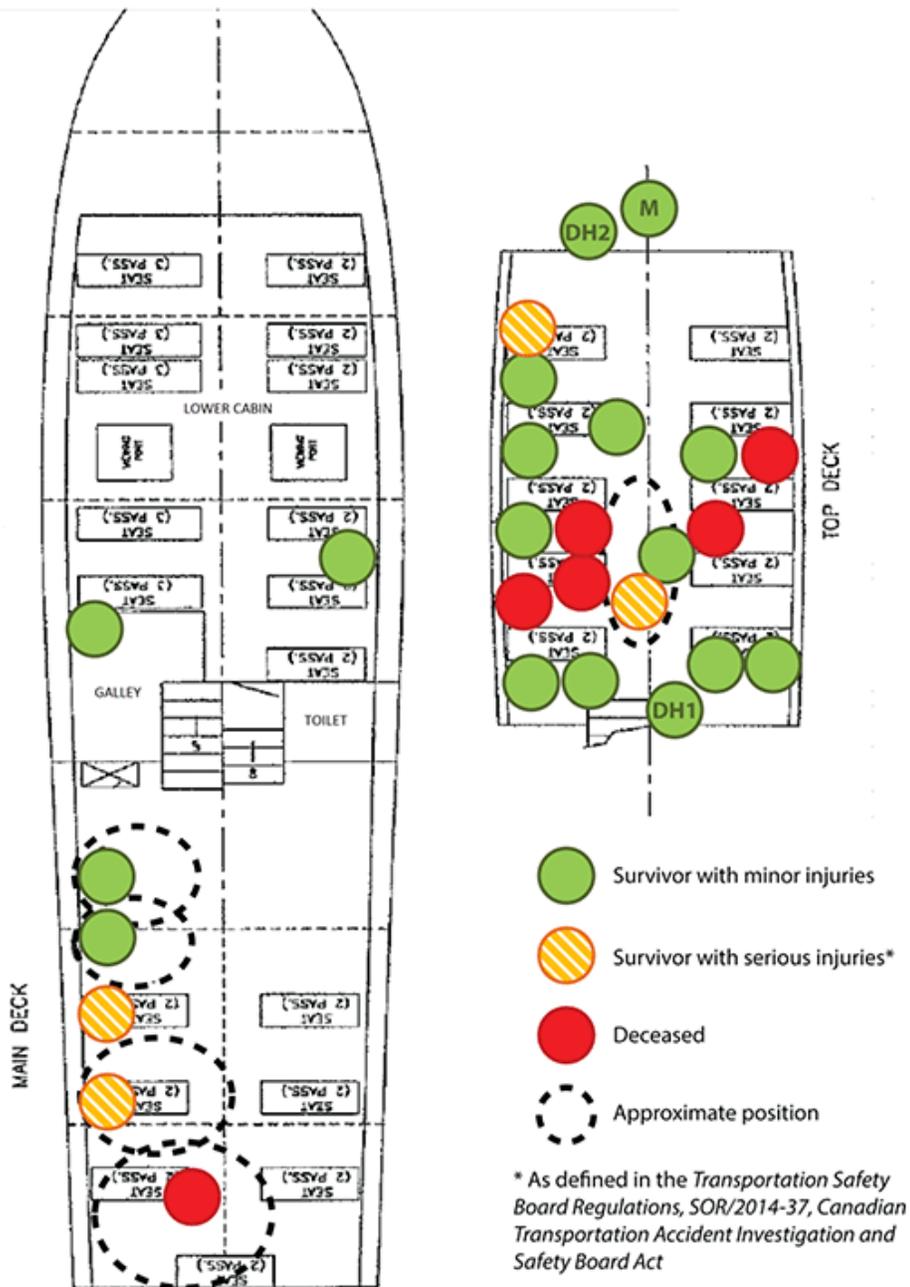
Appendix C – Approximate locations of passengers and crew before the capsizing

Note: The locations of the master and deckhands are indicated with M, DH1, and DH2.
 Source: *Leviathan II* stability booklet, with location of passengers and crew overlaid by TSB.
