MARINE TRANSPORTATION SAFETY INVESTIGATION REPORT M18C0225

GROUNDING

Passenger vessel *Akademik Ioffe*
Latitude 69°43.043' N
Longitude 091°20.951' W
Astronomical Society Islands, Nunavut
24 August 2018

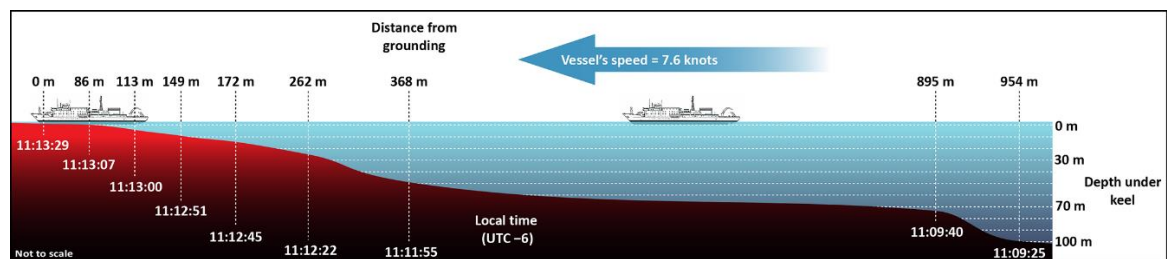
course was 218°G; the water depth gradually reduced and, at 1111:55, reached 50 m. At 1112:54, the OOW realized that the under-keel water depth was 14 m and decreasing. At 1113:29, the vessel contacted a rocky shoal, in the Gulf of Boothia and at the entrance of Lord Mayor Bay, in position 69°43.043' N, 091°20.951' W (figures 3 and 4). A loud crushing noise was heard and vibrations were felt by everybody through the entire vessel; the vessel rapidly came to a stop and heeled to starboard. The deceleration caused the passengers who were standing to lose their balance, while dishes and crockery from the galley and dining room shattered on the deck. At that time, the first shore excursion safety briefing had just been completed and the expedition staff was about to begin the second briefing for the remaining half of the passengers.

Figure 3. Times, under-keel depths, and distances prior to the grounding of the *Akademik Ioffe* (Source: TSB)

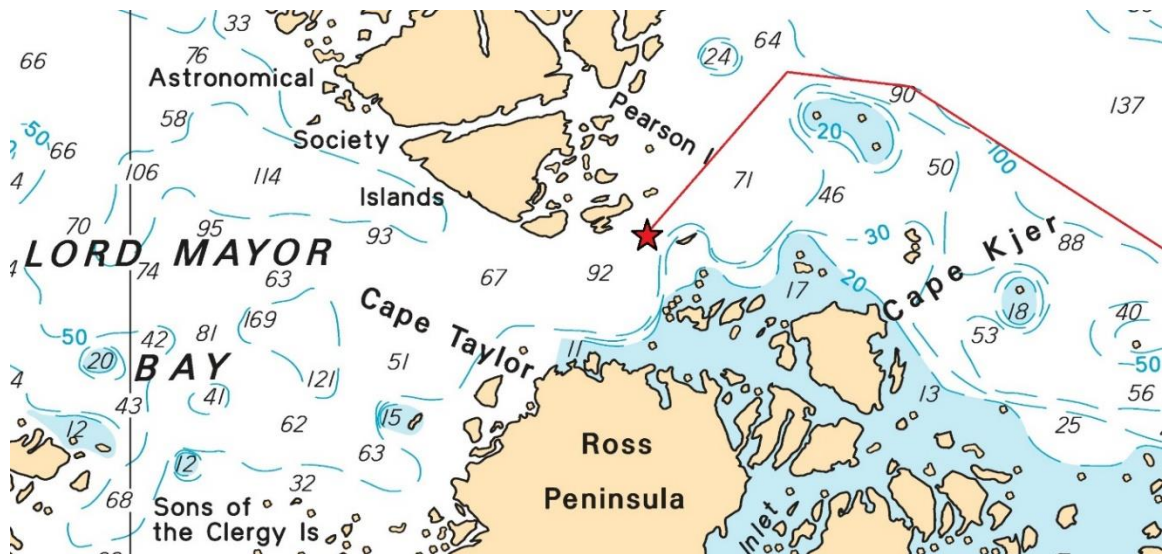
Figure 4. Track and position of grounding of the *Akademik Ioffe* (Source: Canadian Hydrographic Service, with TSB annotations)

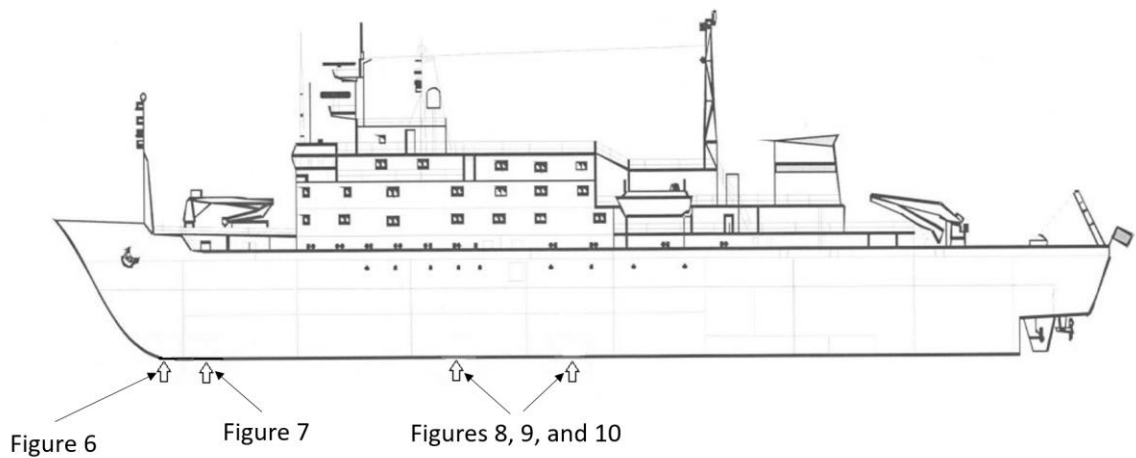
Figure 5. Location of hull breaches, indicated by arrows (Source: TSB)

Following the grounding of the *Akademik Ioffe* and the subsequent attempts to refloat it, the vessel sustained extensive structural and hull damage in way of the double-bottom ballast water and fuel oil bunker tanks, from the bow to amidships (Table 2). Two fuel oil bunker tanks (No. 41 port and No. 41 centre) and 2 ballast water tanks (No. 21 centre and No. 51 port) were breached and took on seawater, flooding to their maximum capacity. Details of the damage and location of hull breaches are also provided in Figure 5.

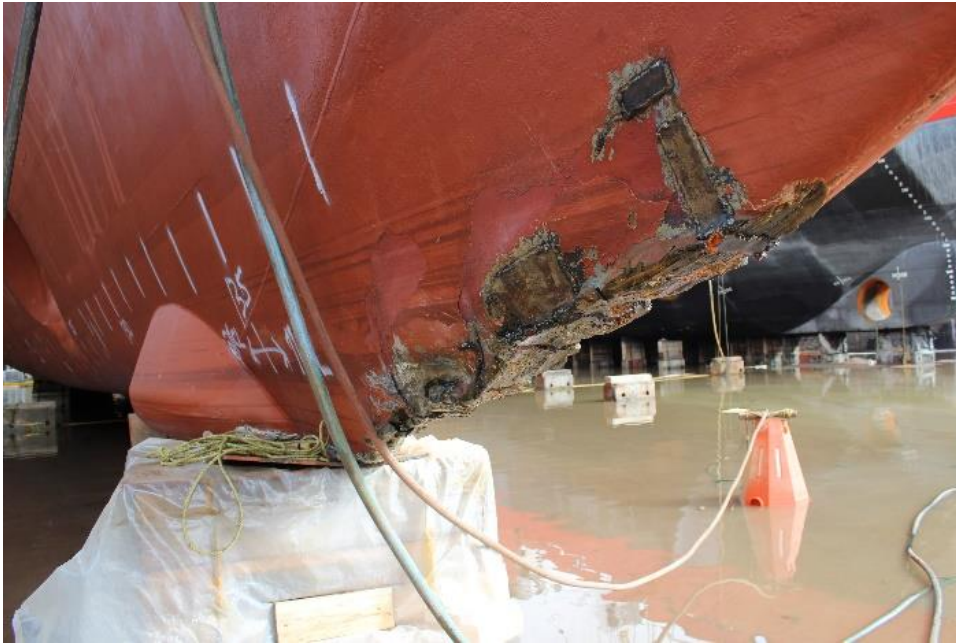
Figure 6. Side view of the bow ice strike, showing temporary repairs carried out by the divers off the Astronomical Society Islands (Source: TSB)

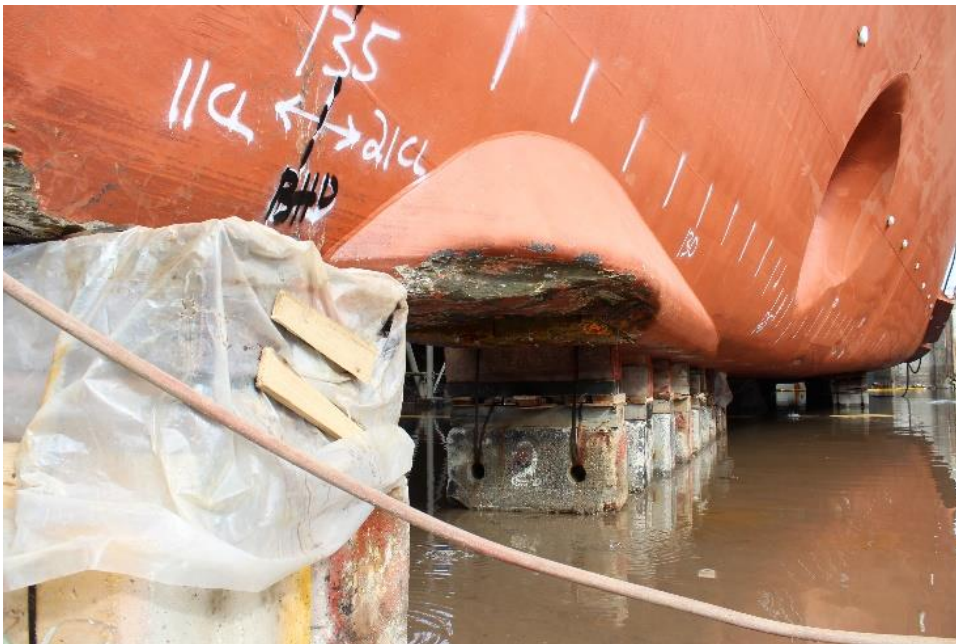
Figure 7. View of damage to the portside under-hull scientific transducer housing, in way of ballast water tank No. 21 centre (Source: TSB)

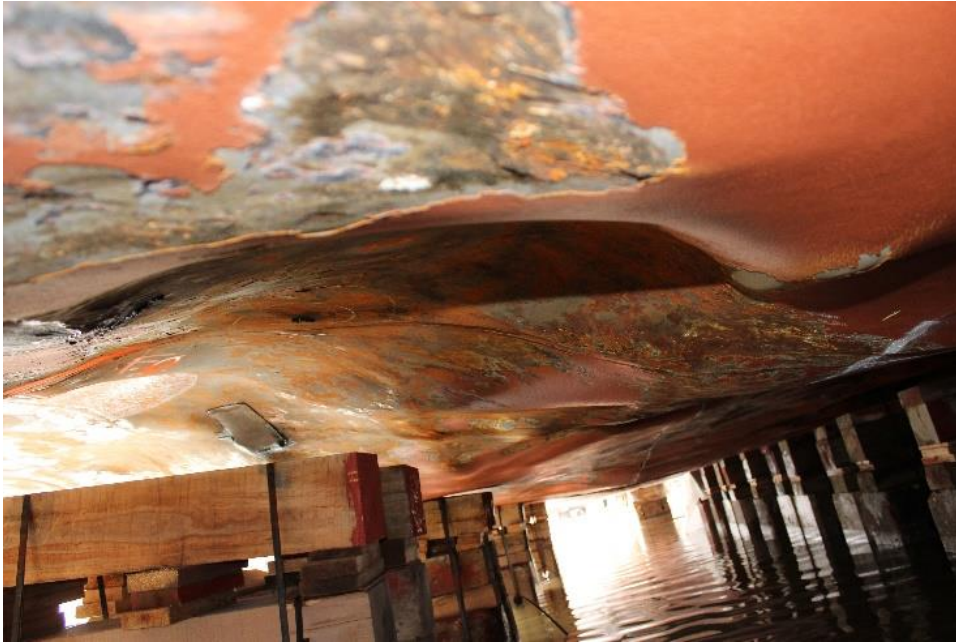
Figure 8. View of hull bottom shell plating deflections, breaches, and temporary repairs carried out by the divers off the Astronomical Society Islands (Source: TSB)

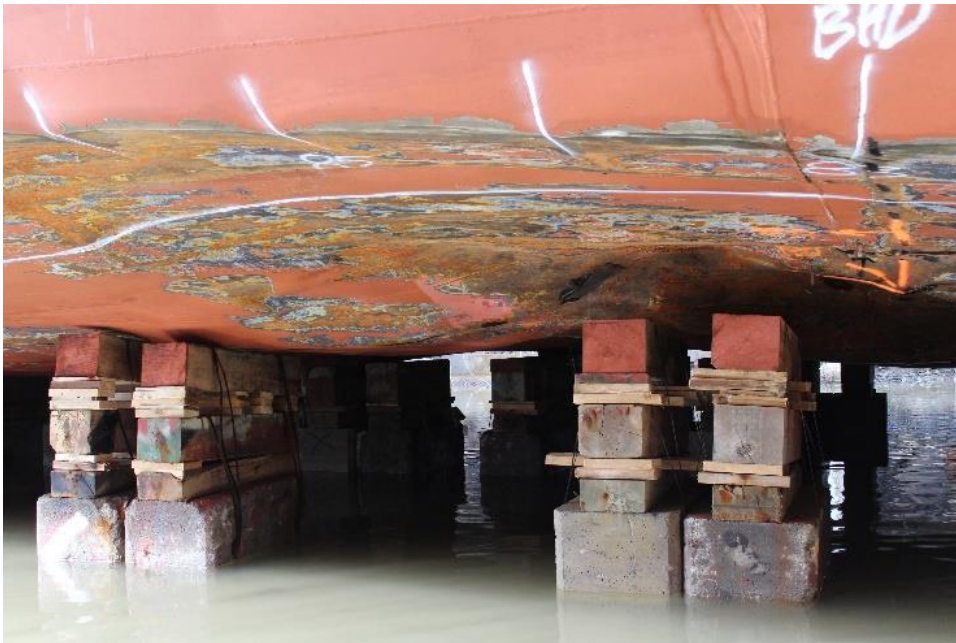
Figure 9. View of hull bottom shell plating deflections, breaches, and temporary repairs carried out by the divers off the Astronomical Society Islands (Source: TSB)

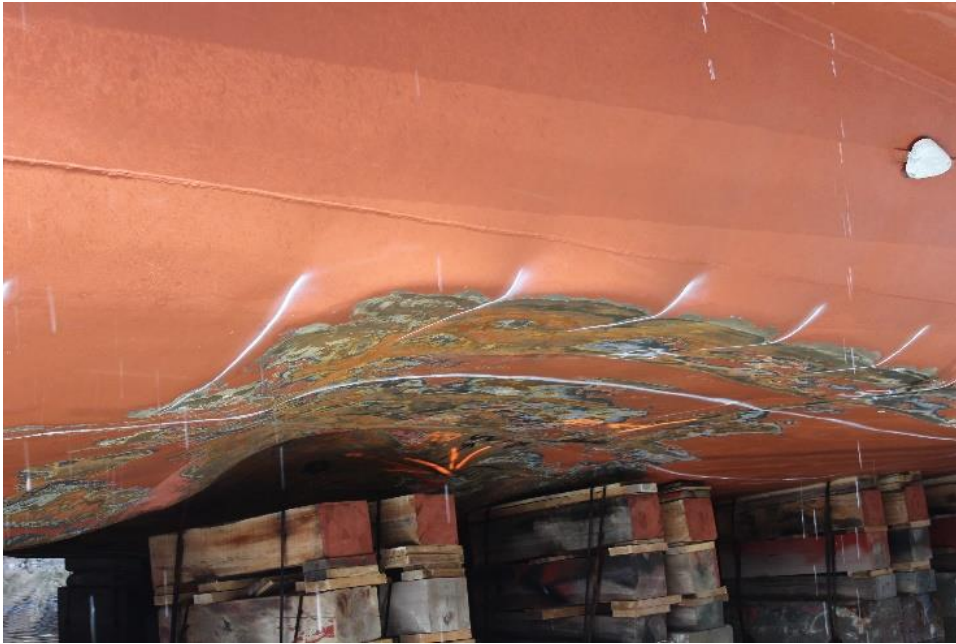
Figure 10. View of hull bottom shell plating deflections, breaches, and temporary repairs carried out by the divers off the Astronomical Society Islands (Source: TSB)
