RAILWAY INVESTIGATION REPORT

R99S0071

CROSSING ACCIDENT

VIA RAIL CANADA INC.

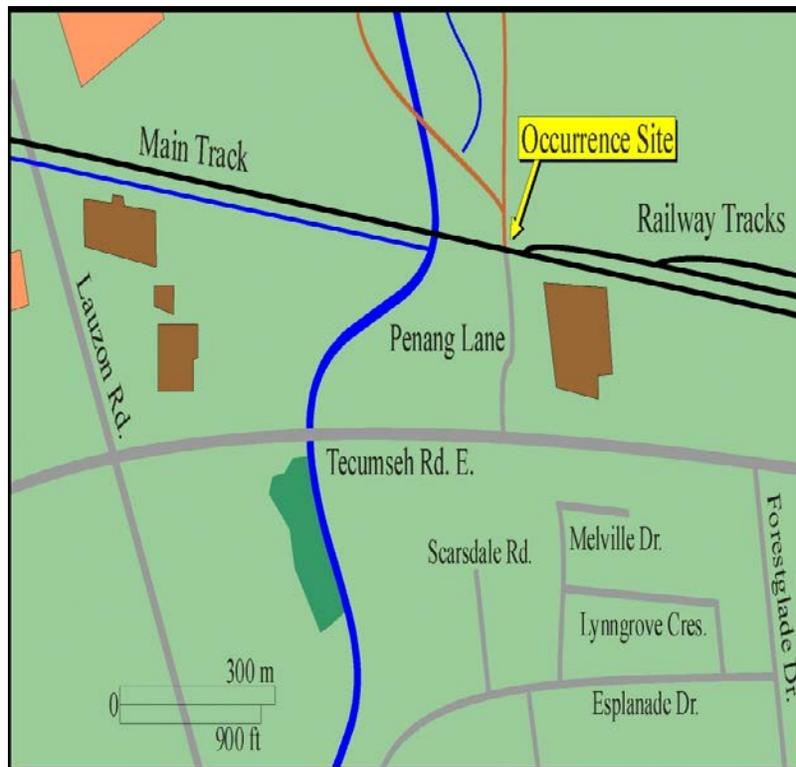
lights, bell and gates. Just west of Penang Lane, Lauzon Road (Mile 101.76), a two-lane paved roadway, intersects the track at 90 degrees and is also protected by flashing lights, bell and gates. Figure 1 shows the area in the vicinity of the crossing.

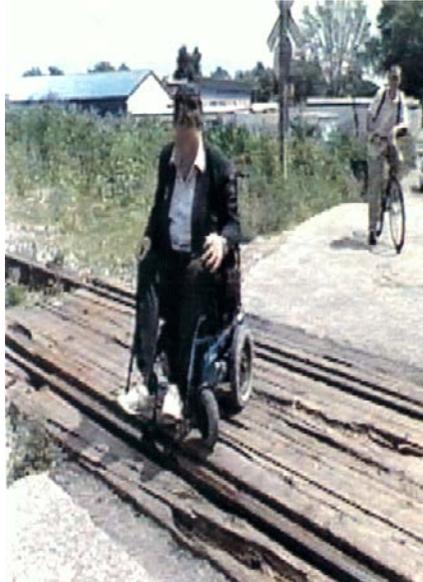
The pedestrian crossing intersected the single main track at 71 degrees and was protected on both sides with standard reflectorized crossing signboards (crossbucks) and a stop sign. The asphalt approach, north of Penang Lane, was uneven adjacent to the planking. The crossing planking was in very poor condition, with missing pieces of splintered wood having created an uneven surface (see Figure 2). The planking extended through the crossing with one plank on each side beyond the field side of the rails.

Subsequent to the crossing accident, railway officers from Transport Canada's (TC) Ontario Region, along with supervisors from Canadian National (CN) and the City of Windsor, inspected the crossing. As a result, the crossing planks were immediately replaced.

Another CN inspection of the newly installed crossing surface determined that a further enhancement to safety could be achieved by paving the crossing surface. The planking which was installed immediately after the accident was removed and replaced by an asphalt surface, with flange and mud rails on either side of the rails. Underbrush and vegetation growth along the right-of-way in the four sighting quadrants were also cleared within two weeks of the accident.

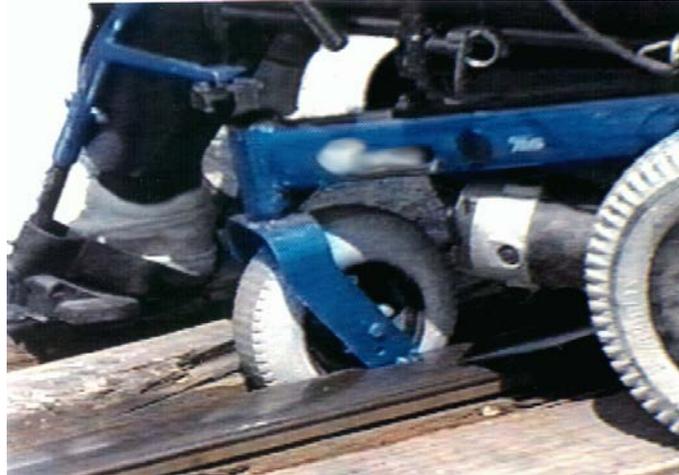
The crossing planking was located such that it provided a space for train wheel flanges to move safely through the crossing. Transport Canada's (TC) *Railway-Highway Crossing at Grade Regulations* require that a flangeway, with a width of between 65 mm and 120 mm to a depth of between 50 mm and 75 mm, be provided between the gauge side of the running rail and the highway surface. The typical width of front wheels for power-assisted wheelchairs with pneumatic tires is between 45 mm and 50 mm. Figure 3 shows a typical power-assisted wheelchair with a castor wheel in the field side of the rail.

It is probable that the roughness of the poorly maintained approaches and planking affected the control of these wheelchairs to the extent that the front castors were oscillating, or bouncing, and they easily fell into the flangeways.

1. The persons in the wheelchairs became immobilized at the crossing when their wheelchairs became stuck in the flangeways adjacent to the running rails. The flangeways were slightly wider than the width of the front wheels. The width and depth of the flangeways were such that it was not possible for the occupants to extricate themselves.
2. The deteriorated condition of the crossing planking and the asphalt approach to the crossing probably led to a loss of steering control of the wheelchairs.
