RAILWAY INVESTIGATION REPORT
R99W0231

DERAILMENT AND COLLISION

CANADIAN PACIFIC RAILWAY
TRAIN 472-30 AND TRAIN 471-30
MILE 42.4, CARBERRY SUBDIVISION
NEAR POPLAR POINT, MANITOBA

01 NOVEMBER 1999

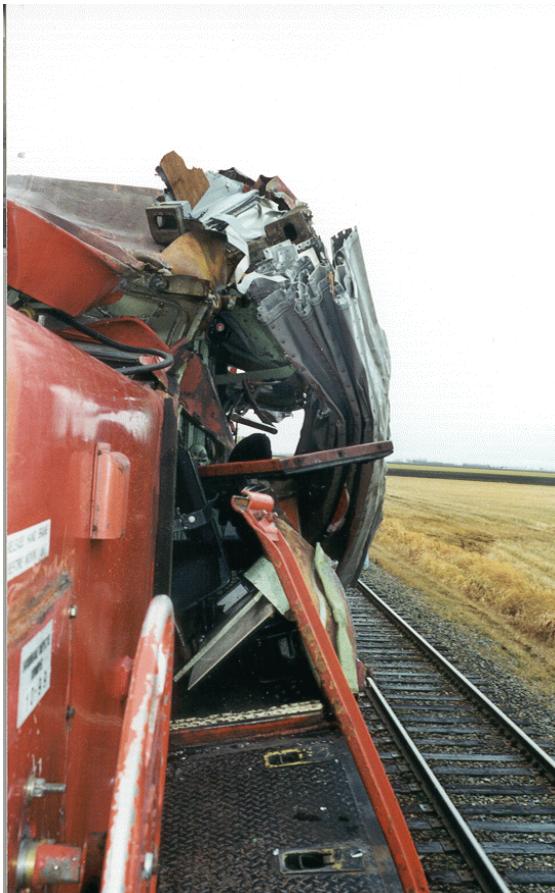
The three SD-40-2 locomotives on train 472 sustained extensive damage. However, the locomotives did not derail. The conductor's side of the lead locomotive on train 472, CP 5921, was raked open and the metal skin peeled back the length of the locomotive cab. The locomotive windshield and side windows were broken and the locomotive cab roof was buckled inward. The front door on the conductor's side was catapulted into the conductor's seat (see Figure 1).

The damage to the three locomotive cabs was extensive considering the relatively light mass of the items striking them. While it is appreciated that accident impact damage to locomotive bodies commonly occurs to the collision-protected areas below the cab, this accident has demonstrated that, in some situations, locomotive cabs can be subjected to significant impact. It is apparent therefore that improved AAR locomotive cab strength and safety feature specifications, projected to be a requirement for locomotives built in 2003 and beyond, are warranted and will enhance safety. However, it will take a considerable time for the full safety benefits to be realized. Because of the long service life of locomotives in North America (20 to 40 years), a significant number of less well-protected units will remain in road service for many years, with a commensurate higher safety risk to operating crew members.

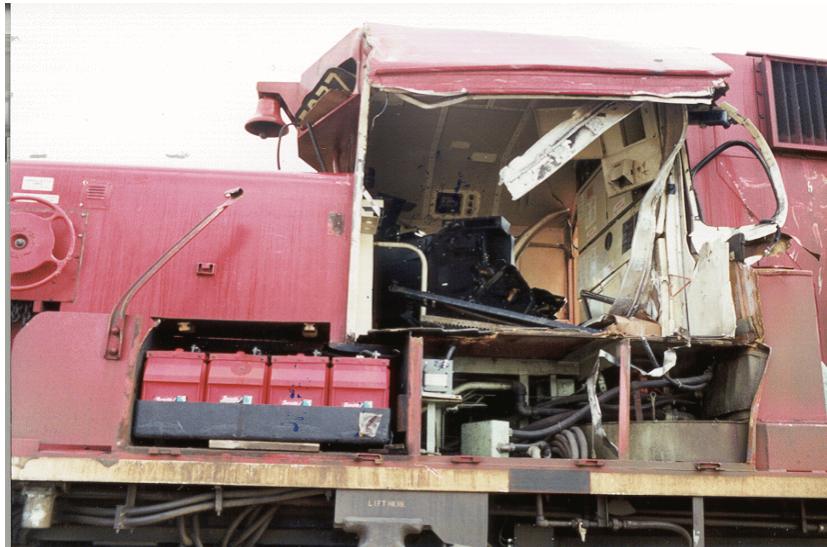
The second locomotive on train 472, CP 5877, was similarly raked open on the conductor's side and the metal skin peeled back exposing the locomotive batteries and the interior of the locomotive cab (see Figure 2). The conductor's seat was torn from its mount and was located approximately 400 feet away from the locomotive, laying on the ballast between the two main tracks.

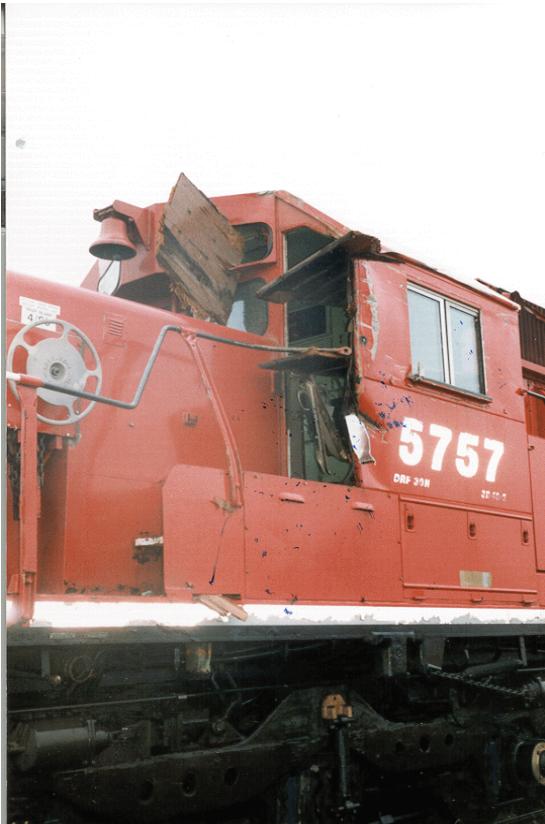
The cab of the third locomotive on train 472, CP 5757, was penetrated through the windshield and conductor's side door by large, splintered pieces of plywood from containers that were breaking up at the time of contact with the third locomotive (see Figure 3).
