RAILWAY INVESTIGATION REPORT
R08E0150

MAIN-TRACK DERAILMENT

CANADIAN NATIONAL
FREIGHT TRAIN A41651-16
MILE 106.20, EDSON SUBDIVISION
PEERS, ALBERTA
18 DECEMBER 2008

Report Number R08E0150

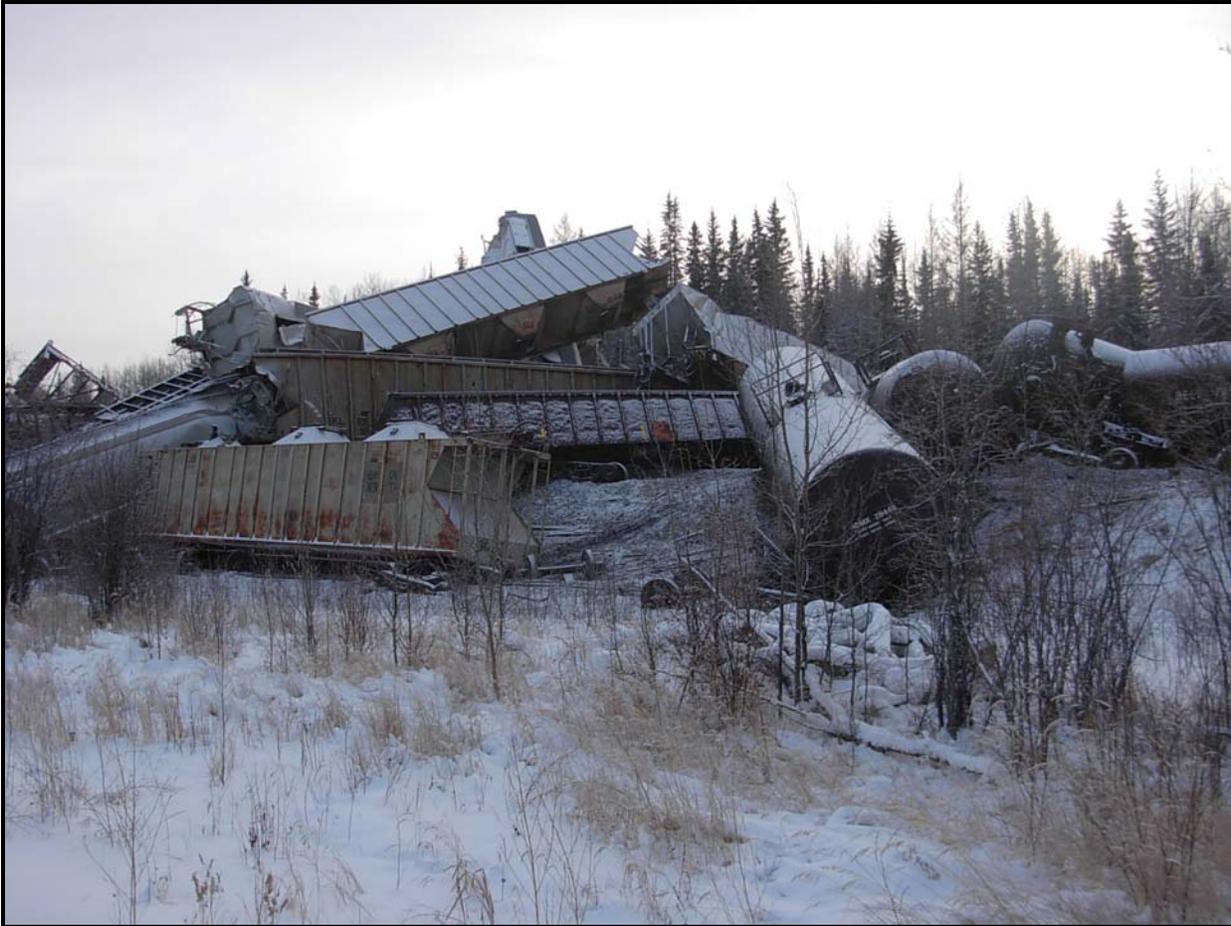
After making the necessary emergency broadcast and notifying the rail traffic controller (RTC), the conductor initiated an inspection and discovered that 48 cars, the 22nd through 69th, had derailed (see Photo 1). The derailed cars included 16 loaded hopper cars, 7 loaded centre beam bulkhead flat cars, 3 loaded box cars, 12 empty covered hopper cars, a loaded gondola, and 9 empty tank cars. The first 6 derailed cars had left the track on the high side of the curve. The following 42 cars were derailed on both sides of the track. Approximately 1715 feet of main track was damaged.

Photo 1. View of derailment, looking east
