**RAILWAY INVESTIGATION REPORT
R12W0182**

CROSSING ACCIDENT

**CANADIAN PACIFIC RAILWAY
FREIGHT TRAIN 205-09
MILE 128.90, BROADVIEW SUBDIVISION
BROADVIEW, SASKATCHEWAN
9 AUGUST 2012**

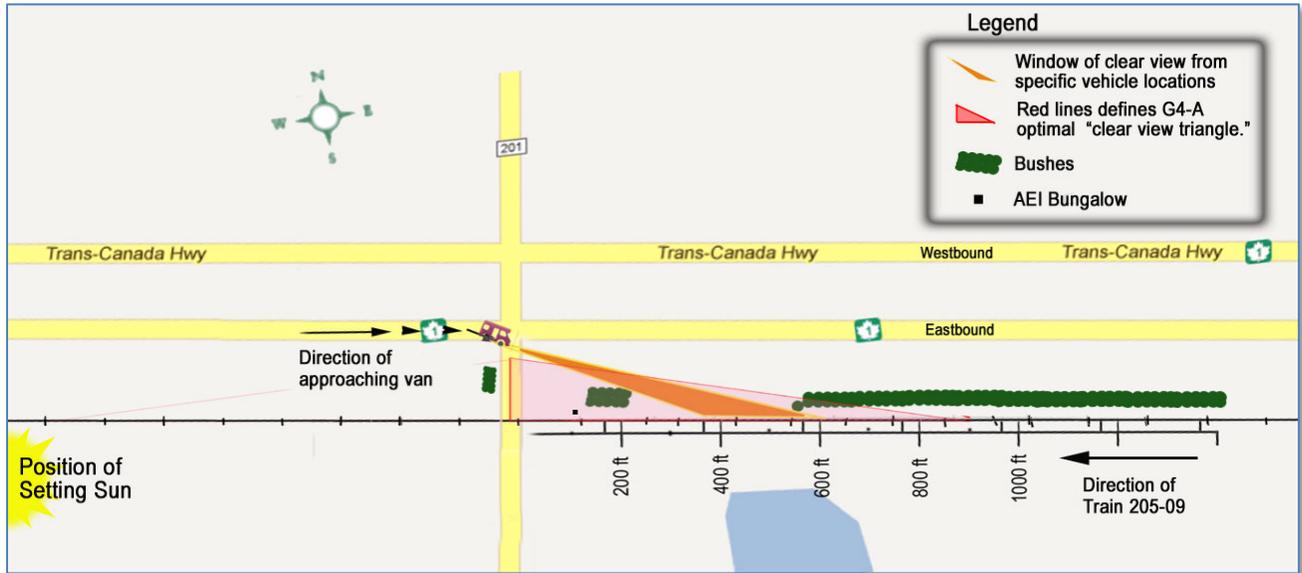
Figure 2. Site diagram

Approaching Airport Road (Provincial Road 201), the van moved right onto the paved turning lane and slowed almost to a stop before turning south (right) onto Airport Road (Figure 2).

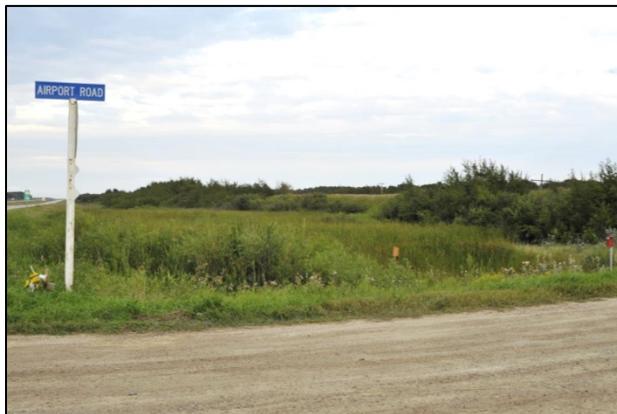
The driver looked left for trains coming from the east (Photo 1) before proceeding towards the crossing (Photo 2). Seeing no train approaching from the east, the driver then looked right for any trains approaching from the west (Photo 3). The view westward was directly into the setting sun; brush along both the road and ROW partially obscured the tracks.

Photo 1. Eastward view 40 m north of the crossing (12 August 2012)

Two groups of trees and other bushes were situated on the north side of the railway right-of-way (ROW), east of the crossing. For eastbound vehicles on Highway 1 and for vehicles turning south onto Airport Road, the vegetation obscured drivers' view of approaching westbound trains. The sightlines to the east were limited to less than 700 feet. For the westbound train, the train crew first observed a flash of light reflected from the windshield of the van approaching the crossing from the north, about 575 feet east of the crossing, as the train cleared trees along the ROW.

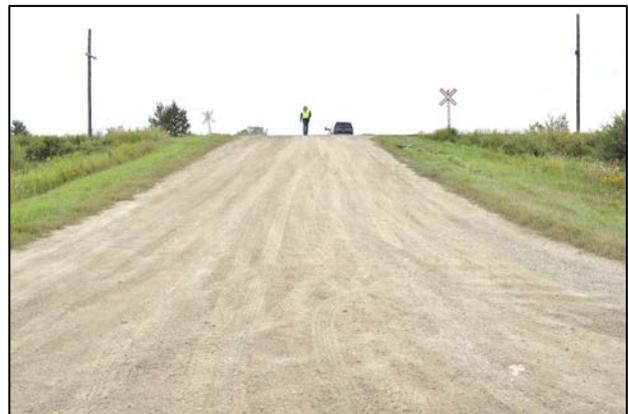
Photo 2. Southward view approaching the crossing from the north (12 August 2012)

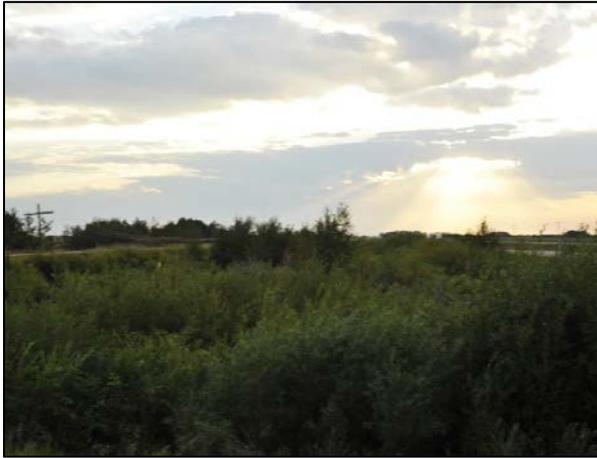
Photo 3. Westward view from 30 m north of the crossing (12 August 2012)

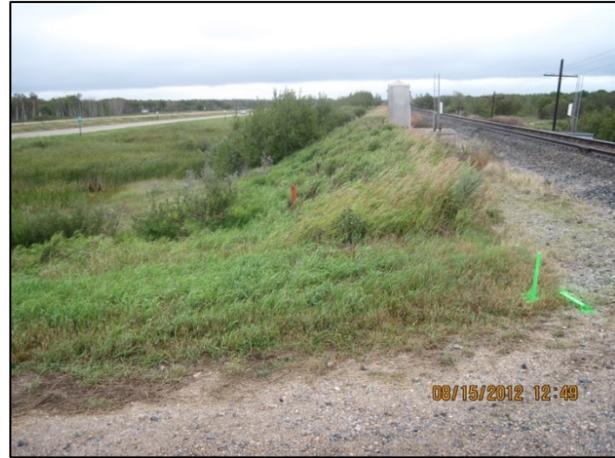
After turning, the driver briefly accelerated up to nearly 28 km/h and then slowed to about 18 km/h near the crossing. Just before reaching the crossing, the driver shoulder-checked again to the left (east) and for the first time saw the approaching train framed between the signal

bungalow and the crossing (Photo 4). The driver accelerated at the last moment, but it was too late to avoid the collision. The airbags deployed as a result of the accident.

Photo 4. Eastward view from 5 m-10 m north of the crossing (12 August 2012)

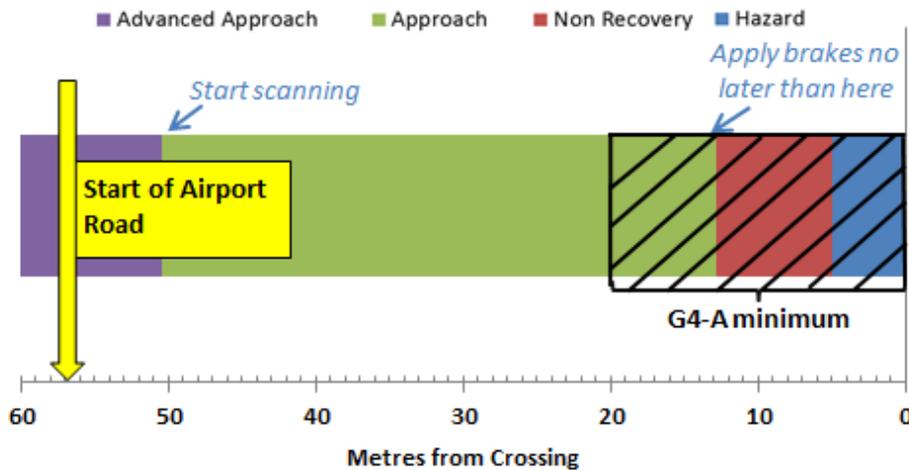
Considering the 4 zones drivers encounter when approaching a passive crossing equipped only with SRCS, when a 4.5 s PRT is used to calculate the optimal required sightline distance at this crossing (Figure 4) and is compared to minimum G4-A sightlines (Figure 4, hatched area), a significant proportion of vehicle/driver approaches (i.e., up to 83%) could potentially result in inadequate sightlines.

Figure 4. Passive level crossing approach zones for the Broadview crossing, assuming a driver PRT of 4.5 s and average vehicle speed of 30 km/h, overlaid with minimum G4-A sightlines based on PRT of 2.5 s (hatched area)
