# AIR TRANSPORTATION SAFETY INVESTIGATION REPORT A23W0122

## **RUNWAY INCURSION AND RISK OF COLLISION**

Jazz Aviation LP De Havilland Aircraft of Canada Limited DHC-8-402,  
C-GGNZ

Calgary International Airport (CYYC), Alberta

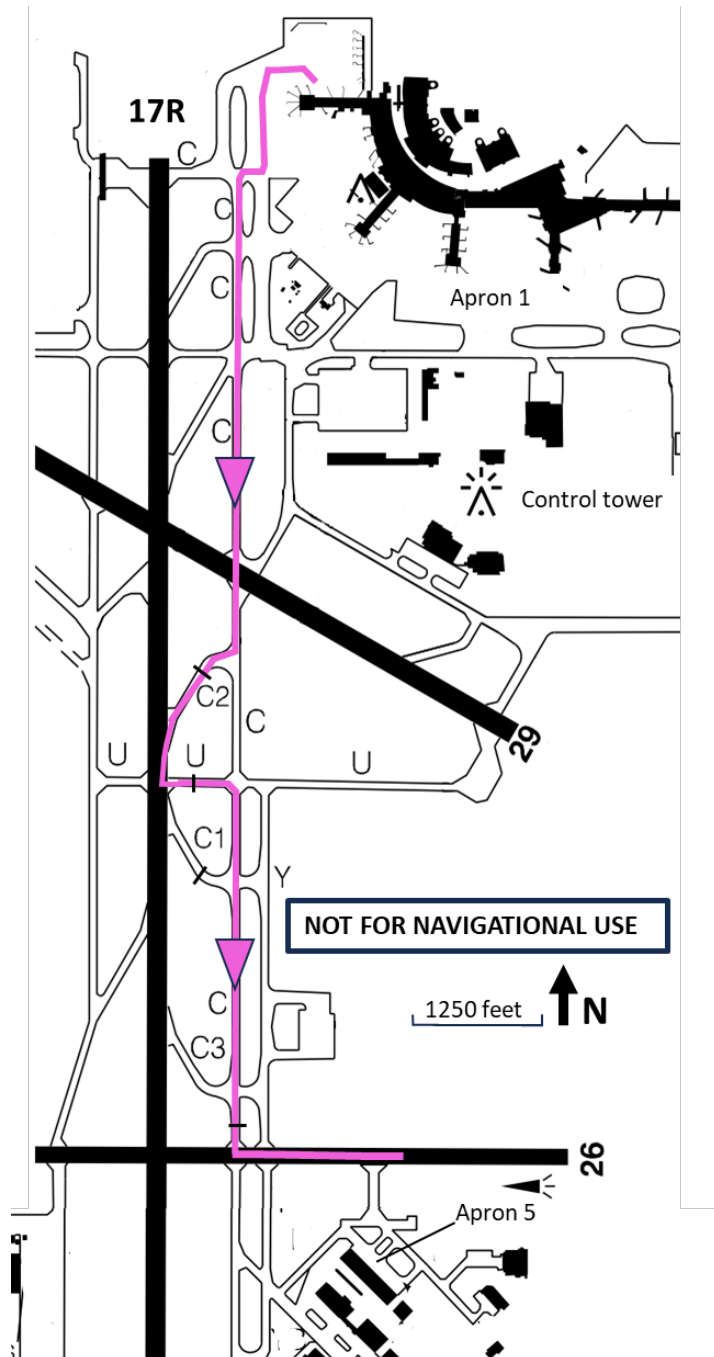
By 1103:00, the 2 tugs were on Taxiway C2 and stopped on the centreline, just short of the runway holding position marking for Runway 17R. For the lead tug driver, this was a typical position at which to stop when told to hold short of a runway, because of the fact that when

Figure 1. Tugs' path (solid magenta line with directional arrows) at Calgary International Airport (Source: NAV CANADA, *Canada Air Pilot [CAP]*, CAP 3: Alberta, Saskatchewan, and Manitoba, effective 11 July 2024 to 05 September 2024, with TSB annotations)

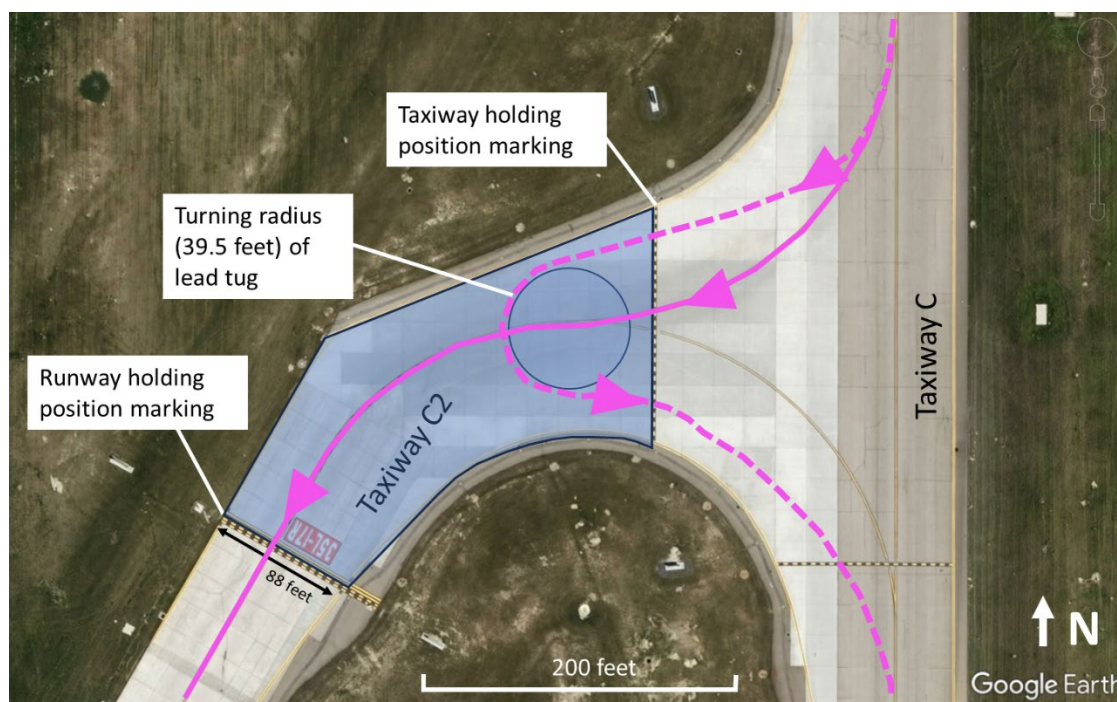
At this time, the lead tug was positioned close to the Runway 17R runway holding position marking on Taxiway C2. The driver of the lead vehicle had never turned around on a taxiway before and believed this was not allowed. In the absence of an explicit instruction to turn around in the ground controller's last communication, the lead driver also believed that doing so on Taxiway C2 to join Taxiway C would not be possible because he perceived that there was not enough space for both vehicles to turn around, given each vehicle's turning radius (Figure 2).

Figure 2. Path that the ground controller had intended for the 2 tugs (dashed magenta line) and the actual path taken (solid magenta line). The shaded area is where the ground controller had wanted the tugs to hold until the aircraft taxiing on Taxiway C in the opposite direction (flight JZA133) had passed (Source: Google Earth, with TSB annotations)

As a result of where he had stopped while waiting for the taxiing aircraft to pass, he did not feel he was able to turn around once the instruction to proceed on Taxiway C was received. The area on Taxiway C2 around the runway holding position marking is a narrow space (approximately 88 feet wide) and given the lead tug driver's turning radius while in 2-wheel steering mode (39.5 feet), the space appeared inadequate to the lead driver for the purposes of accomplishing the manoeuvre. Furthermore, he did not deem backing up an option because it would have required both drivers to exit their vehicles and disconnect the towbar from the 2nd tug. The lead tug driver also had a strong belief that, unless explicitly instructed by the controller to do so, drivers were not supposed to turn around while driving on controlled airport surfaces, such as taxiways and runways, and that this would require specific instructions from the controller. Therefore, all of these elements resulted in his conclusion that turning around was not a viable option.

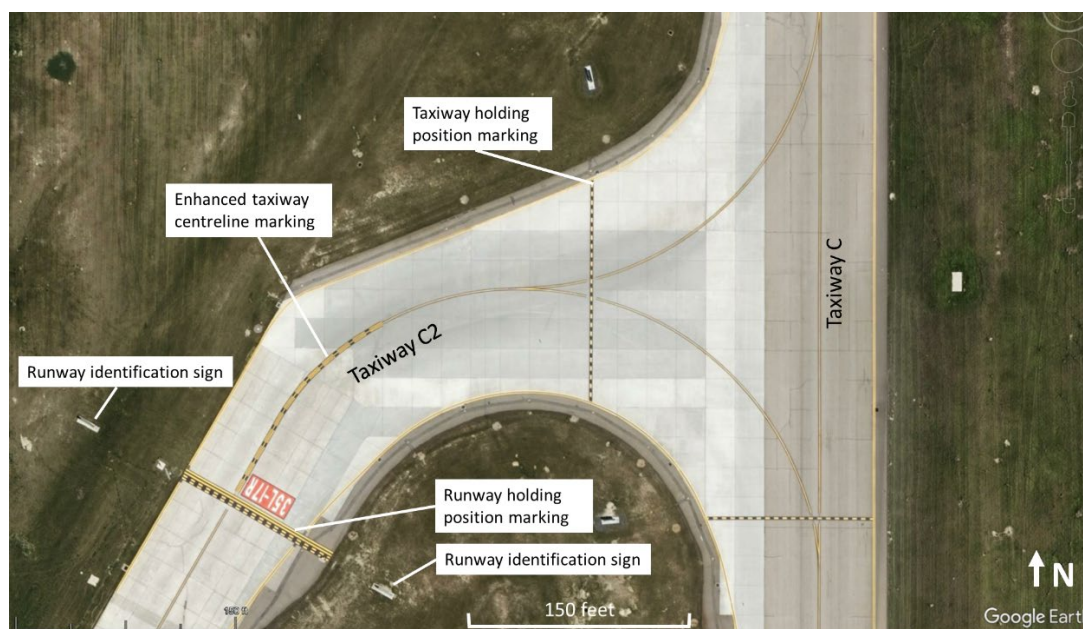
The runway holding position marking used on Taxiway C2 is of the pattern A variety<sup>13</sup> and features an enhanced taxiway centreline marking leading up to it. In addition, there are runway identification signs, along with elevated runway guard lights, on opposite sides of the runway holding position marking where Taxiway C2 joins with Runway 17R. A red rectangle with the runway designation marking (runway number and letter) painted in white letters is collocated with the runway holding position marking on the taxiway entrance to the runway (Figure 3).

Figure 3. Taxiway C2 markings and signage (Source: Google Earth, with TSB annotations)
