# AIR TRANSPORTATION SAFETY INVESTIGATION REPORT A24P0002

## CONTROLLED FLIGHT INTO TERRAIN

Aircraft Guaranty Corp Trustee  
Bell 206B (helicopter), N617TT  
Revelstoke Aerodrome (CYRV), British Columbia, 11 NM ENE  
05 January 2024

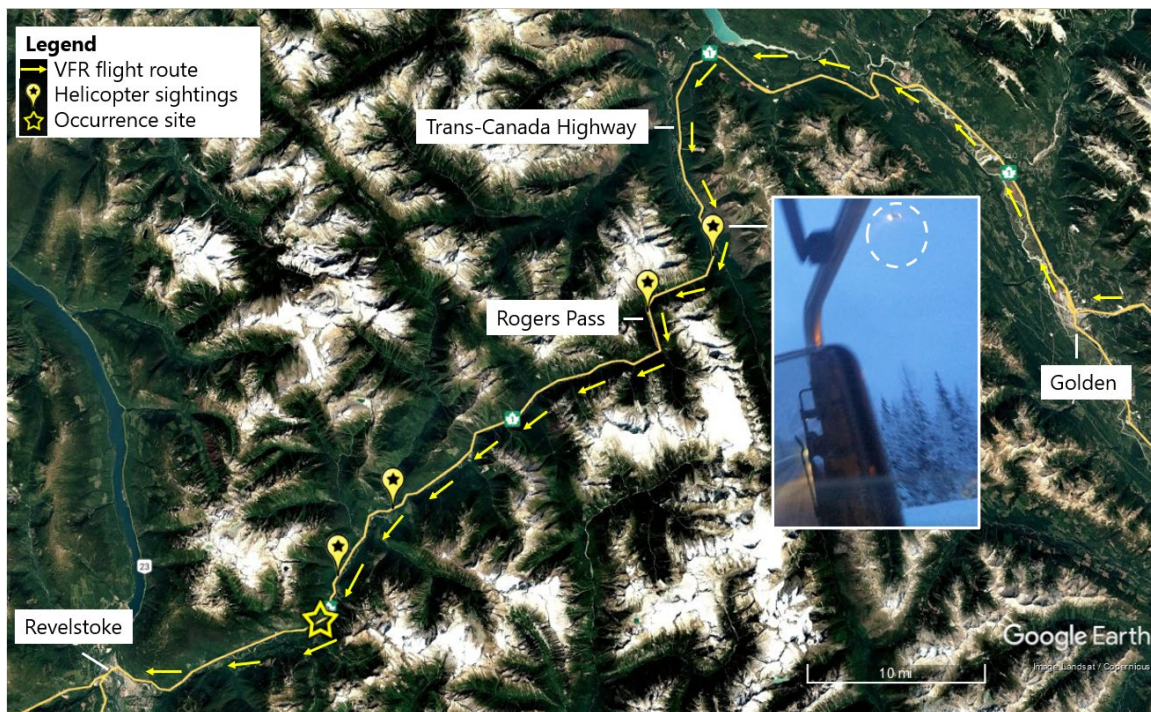
The occurrence helicopter was spotted by motorists and witnesses at various locations along the VFR route (Figure 1). At 1622, the helicopter was first seen approximately 5 nautical miles (NM) north-northwest of Rogers Pass with the forward landing light on and flying in the valley below the cloud toward the pass.

The helicopter was last seen about 20 NM southwest of Rogers Pass, flying southwest in fog at approximately 50 to 100 feet above the trees on the south side of the highway. The helicopter was observed on 3 occasions making 360° left-turn orbits before returning to the same position on the south side of the highway. At approximately 1640, the helicopter made a right turn in a northwest direction and flew across the highway toward upsloping terrain. No further visual contact was reported.

**Figure 1.** Satellite image of the visual flight rules (VFR) route between Golden, British Columbia, and Revelstoke, British Columbia, that is published on the Calgary, Alberta, VFR Navigation Chart, along with the approximate location of 4 witness sightings of the helicopter and the occurrence site. Inset is an image of the helicopter (circled) taken at the 1st witness sighting. (Source of main image: Google Earth with TSB annotations; source of inset image: Chris Dubasov, with permission)

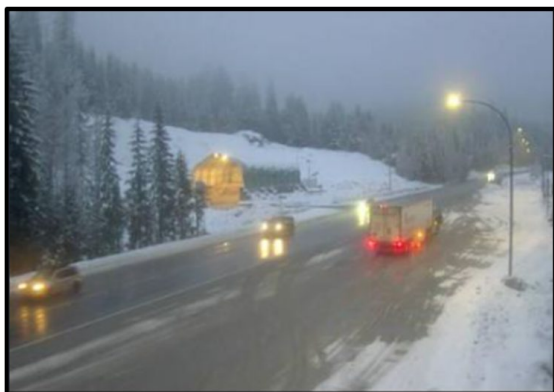
The pilot of a local commercially operated helicopter that was on a return flight from Rogers Pass to Revelstoke reported building fog and cloud layers with light snow showers while passing through the occurrence area at approximately 1600 (Figure 4). As the day transitioned through civil twilight, the visibility likely degraded from a combination of these conditions and the surrounding mountains (Figure 5).

Figure 4. Still image taken from the Albert Canyon webcam at 1600 on 05 January 2024 (Source: DriveBC.ca)

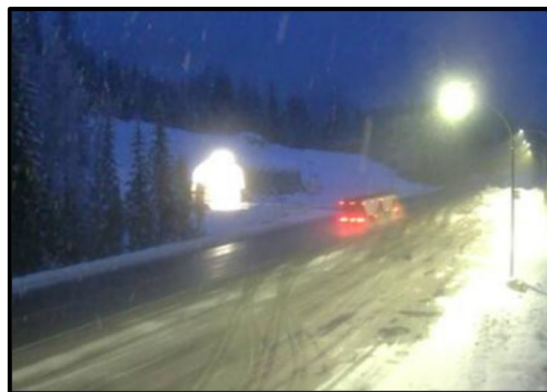
Figure 5. Still image taken from the Albert Canyon webcam at 1630 on 05 January 2024 (Source: DriveBC.ca)

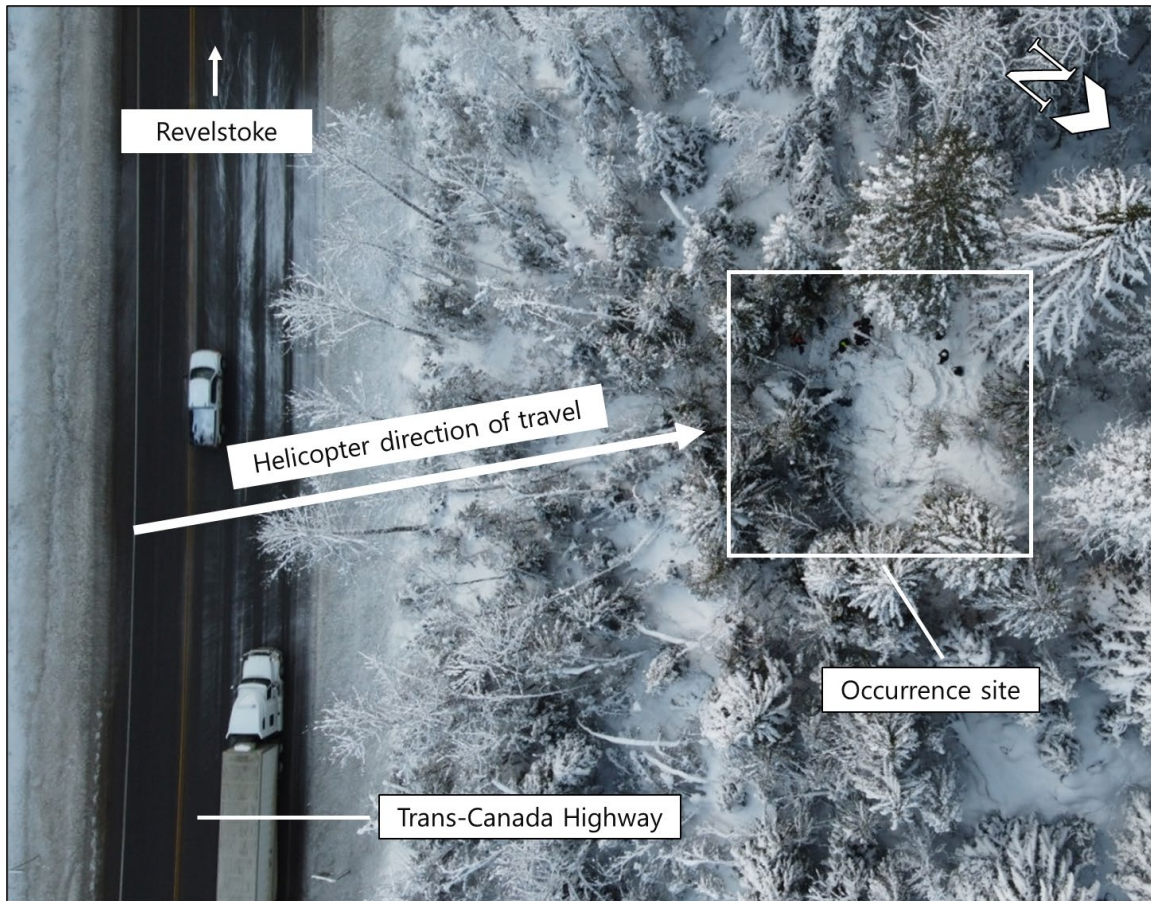
The wreckage was located on a 35° forested slope north-northwest of, and approximately 200 feet higher in elevation than, the Trans-Canada Highway. The wreckage was obscured by snow that had fallen during and after the occurrence flight (Figure 6). The helicopter collided with terrain on a heading of approximately 310°.

Figure 6. Overhead view of the helicopter's approximate direction of travel and the occurrence site location relative to the Trans-Canada Highway with investigators and the recovery team at the site (Source: TSB)

The fuselage deformation and damage were consistent with a high-energy impact in a forward direction. The 2 main rotor blades were fractured at different lengths and deformed, while the main transmission was ejected from the fuselage and not recovered. The engine had severed at the interface between the accessory gearbox and the turbine section. The engine 1st-stage axial compressor blades exhibited impact and bending damage that was consistent with the engine operating at impact.

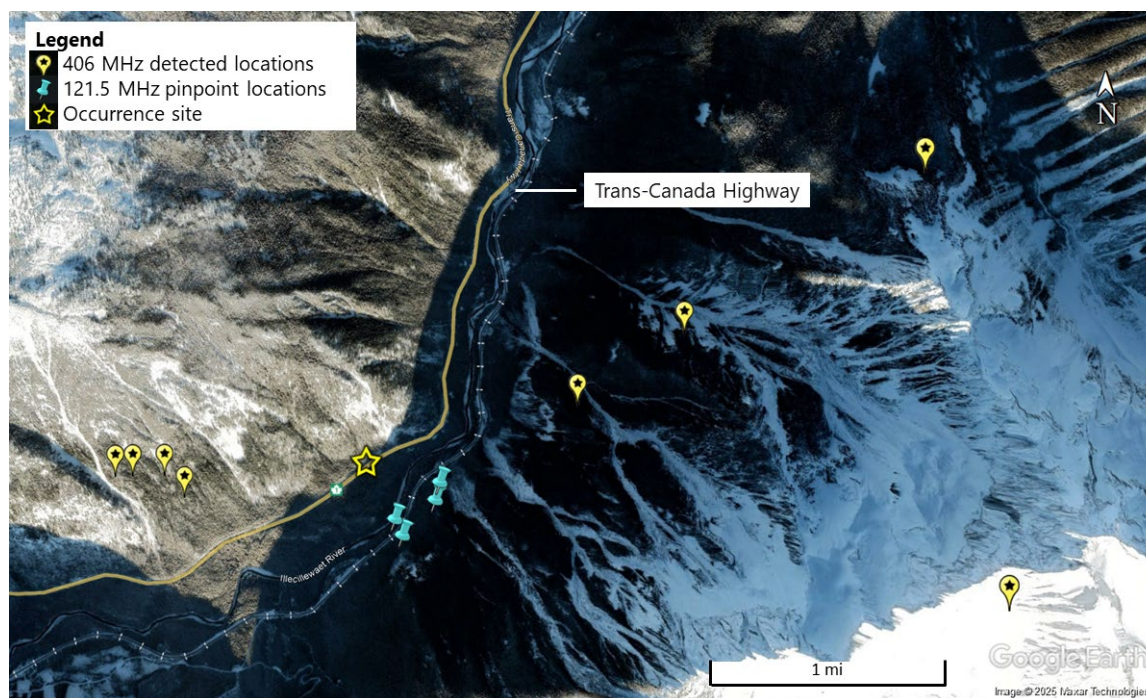
In this occurrence, the ELT activated. It was ejected from the occurrence helicopter and was no longer attached to its external antenna. The JRCC received a 406 MHz signal that provided multiple GPS coordinates within a radius of 2.5 NM of the helicopter (Figure 7). The SAR aircraft were unable to detect a 121.5 MHz signal at higher altitude and, although the ground SAR were able to detect the signal on the ground, they were unable to pinpoint the location until the Cormorant helicopter was able to assist when the weather improved on 07 January.

**Figure 7.** Satellite image showing the locations a 406 MHz emergency locator transmitter signal was detected by the COSPAS-SARSAT system, the locations a 121.5 MHz signal was detected by the air and ground search and rescue teams, as well as the occurrence site (Source: Google Earth, with TSB annotations)

The TSB Engineering Laboratory in Ottawa, Ontario, examined the ELT and determined that the 406 MHz signal performed within specifications, but the 121.5 MHz signal transmitted for approximately 10 seconds within specification and then stopped. The 121.5 MHz signal did not transmit for the remainder of the test, and investigators could not determine the reason for the malfunction.

heavily treed mountainous terrain, the unfavourable weather, the snow-covered wreckage, and the degraded 121.5 MHz ELT signal likely delayed rescue teams in locating the accident site.
