MARINE INVESTIGATION REPORT
M01C0054

STRIKING AND SUBSEQUENT FIRE ON BOARD

BRIDGE 11, WELLAND CANAL
AND
BULK CARRIER *WINDOC*
WELLAND CANAL, ALLANBURG, ONTARIO
11 AUGUST 2001

Report Number M01C0054

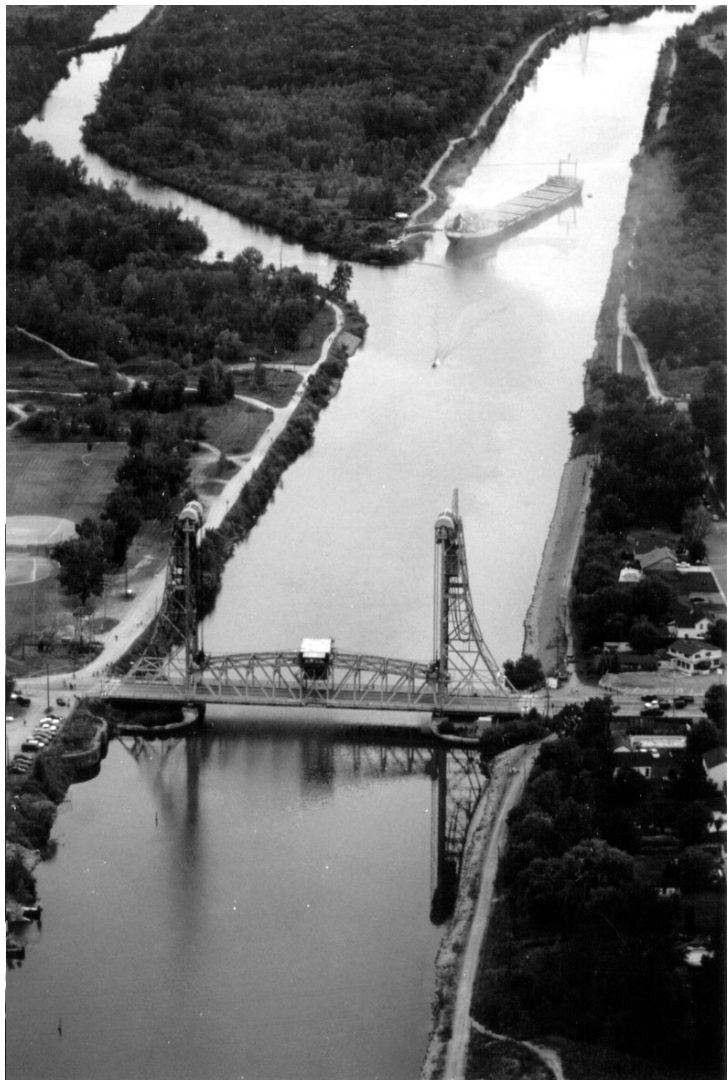
The master and third officer left the wheelhouse by the starboard navigation bridge wing. As they proceeded down the external bridge access ladder, the span of the bridge struck the vessel in way of the wheelhouse front windows, subsequently destroying the vessel's wheelhouse and funnel (see Photo 1).

Photo 2. Bridge lift striking vessel in way of the wheelhouse and funnel after the striking. (Rephotograph by Captain Rossini)

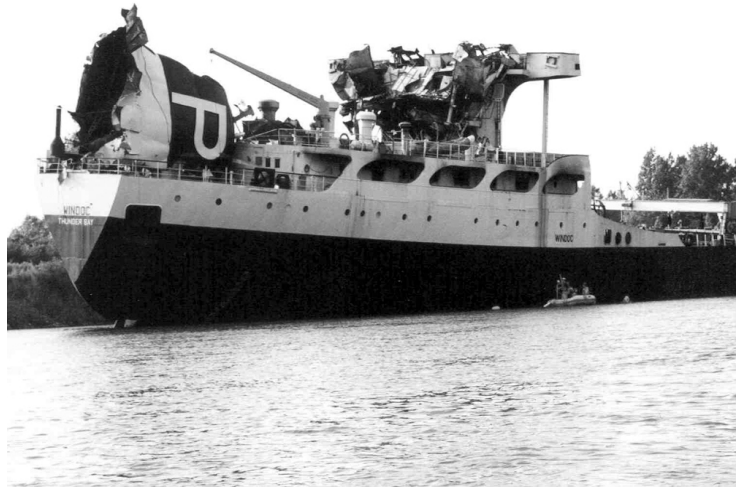
The wheelhouse, main mast, engine room vents, and funnel were destroyed by contact with the lift span of the bridge. The incinerator fuel oil tank, located in the funnel casing, was ruptured, spilling fuel into the engine room and onto the boat deck. Accommodation on the various decks was destroyed by fire, heat, and smoke. The engine room casing and main engine were damaged by fire, heat and water. The bilge shell plating in way of starboard ballast tank No. 1 was creased and fractured. The aft bulkhead and bilge floors were distorted and torn adrift. The vessel was declared a constructive total loss. No damage to the cargo was reported (see Photo 4).

Photo 4. View of damaged superstructure and funnel.

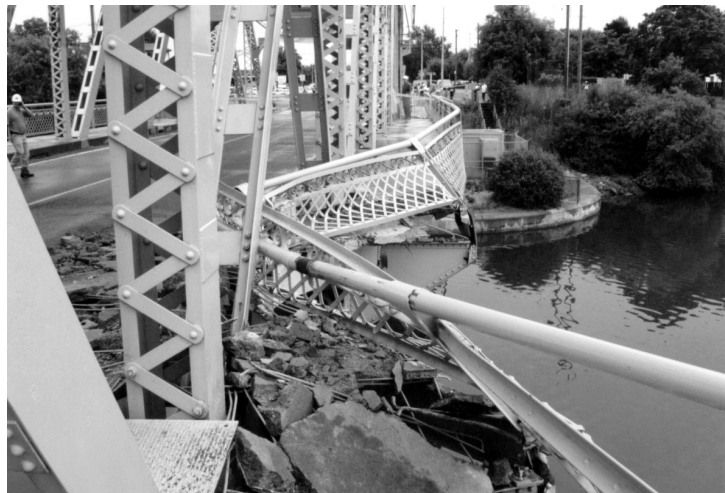
The bridge sustained structural damage to the centre of the vertical-lift span (see Photo 5). There was also damage at the extremities of the span as a result of lateral movement caused by the striking.

Other than minor adjustments on the wire ropes which operate the bridge, there was no damage, mechanical or electrical, to the bridge's systems.

Photo 5. Damage to Bridge 11. (Photograph by Thorold Fire Department)

Repairs to the bridge were carried out while the vertical-lift span was in the fully-raised position to permit vessel traffic to transit the canal. Upon inspection by SLSMC engineers, the bridge reopened to vehicular traffic on 16 November 2001.

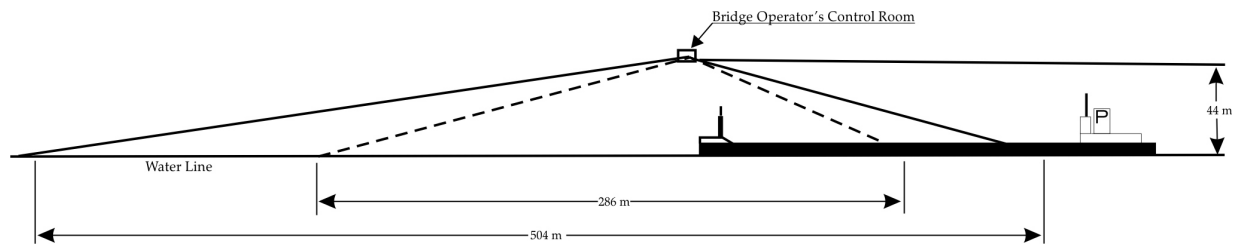
The span was being lowered when it struck the vessel in way of the wheelhouse front windows, at a height of approximately 18.6 m above water level. It took between 49 and 65 seconds to lower the span 18 m. With the vessel travelling at a speed of approximately five knots, its bow would have been under or just clear of the bridge when the bridge operator began to lower the span. The approaching vessel's aft superstructure would have been visible to the bridge operator (whether seated or standing) through the south-facing control room window (see Figures 1 and 2, Photos 6 and 7).

Figure 1. Diagram of a bridge operator's field of view when the bow of the vessel is under the operator's control room. Bridge is in the fully-raised position.

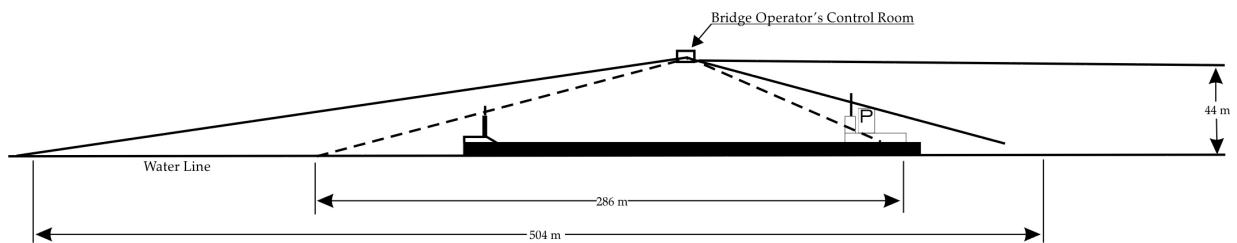
Figure 2. Diagram of a bridge operator's field of view when the vessel is amidships under the operator's control room. Bridge is in the fully raised position.

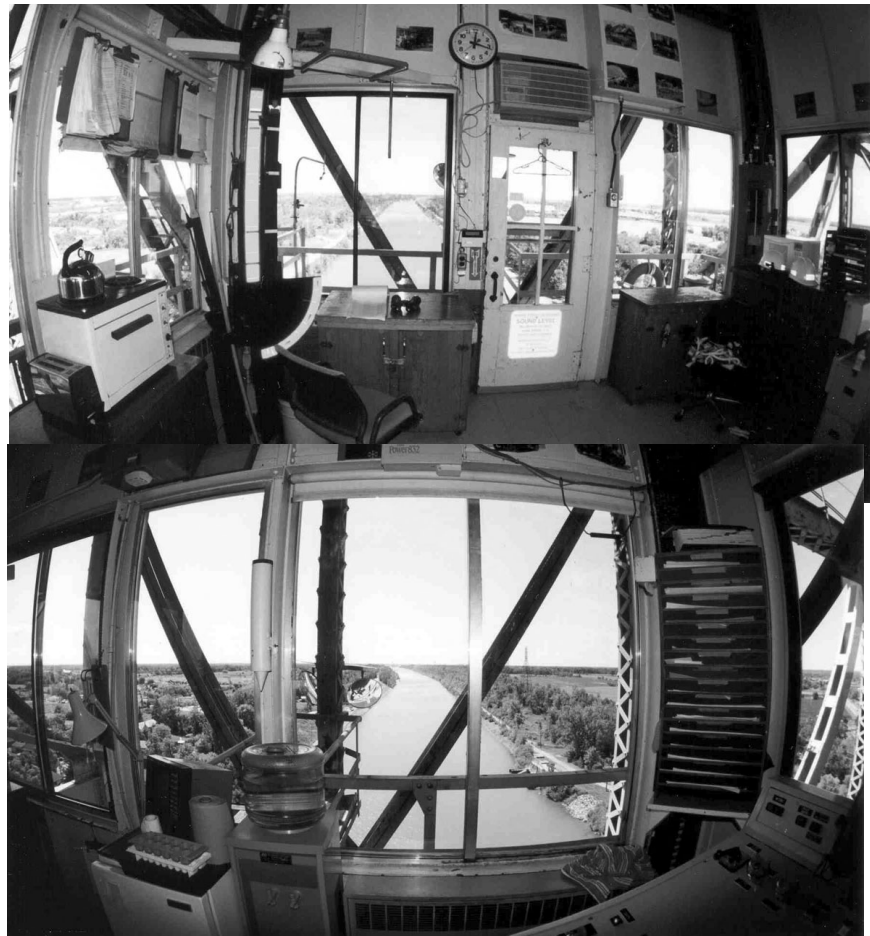
Photo 7. Looking south from inside bridge operator control room with bridge in fully raised position (using fish-eye camera lens).

the bridge.⁷ The bridge operator described having seen the stern of the vessel through the north windows of the control room (i.e. looking downstream the canal) where the door is located.
