AIR TRANSPORTATION SAFETY INVESTIGATION REPORT A24W0116

FUEL EXHAUSTION

Simpson Air (1981) Limited
De Havilland Aircraft of Canada Limited DHC-2 Mk. I (Beaver) (floatplane),
C-GMGD
Fort Simpson Island Water Aerodrome (CEZ7), Northwest Territories,
7 NM W
29 August 2024

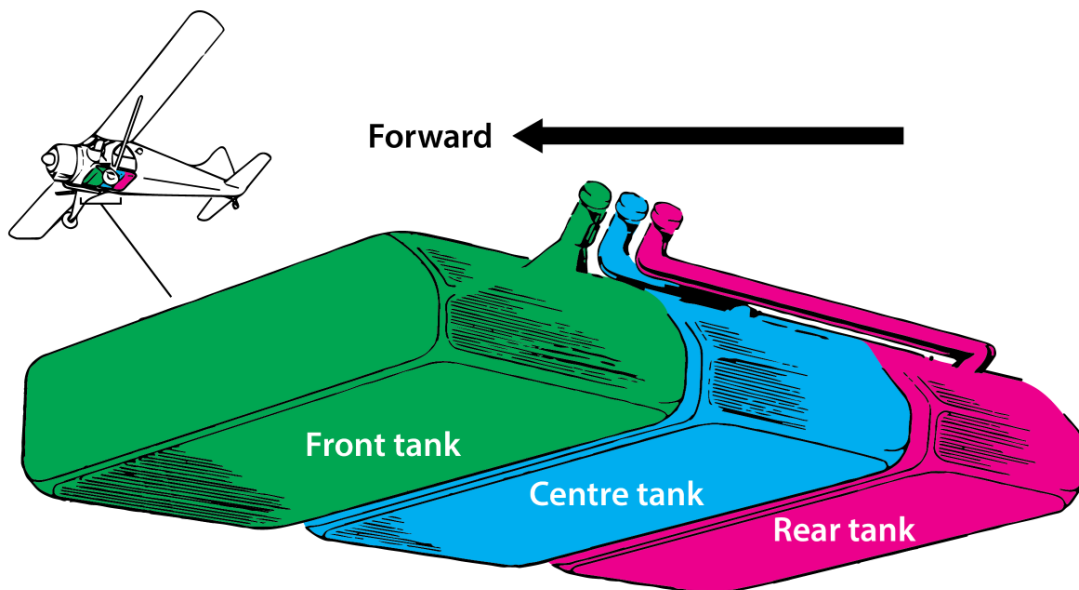
Figure 1. Main fuel tanks in the Beaver aircraft (Source: TSB based on figures in De Havilland Aircraft of Canada Limited, *DHC-2 Mk. I & Mk. II Airplane Flight Manual [PSM 1-2-1]*)

The front, centre, and rear main fuel tanks are under the cabin floor and are serviced through 3 filler necks in a filler compartment located on the left side of the fuselage, adjacent to the cockpit door (Figure 1). The wingtip fuel tanks are serviced through a filler door on the top of each wing. The pilot was aware that patience is required when fuelling while docked, particularly in rough water conditions, because it can take several minutes for the fuel, which is gravity fed, to settle in the main fuel tanks. This is particularly true for the rear fuel tank because of its longer filler neck.

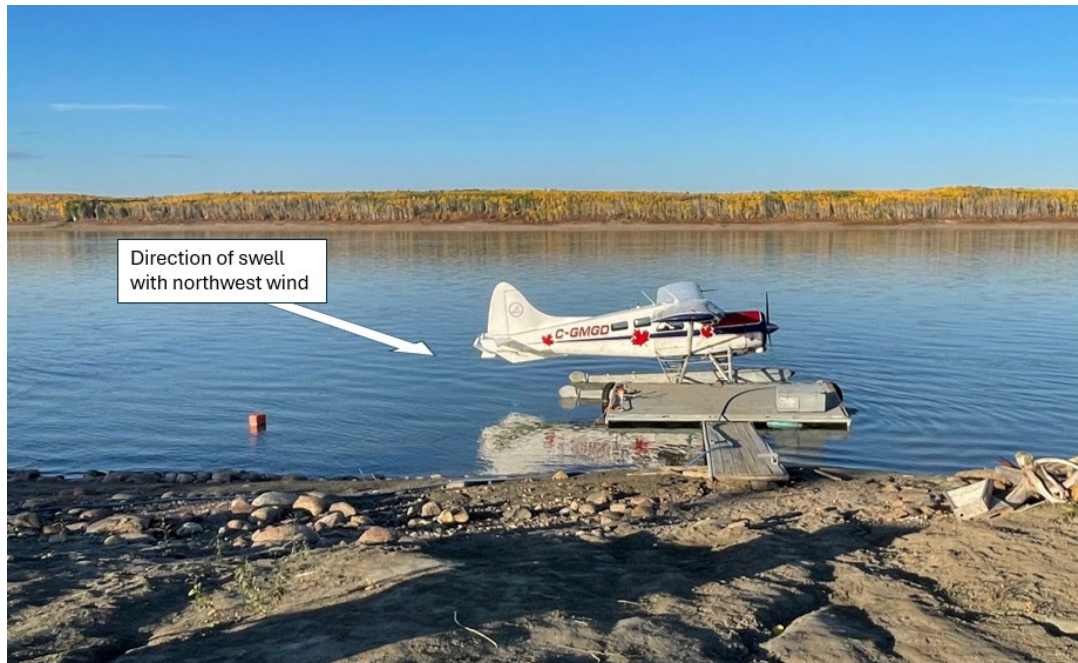
Figure 2. The occurrence aircraft at the Fort Simpson Island Water Aerodrome dock (not on the day of the occurrence). The arrow depicts the direction of the swell on the day of the occurrence (Source: Simpson Air [1981] Limited)

On the day of the occurrence, the Mackenzie River water level at the CEZ7 dock was low and the winds were from the northwest above 10 knots. This created a swell that was hitting the aircraft from the left rear at approximately 45° (Figure 2) to the aircraft's longitudinal axis. This condition can give the appearance of the fuel tank being full at the filler neck. During fuelling, the swell was sufficient to cause fuel to be sloshed and splashed onto the pilot's clothes. The pilot normally checks the fuel gauges before taking off but could not recall if that was completed for the occurrence flight.

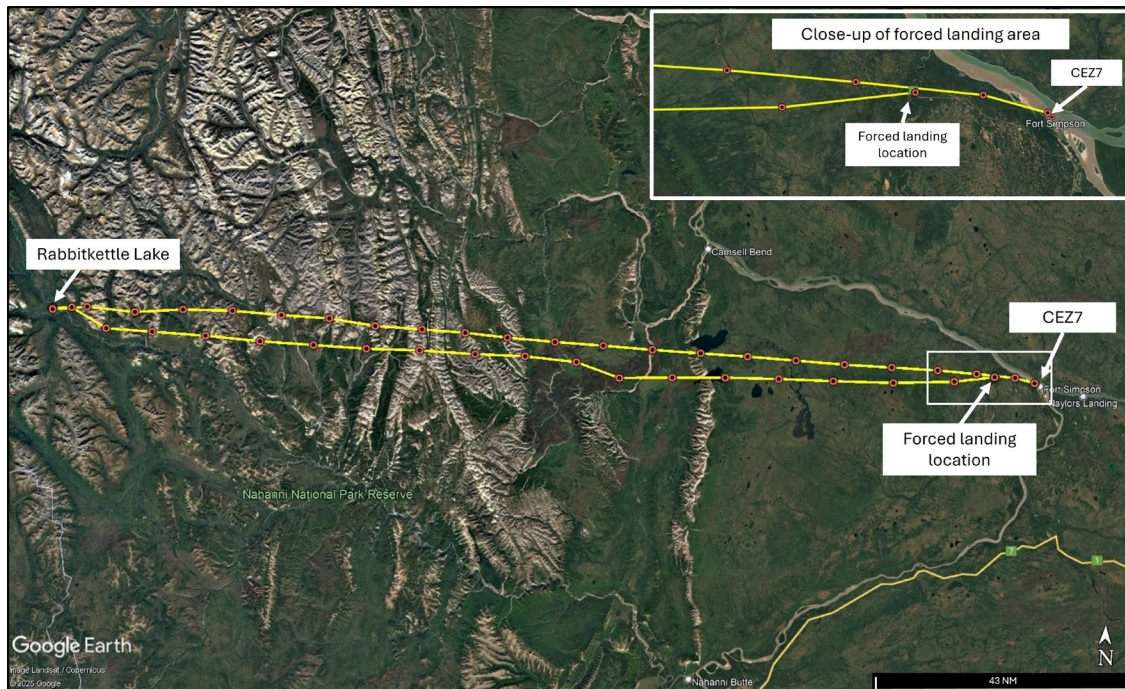
Figure 3. Occurrence aircraft's flight path and forced landing location, with a close-up view of the forced landing area in inset (Source of main image and inset: Google Earth, with TSB annotations)

At approximately 1240, the pilot recalled that the fuel gauge showed empty. Again, this happened sooner than he expected. At that point, he began considering options in the event the fuel gauge was accurate. In the absence of other viable options, the pilot turned toward, and followed the Mackenzie Highway in case an emergency landing was required. When the aircraft was approximately 8 NM west of CEZ7 and at around 1500 feet above ground level (AGL), the engine⁶ experienced a complete loss of power. The pilot was able to carry out a forced landing on the highway, landing at approximately 1250, 7 NM west of CEZ7 (Figure 3).
