RAILWAY INVESTIGATION REPORT R14M0002

MAIN-TRACK DERAILMENT

CANADIAN NATIONAL

07 JANUARY 2014

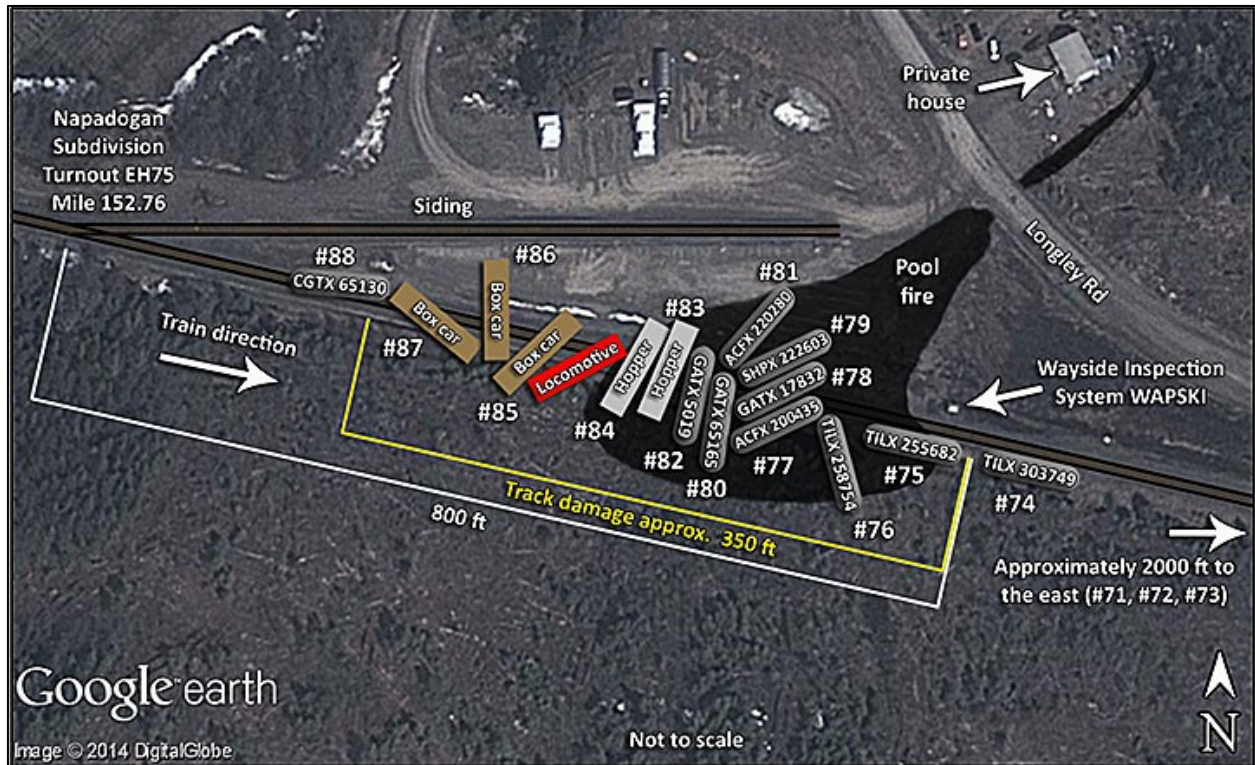
Figure 2. Diagram of the pile-up of derailed cars (Source: Google Earth, with TSB annotations)

A piece of rail measuring about 2 feet was found on the south side of the track beside the last 2 derailed cars (the 87th and 88th). There were batter marks at one end of the piece of rail. Approximately 350 feet of track was completely destroyed where the pile-up occurred. The EH75 turnout, about 800 feet west of the WIS, was also damaged (Figure 2). In addition to the damage to the rolling stock and railway track, the fire caused by the crude oil spill damaged a nearby house.

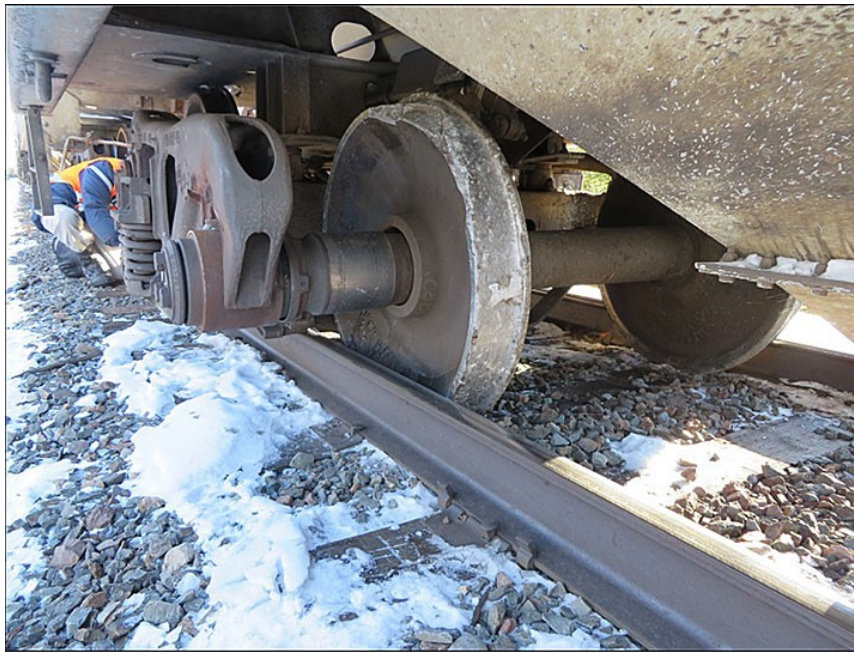
Photo 1. Derailed axle of car CRDX 15109

Examination of the eastbound track, from the site of the car pile-up, showed the presence of grooves in the snow and impact marks on the rail anchors and tie plates that extended up to car CRDX 15109 (13th car). This car came to a stop at Mile 151.44, and the trailing axle of its leading truck (Photo 1) had derailed.

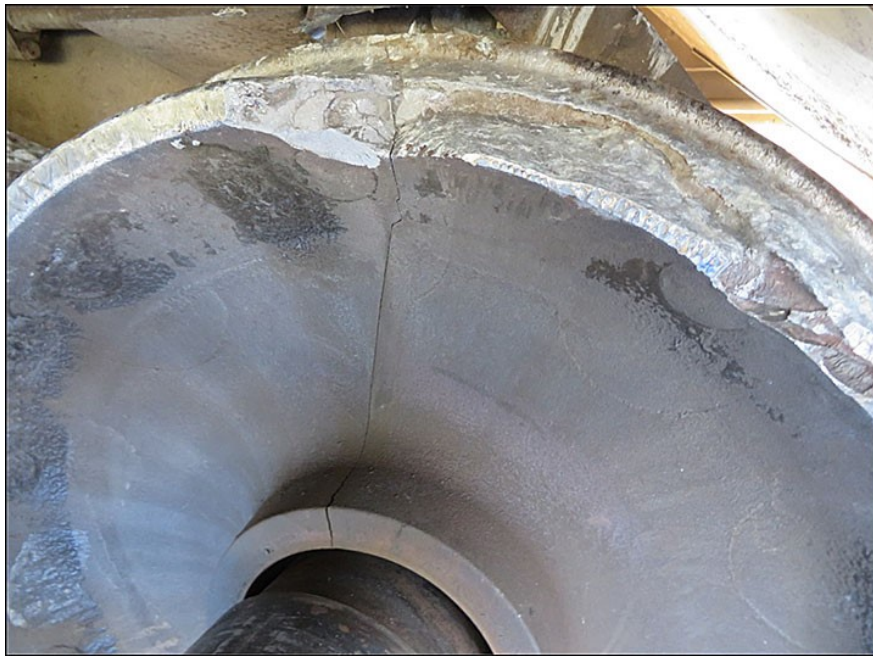
Photo 2. Crack in L3 wheel of car CRDX 15109

The L3 wheel had separated from the wheel seat and shifted inward. Its wheel tread was broken and a section measuring about 24 inches had separated. An open crack extended across the wheel web, from the wheel tread to the hub (Photo 2). The R3 mating wheel showed significant shelling on its entire circumference.

- An open crack extended across the wheel web from the wheel tread to the hub. There was no evidence of progressive failure on the crack surface. Chevron markings pointed to the wheel tread, indicating that the crack began when a section of the running surface shattered; the subsequent wheel pounding caused the crack to spread.

- The L3 wheel tread was broken and a section measuring about 24 inches in length was missing.
- The wheel tread was 1 1/16 inches thick, exceeding the AAR limit of 7/8 inch.

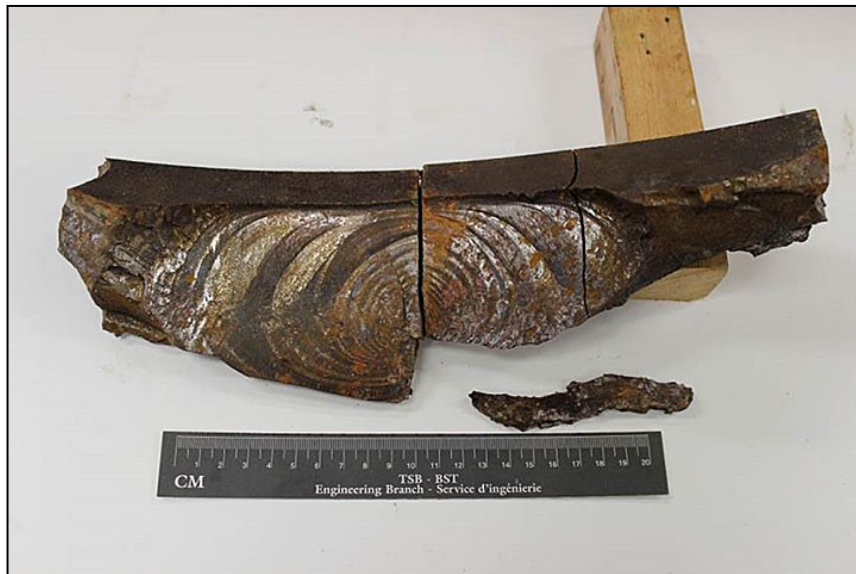
Photo 3. Shattered rim of L3 wheel

- Growth rings were visible on the fragments and indicated that fatigue cracking led to a shattered rim. Concentric marks pointed to a single point of origin, located about 1/2 inch below the surface of the wheel tread and 2 7/8 inches from its gauge face (Photo 3).

The metallurgical analysis of the L3 wheel and the fragments revealed an area of porosity of about 4 mm in diameter at the crack's point of origin. A sample of the failed wheel was sent to an external certified laboratory for a detailed chemical analysis (American Society for Testing and Materials [ASTM] E415-08). The chemical analysis of the fractured L3 wheel showed that it met the AAR specifications for a Class C wheel (Table 3).

Before the accident, no external defect had been detected on the L3 wheel of car CRDX 15109. The wheel had passed through a wheel impact load detector (WILD) the day before the accident, and no anomaly was reported. The wheel components complied with the specifications of the Association of American Railroads (AAR) for a Class C wheel; however, the wheel had an area of subsurface porosity that led to fatigue cracking, which in turn caused the wheel tread to shatter.

When the L3 wheel was manufactured in 1991, the area of porosity, while fairly large, was not detected during the ultrasonic testing and therefore the wheel was placed into service even though it had a defect. In 2006, the wheels were reprofiled and, according to the company that performed the work, ultrasonic testing was performed, but no defect was found. Since the porosity defect observed during the metallurgical analysis of the L3 wheel was greater than 1/8 inch, it should technically have been detected during the testing performed after it was reprofiled. However, it was impossible to verify the results of the tests conducted on the L3 wheel since, at the time, there was no requirement to keep test results. However, this deficiency was corrected in 2010 and companies conducting ultrasonic tests must now keep the results for at least 10 years.

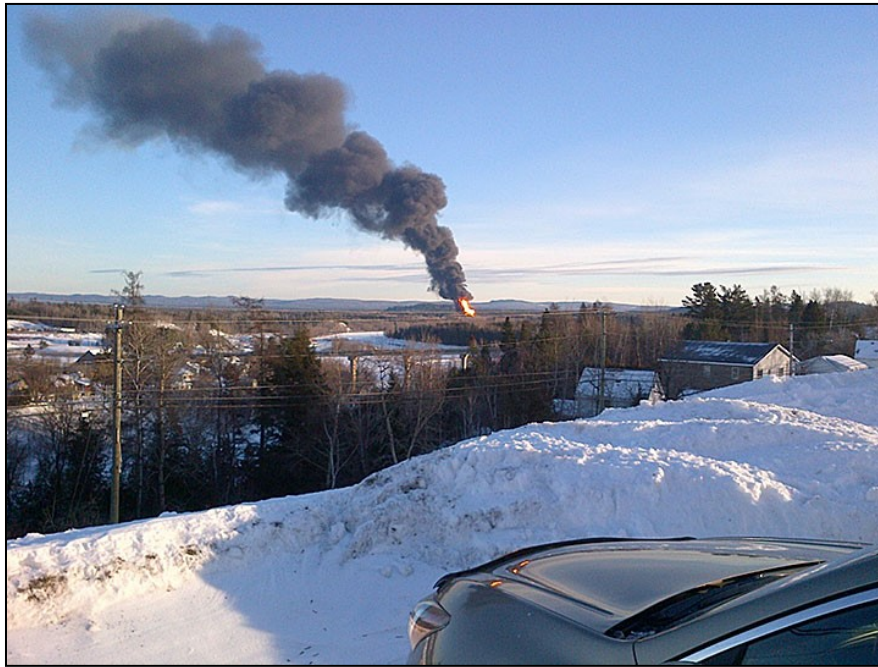
Photo 4. Vent and burn operations

On 10 January 2014, CN submitted a plan to the Ministry of the Environment to the effect that a specialized explosives contractor was to conduct vent and burn operations on 3 tank cars loaded with butane. The Ministry of the Environment and Transport Canada approved the vent and burn plan, which was executed at about 1400 (Photo 4).
