MARINE TRANSPORTATION SAFETY INVESTIGATION REPORT M24A0412

FIRE

Fishing vessel *Fundy Leader*
100 nautical miles southwest of Cape Sable, Nova Scotia
06 December 2024

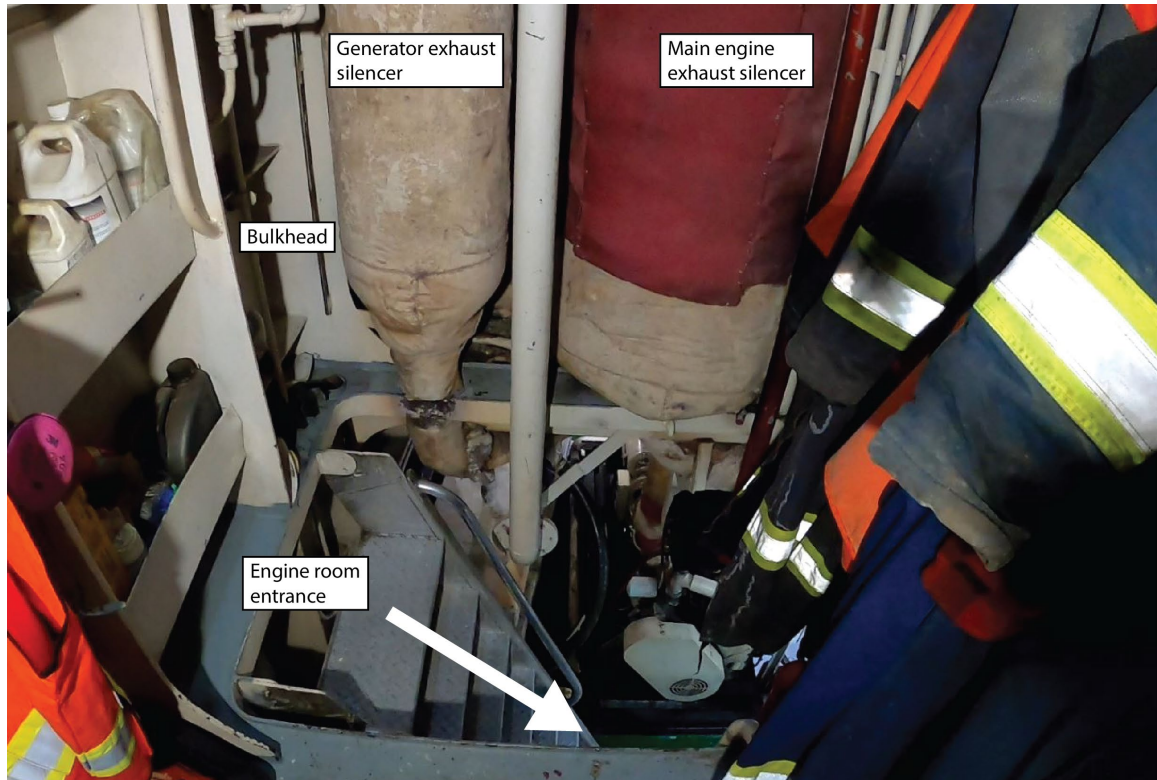
within 10 cm of the steel bulkhead that separates the exhaust trunking from the accommodations (Figure 2).

Figure 2. View of the exhaust trunking showing the location of the main engine exhaust silencer and a generator exhaust silencer. Note that this photo was taken after repairs following the fire. (Source: TSB)

The sections of exhaust lagging damaged in the fire were replaced with a type of lagging that can be removed for inspections by vessel crew and regulators.

During vessel repairs post-occurrence, the company that owns and operates the *Fundy Leader* removed the remaining wood framing in the bulkheads separating the cabin and galley from the exhaust trunking. Metal framing was installed in its place. The wooden fire axe handles were replaced with fibreglass handles.

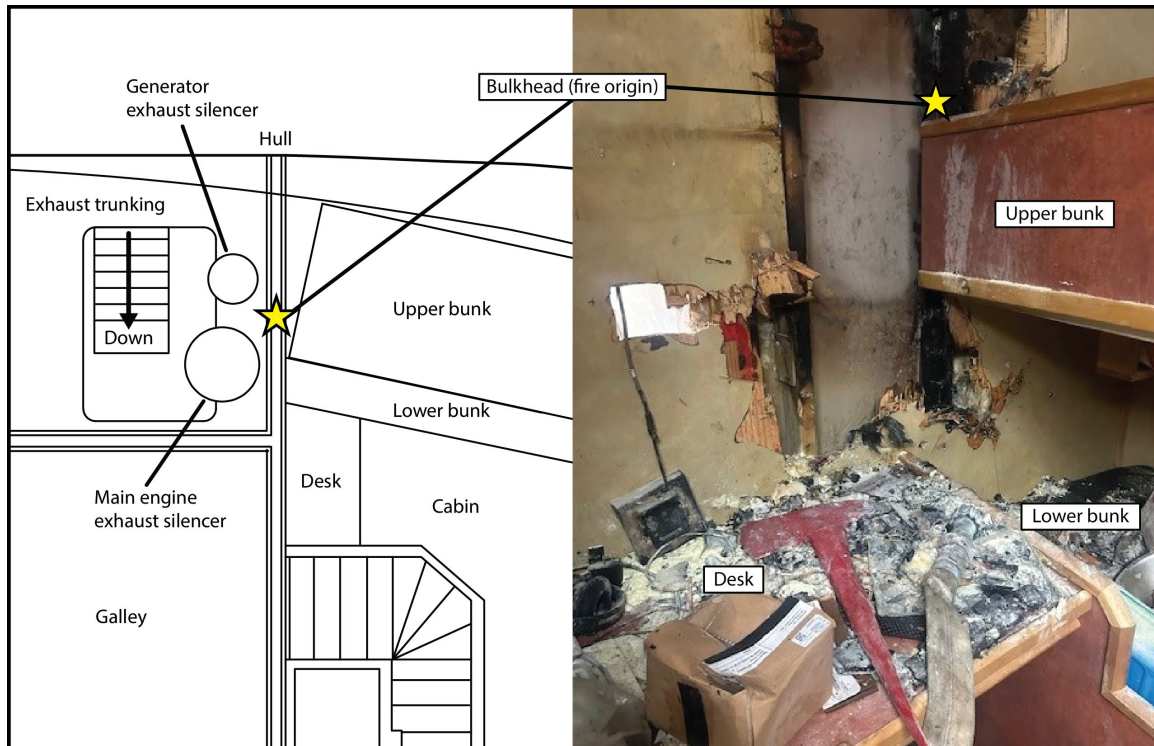
Data collected post-occurrence indicated that the source of ignition originated from a crack in the main engine exhaust silencer. The crack was approximately 30 cm in length and near the top of the silencer, on the side that faced the bulkhead separating the exhaust trunking from the cabin. Low-flame-spread⁵ wall panelling was attached to the wood framing on the side of the bulkhead facing the cabin.

In this occurrence, hot exhaust gases were escaping from the cracked silencer and heating up the steel on the bulkhead, which was less than 10 cm away. By conduction, the heated steel ignited the wood framing and caused the fire (Figure 4).

Figure 4. Fire origin shown on the vessel layout (left) and on a photograph of the cabin (right) (Source of left image: TSB, based on the vessel's general arrangement; source of right image: Clearwater Seafoods, with TSB annotations)
