MARINE TRANSPORTATION SAFETY INVESTIGATION REPORT M24C0217

GROUNDING

General cargo vessel *Heemskerkgracht*
Kahnawake, Quebec
22 August 2024

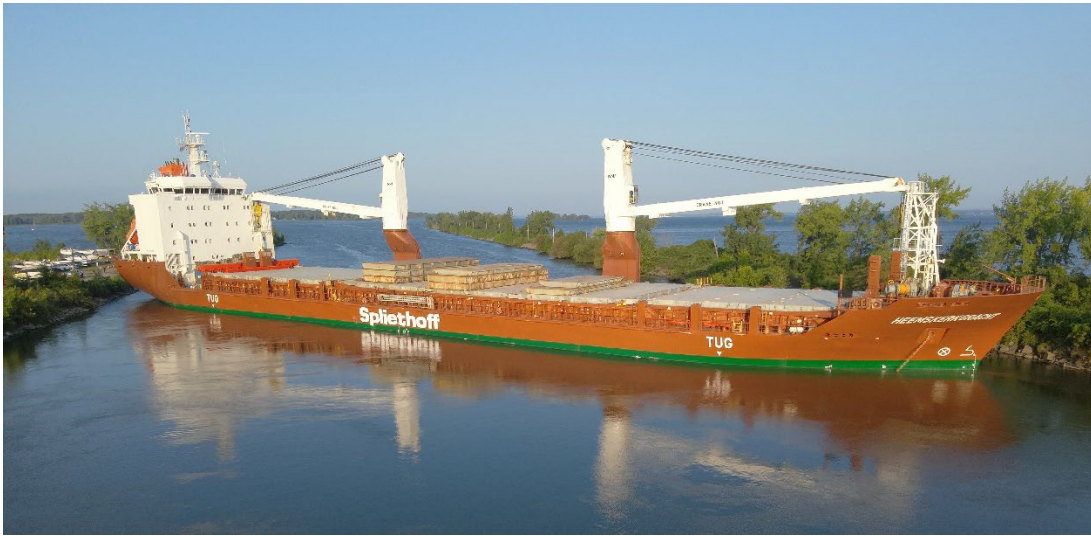
At 1837, the vessel's bow sheered to starboard and made contact with the south bank of the canal. The bow then rebounded and sheered to port, toward the north bank of the canal. At 1838, the 2 forward anchors were deployed at the master's order. Within a minute, the *Heemskerckgracht* had grounded with its port bow and starboard quarter on opposite banks, blocking the South Shore Canal (figures 2 and 3).

Figure 2. The *Heemskerkgracht* aground (Source: Canadian Coast Guard)

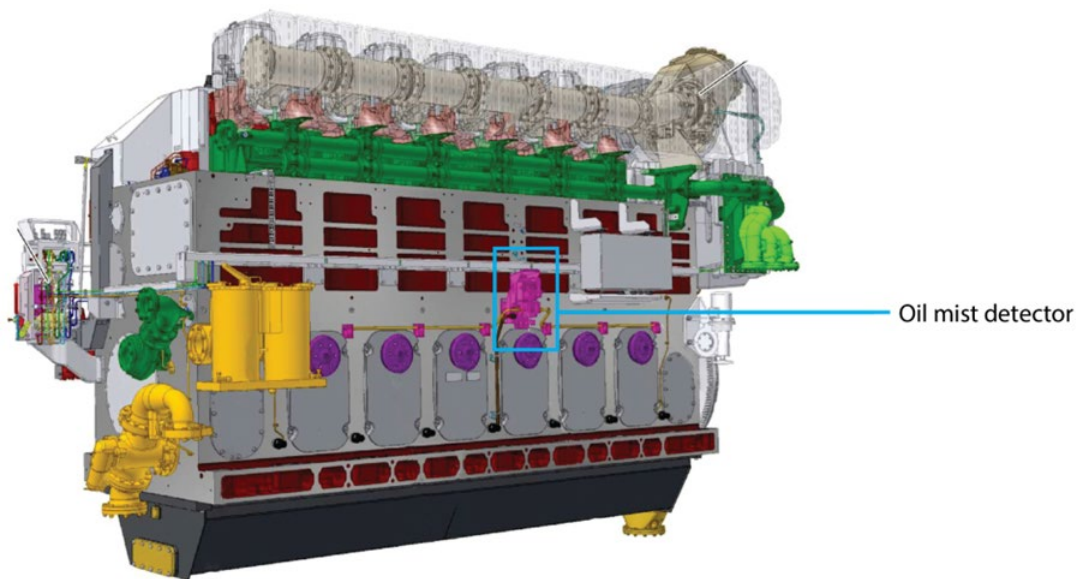
The *Heemskerkgracht*'s medium-speed engine was fitted with an OMD that provided an alarm and immediately shut down the engine in the event the concentration of oil mist exceeded allowable parameters. The OMD on the *Heemskerkgracht* met SOLAS requirements for the vessel's engine type. It also met the requirements set out by the International Association of Classification Societies. The OMD was located on the engine crankcase (Figure 4).

Figure 4. Location of the oil mist detector on the *Heemskerkgracht*'s engine (Source: Caterpillar Motoren GmbH & Co. KG, with TSB annotations)

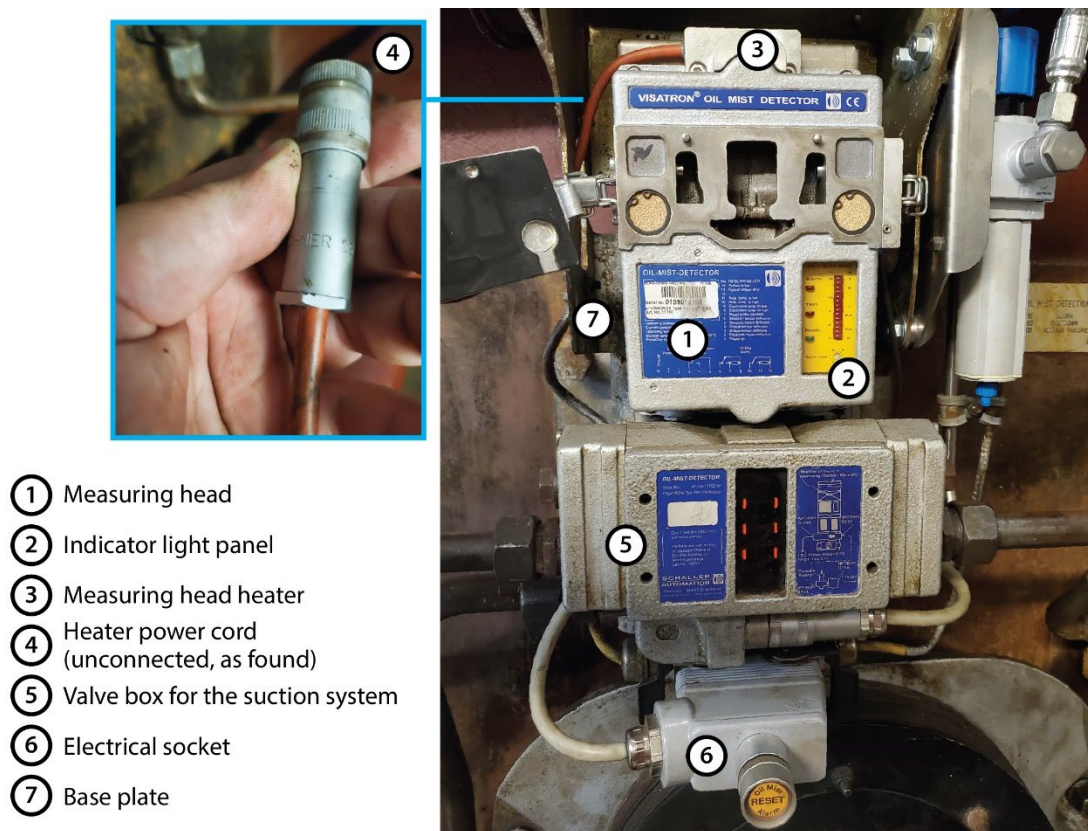
Figure 5. Oil mist detector on the *Heemskerkgracht*. Note that the inspection cover for the measuring head is open in this photo (Source: TSB)

After the occurrence, the TSB visually examined the OMD and observed that the power cord for the heater was not connected (Figure 5). The TSB also obtained data after the occurrence indicating that the condition of the lubricating oil was satisfactory and that there was no contamination of the crankcase by engine cooling water.

During planned maintenance, the measuring head for the vessel's OMD was replaced with a different model that required a separate power source for its heater; however, a separate power source was not available and the heater was left unpowered.

During the occurrence voyage, water vapour built up in the OMD measuring head and caused a false alarm that then triggered an automatic shutdown of the main engine.

After the occurrence, the operating company replaced the vessel's measuring head with a Visatron VN 116/87 Plus model under the supervision of a private marine surveyor and a Bureau Veritas class surveyor. The measuring head was confirmed to have been installed per the manufacturer's instructions and was calibrated and tested.
