# MARINE TRANSPORTATION SAFETY INVESTIGATION REPORT M23C0257

## SINKING AND SUBSEQUENT LOSS OF LIFE

Fishing vessel *Silver Condor*  
La Tabatière, Quebec  
25 September 2023

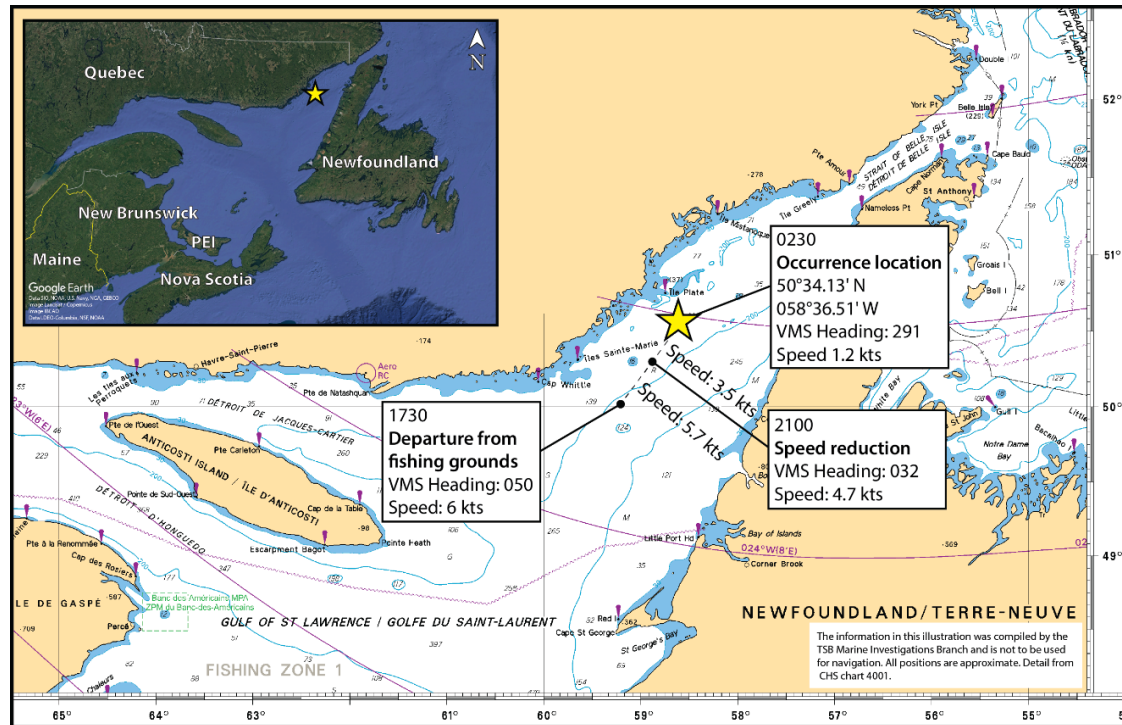
The VMS data indicates that the *Silver Condor* made way north-northeast at an average speed over ground of 4.5 knots until 0200. At 0230, the vessel changed course to west-northwest and slowed to 1.2 knots at position 50°34.13' N, 058°36.51' W, which is the last known position of the vessel (Figure 7).

Figure 7. Map of the occurrence area showing the *Silver Condor*'s last known position (Source of main image: Canadian Hydrographic Service Chart 4967; source of inset image: Google Earth, with TSB annotations)

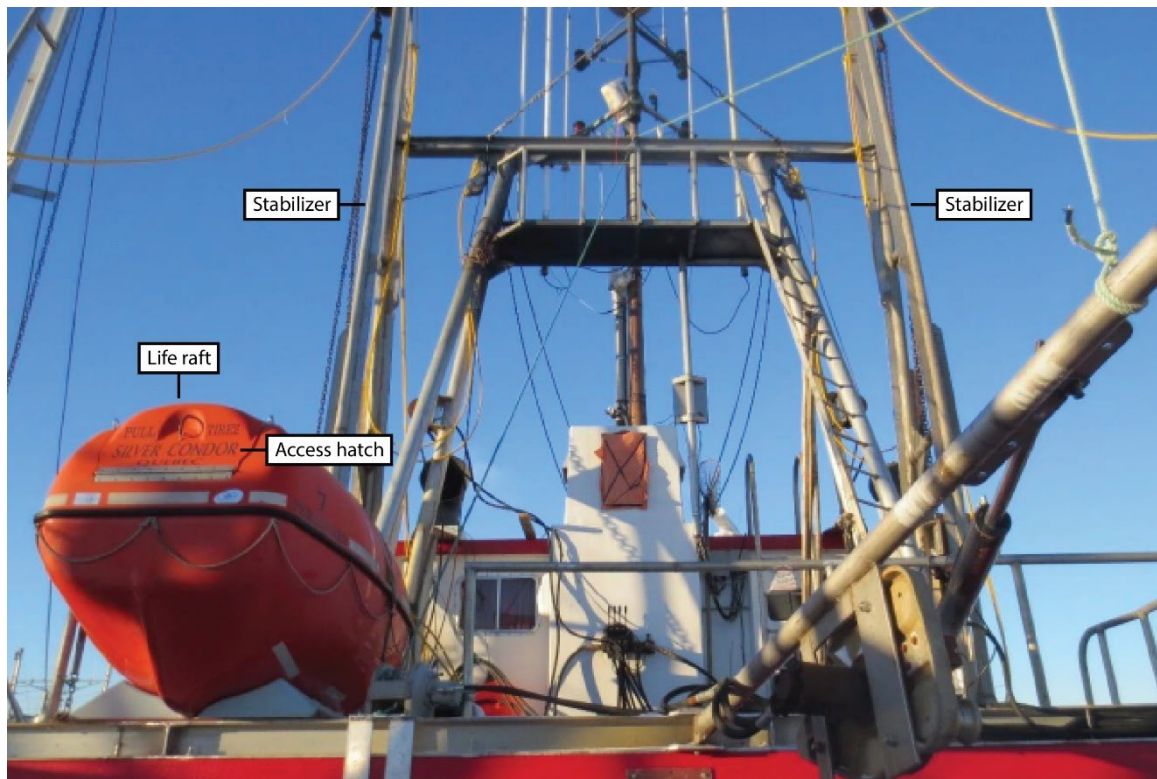
Figure 8. View of the Silver Condor's aft upper deck showing the vessel's life raft with fishing gear (including ropes, wires, and stabilizers) overhead (Source: Third party, with permission and with TSB annotations)

The life raft was not spotted during the SAR operation; it was recovered by a fishing vessel 8 days after the occurrence.

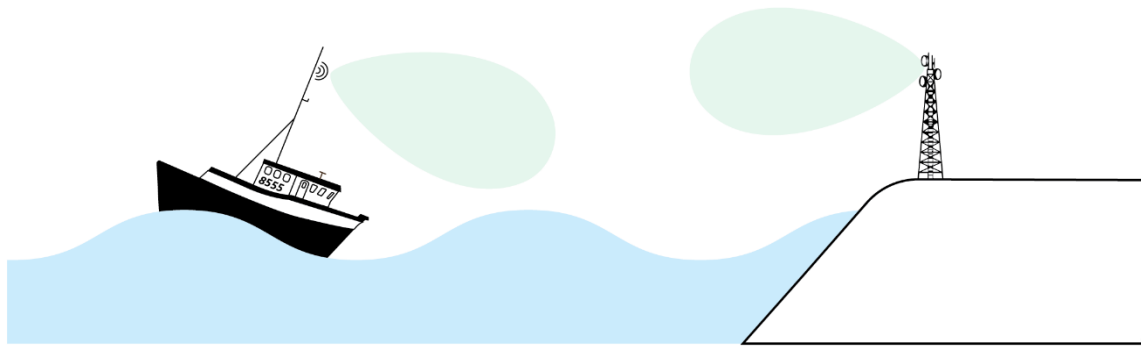
In heavy seas, a vessel will pitch and roll, which causes the vessel's antenna and the shore-based antenna to become misaligned (Figure 11) and reduce the effectiveness of the signal. Waves also raise and lower a vessel, which increases and decreases the line-of-sight range.

Figure 11. Diagram showing vessel and shore-based antennas misaligned in heavy seas (Source: TSB)

Also, the heavy seas at the time of the occurrence caused a recurring misalignment between the *Silver Condor's* transmitting antenna and the receiving shore-based antennas due in part to the rolling motion of the *Silver Condor*; consequently, the vessel's distress message transmitted over VHF radiotelephone was likely not received by a shore-based radio station.

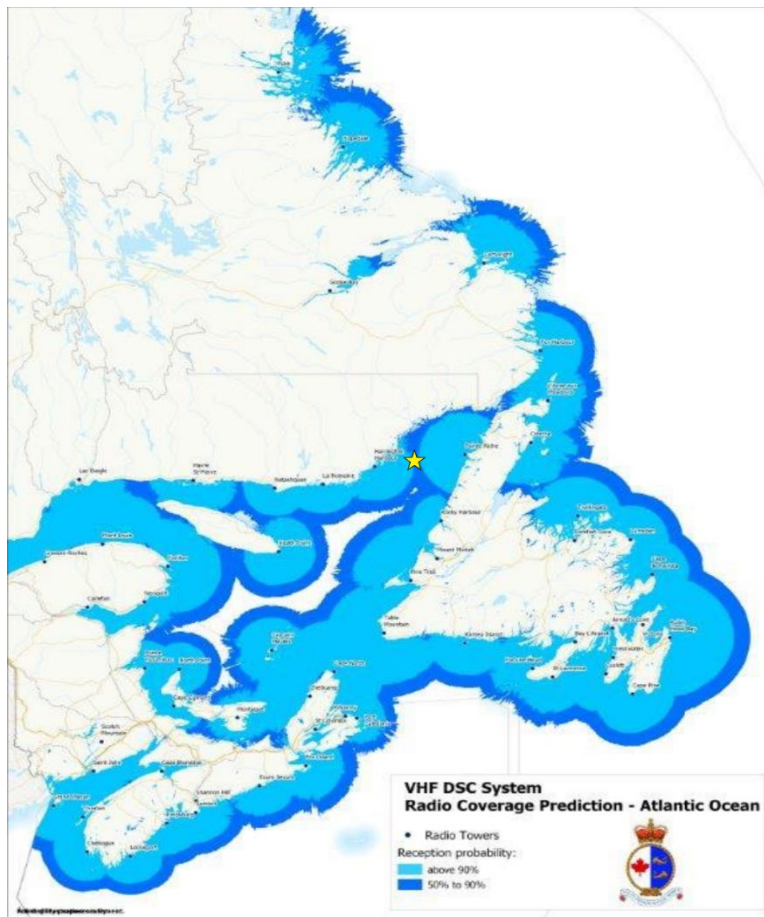
Figure 12. Map showing predicted radio coverage for the Canadian Coast Guard's shore-based antennas along Canada's Atlantic coast. The *Silver Condor's* last known position is indicated with a star. (Source: Canadian Coast Guard, *Radio Aids to Marine Navigation 2023*, with TSB annotations)

Figure 12 also shows areas within sea area A1 that are not covered by a shore-based radio antenna. The occurrence involving the *Silver Condor* took place in sea area A1 with a predicted 50% to 90% shore-based antenna coverage.

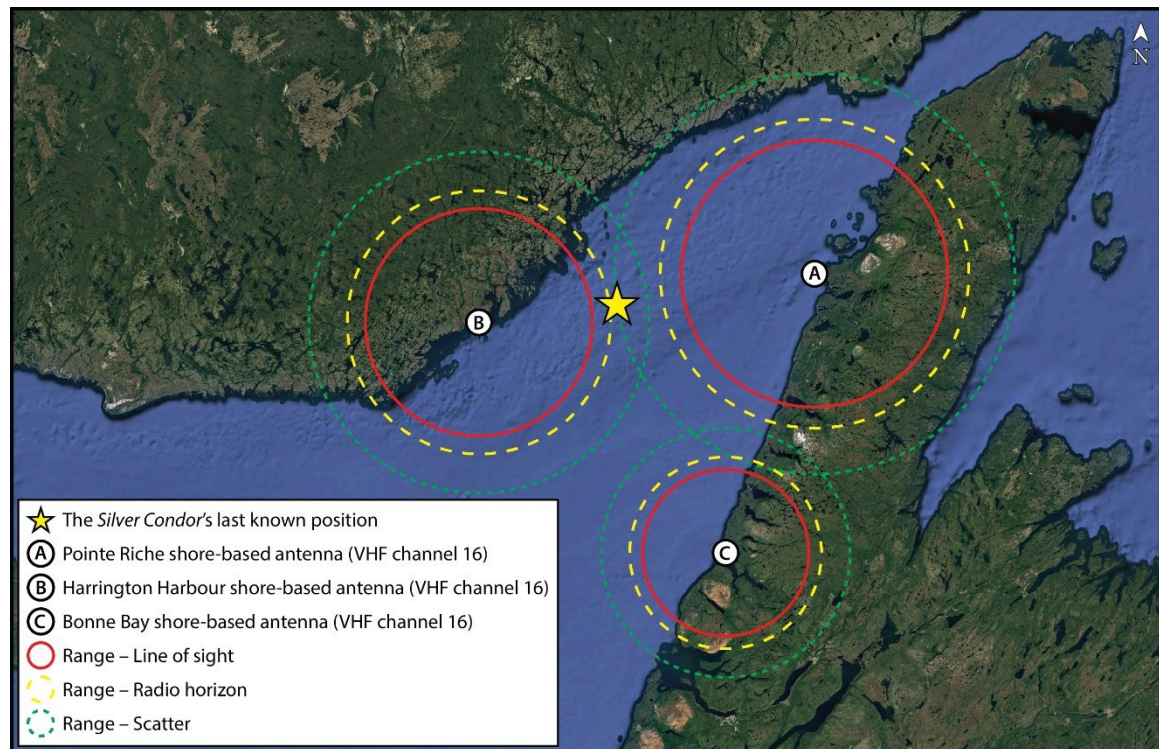
It is important to note that Harrington Harbour and Pointe Riche antennas only monitor VHF channel 16 and are not equipped to listen to VHF channels 6 and 10, which are most commonly used by fish harvesters for their operations.

Figure 13. Map of CCG shore-based antenna coverage in the area of the occurrence (Source: Google Earth, with TSB annotations)

The transmission range of a shore-based VHF station is approximately 40 NM.<sup>22</sup> Following the occurrence, it was determined that the antenna at Harrington Harbour was approximately 33 NM from the vessel's last known position, and the antenna at Pointe Riche was approximately 46 NM from the vessel's last known position.
