# AIR TRANSPORTATION SAFETY INVESTIGATION REPORT A24C0042

## ENGINE FAILURE AND FORCED LANDING

Kudlik Aviation Inc.  
Pilatus PC-12/47, C-FKGE  
Rankin Inlet Airport (CYRT), Nunavut, 5 NM E  
07 May 2024

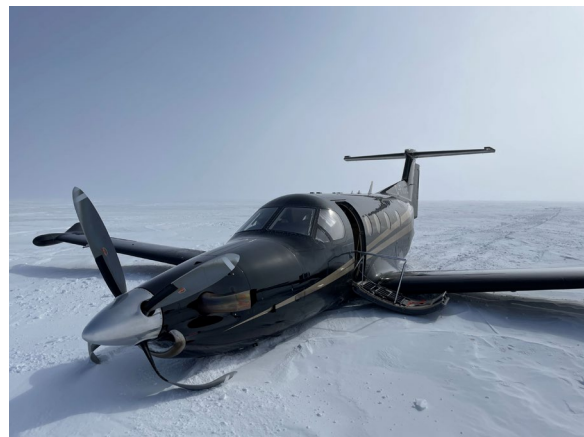
The aircraft landed on its belly on the sea ice, which was covered in a layer of snow (Figure 1). The aircraft's lower fuselage and trailing edge flaps received some abrasion damage, and several plastic fairings were cracked or broken. The largest area of structural damage was on the bottom aft fuselage area at the location of a Nav/Com antenna, which broke loose and tore open approximately 0.5 ft<sup>2</sup> of the fuselage. Two of the 4 propeller blades were bent from contacting the snow and ice.

Figure 1. Occurrence site (Source: Royal Canadian Mounted Police [RCMP])

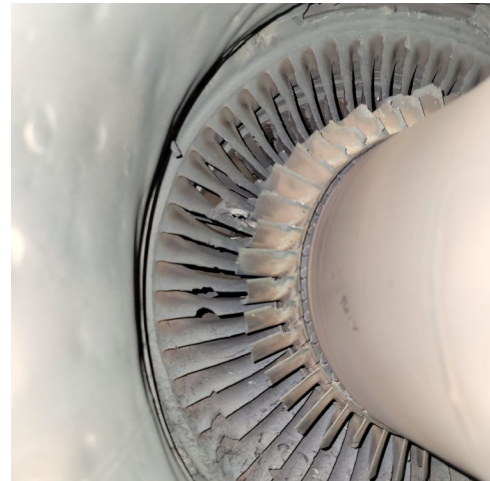
- The engine did not rupture and remained intact with the exception of the 2 power turbine stages, in which all the blades had experienced midspan fractures (Figure 2).
- The majority of the blade fragments exited through the exhaust ducts.
- The exhaust ducts and power turbine vane ring were heavily dented.
- The blade fragments did not appear to damage the aircraft's windscreen or fuselage.
- The compressor section turned freely and, along with the combustion section, presented no abnormalities.
- A borescope inspection of the engine revealed that 1 compressor turbine blade had a small piece of material missing from its trailing edge.
- The front engine (gearbox) magnetic chip detector plug was covered with metal contaminants.
- There were no observed oil or fuel leaks.

**Figure 2. View of the occurrence aircraft's 2nd stage power turbine with broken blades when looking in through the exhaust duct (Source: TSB)**

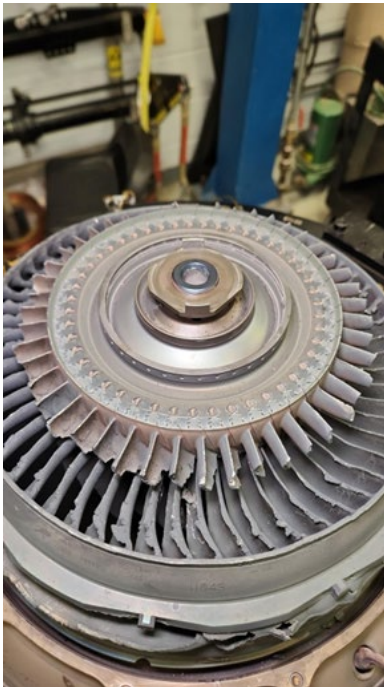
- There was damage to the power turbine section that was consistent with midspan fractures of the power turbine blades (figures 3 and 4).
- There were also overheating signatures and galling of bearing surfaces at the primary planetary reduction gears in the propeller reduction gearbox. The cause of this was not determined.
- The small piece of missing compressor turbine blade was not causal to the power turbine blades fracture.
- The compressor, combustion, lubrication, and fuel sections presented no further abnormalities.

**Figure 3. The occurrence aircraft's 1st stage power turbine once removed from the engine with broken blades visible (Source: TSB)**

was noted. The results of the metallurgical analysis showed fracture by tensile overload. The cause of the power turbine blades fracture could not be established.

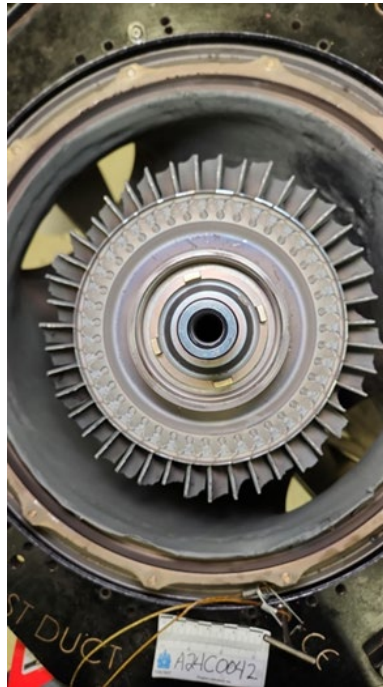
**Figure 4. The occurrence aircraft's 2nd stage power turbine once removed from the engine with broken blades visible (Source: TSB)**
