AIR TRANSPORTATION SAFETY INVESTIGATION REPORT A24A0014

RUNWAY OVERRUN

Beechcraft King Air B200, C-GBYN

Goose Bay Airport (CYYR), Newfoundland and Labrador

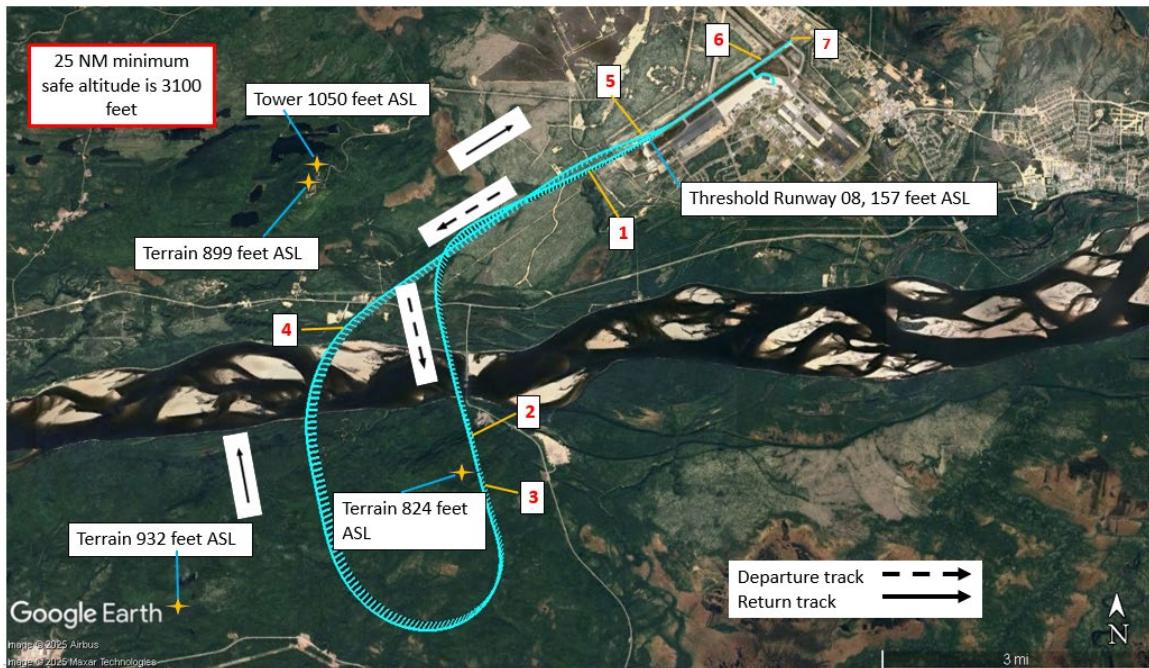
Figure 1. Occurrence flight profile (Source: Google Earth, with TSB annotations)

- 1 Aircraft departing from Runway 26.
- 2 Left engine shutdown.
- 3 Aircraft at 2175 feet ASL; 190 knots indicated airspeed (KIAS); 157 knots ground speed; 143 fpm rate of descent.
- 4 Aircraft at 3.2 NM from threshold; 2090 feet ASL; 177 KIAS; 200 knots ground speed; 239 fpm rate of descent.
- 5 Aircraft 340 feet left of the centreline abeam the threshold; 201 KIAS; 199 knots ground speed; 560 feet ASL; 2800 fpm rate of descent.
Note: Maximum rate of descent on final at 0.2 NM was 2969 fpm.
- 6 Touchdown past Taxiway B; 1975 feet before the end of Runway 08; about 96 knots ground speed.
- 7 Aircraft stopped about 40 feet past the runway end lights.

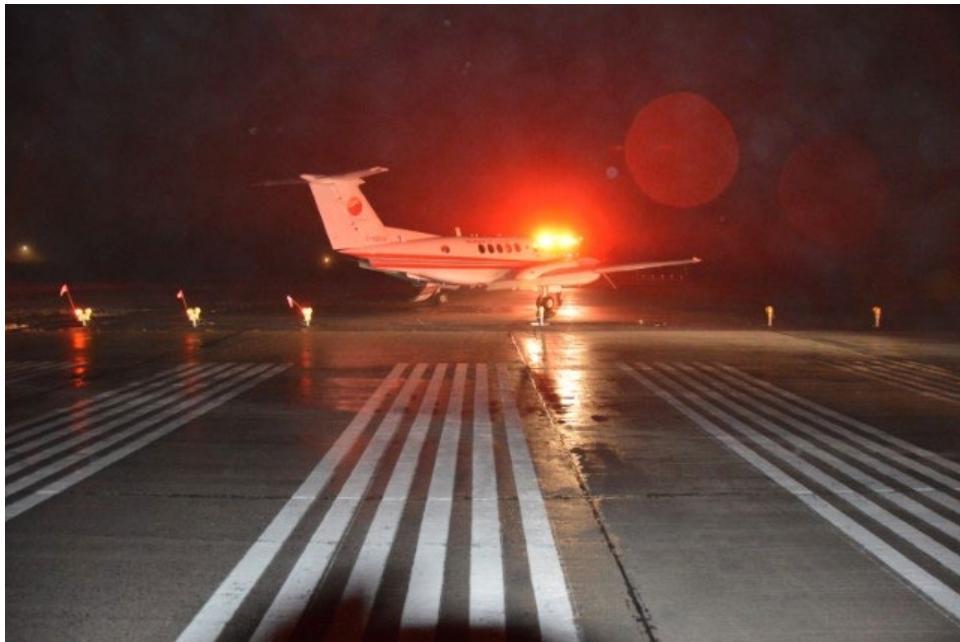
Figure 2. Occurrence aircraft stopped on Runway 08's prepared surface, after the runway overrun (Source: Department of National Defence)

As the aircraft was nearing the end of the runway, it continued to slide sideways and exited the end of the runway at a speed of approximately 20 knots. The right propeller and left main gear hit 2 runway end lights. The aircraft came to a stop on the prepared surface, about 40 feet beyond the end of the runway (Figure 2).

During the runway overrun, 2 adjacent propeller blades on the right propeller hit a runway end light, causing the blade tips to bend and the blades to incur gouge marks. The propeller damage was beyond field repair limitations, and the propeller was replaced. The right engine was replaced to complete the sudden stoppage inspection required following the propeller strike.

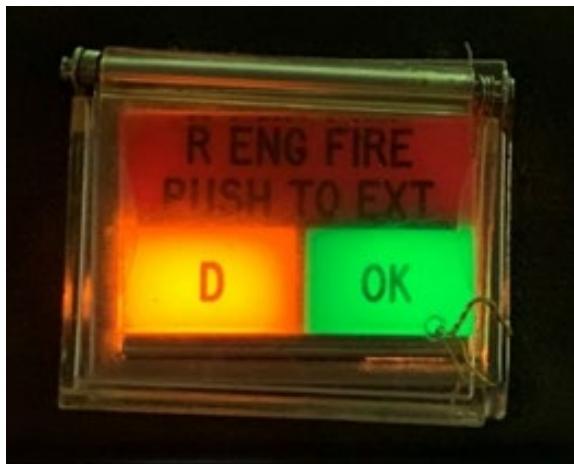
Figure 4. Occurrence aircraft's right-engine fire extinguisher control switch (Source: Keewatin Air LP)

The red lens, placarded L (or R) ENG FIRE - PUSH TO EXT, illuminates if a flame detector is actuated. The amber lens, placarded D, illuminates if the system has been discharged, and the supply cylinder is empty. The green lens, placarded OK, is provided only for the test function, which is used to test the illumination of the bulbs and the circuitry of the system (Figure 4).

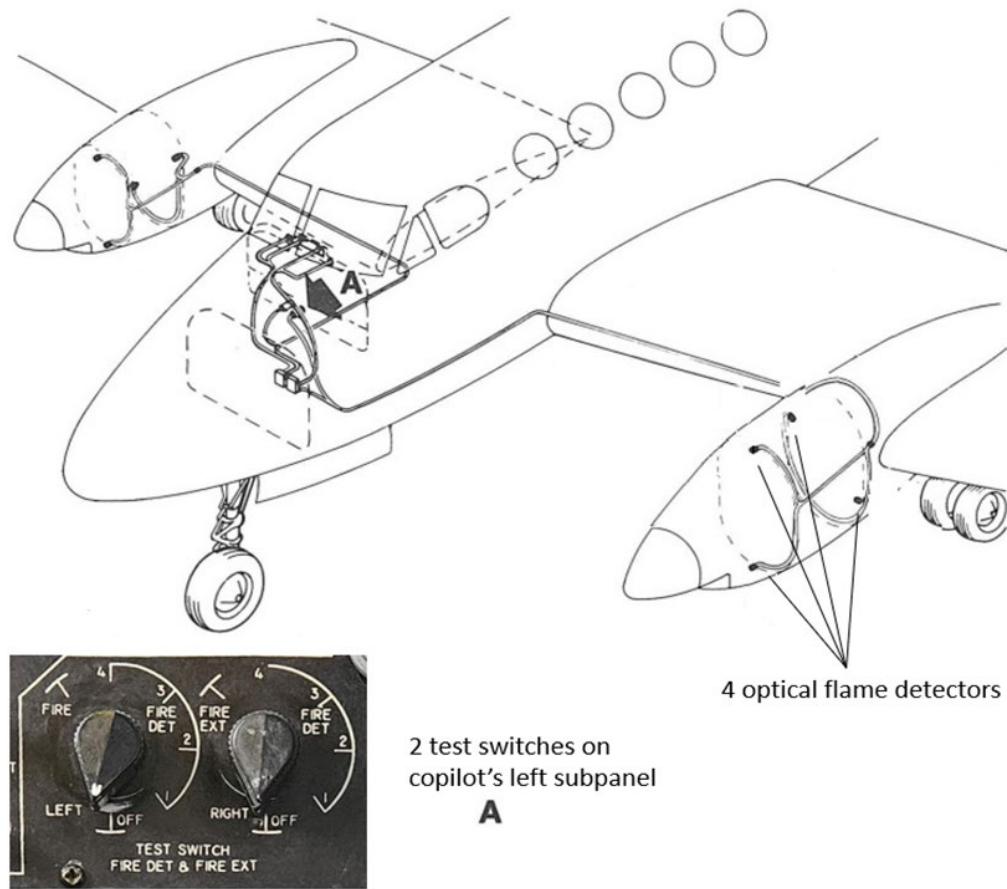
The occurrence aircraft was originally exported to the United Kingdom, where it was equipped with 4-flame detectors on each engine per United Kingdom certification requirements. The aircraft also had an optional fire extinguisher system that uses 2 test switches, each with 6 positions: system off, left/right extinguisher, and flame detectors 4, 3, 2, and 1. The occurrence aircraft is the only King Air B200 in Keewatin Air's fleet with the 2-test-switch, 4-flame-detector system (Figure 5).

Following the occurrence, no signs of heat or fire damage were found in the left-engine nacelle. An inspection of the left-engine fire detection system found abraded wire insulation on the left-engine lower aft flame detector. It was determined that this wire was chafing and made electrical contact with the left-engine firewall, resulting in the left-engine fire indication.

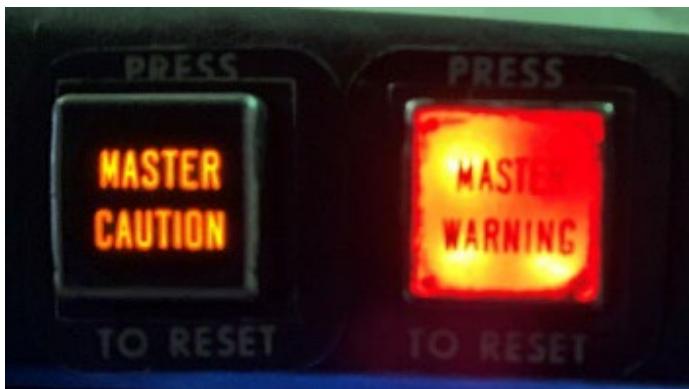
Figure 7. Occurrence aircraft's illuminated MASTER WARNING flasher on the right side of the warning annunciator panel
(Source: Keewatin Air LP)

In addition, the system includes 2 MASTER WARNING flashers, each located on the outer ends of the glare shield that flash when a warning annunciation occurs (Figure 7).¹⁵
