AIR TRANSPORTATION SAFETY INVESTIGATION REPORT A25W0045

COLLISION WITH TERRAIN

Horizon Helicopters Ltd.
Société Nationale Industrielle Aérospatiale AS 350B (helicopter), C-GHZN
Whitehorse/Erik Nielsen International Airport (CYXY), Yukon, 5.5 NM ESE
02 May 2025

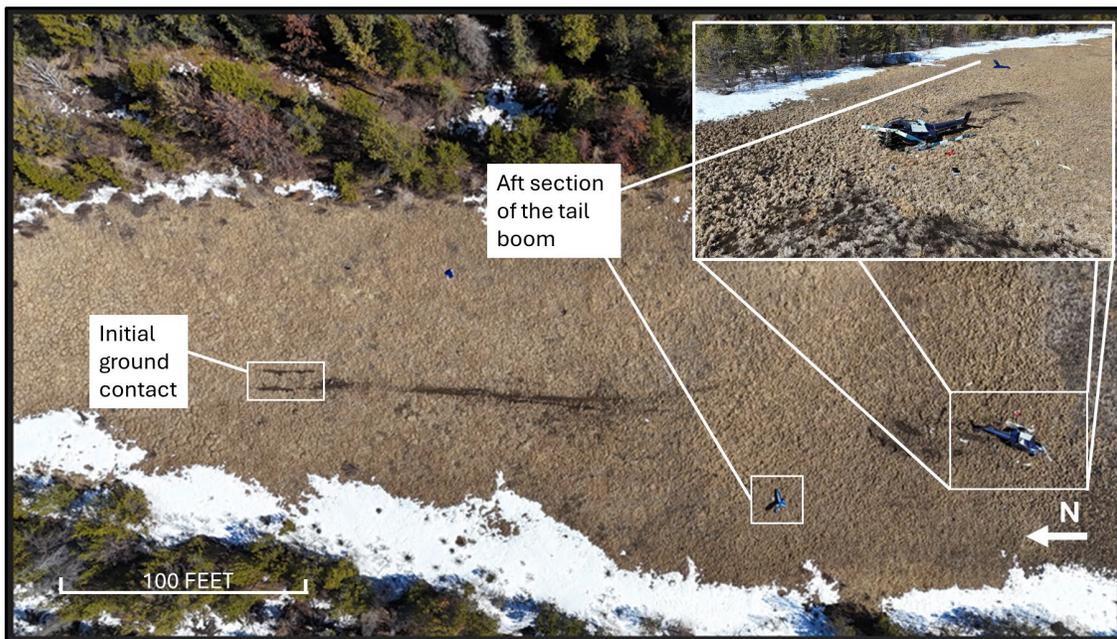
The skid gear spread apart on initial impact and the tail rotor contacted the ground, rendering it ineffective. The helicopter then bounced and became airborne again. As the helicopter descended back to the ground, collective pitch was increased to arrest the ROD, but without the tail rotor, the helicopter began to rotate to the left. The training pilot was unable to reach the fuel flow control lever located on the floor between the front seats due to centrifugal forces. The helicopter was kept level until it impacted terrain a 2nd time, still rotating to the left. It then skidded along the ground until the left cross tube got caught on the ground, broke, and the helicopter rolled onto its left side (Figure 2).

Figure 2. Accident site with close-up view in inset (Source of main image and inset: TSB)

The main rotor blades impacted the ground as the helicopter rolled over and at least one of the main rotor blades entered the cabin over the front seats and struck the candidate. The training
