# RAIL TRANSPORTATION SAFETY INVESTIGATION REPORT R24C0014

## NON-MAIN-TRACK TRAIN COLLISION AND DERAILMENT

Canadian Pacific Railway Company, doing business as CPKC  
Remote control locomotive system yard assignment CK31-10  
Mile 8.0, Crowsnest Subdivision  
Kipp Yard  
Coalhurst, Alberta  
11 February 2024

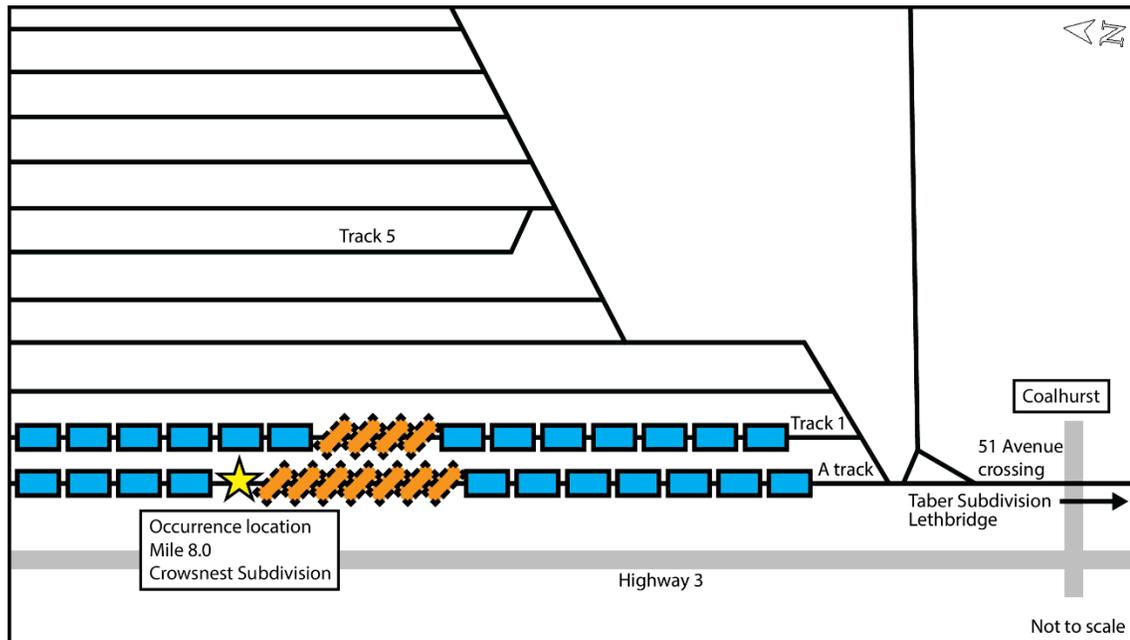
Figure 3. Position of the 11 derailed cars (Source: TSB)

As a result of the collision, the 7 leading cars on the assignment derailed in a jackknife position, striking cars on an adjacent track (track 1) and causing 4 cars on this track to also derail (Figure 3).

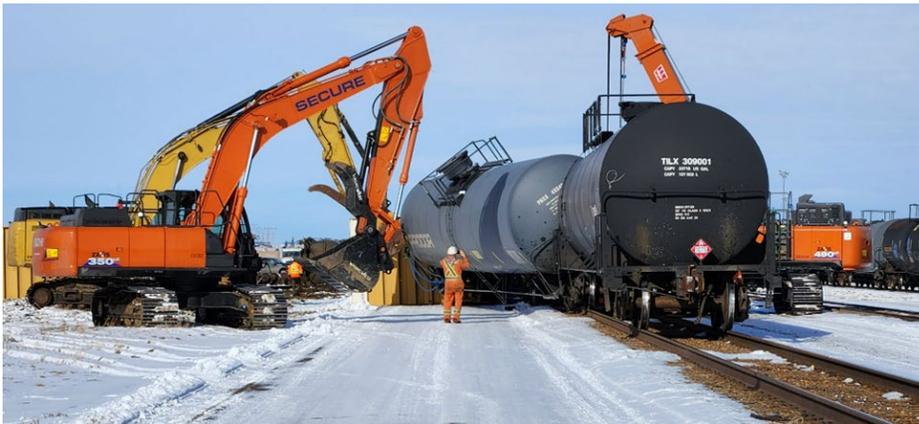
Figure 4. Derailed tank car after the collision (Source: TSB)

Of the 11 derailed cars, 7 were tank cars loaded with, or having last contained, dangerous goods. Figure 4 shows the first derailed car (tank car PROX 45540). None of the cars leaked product, and there were no injuries.

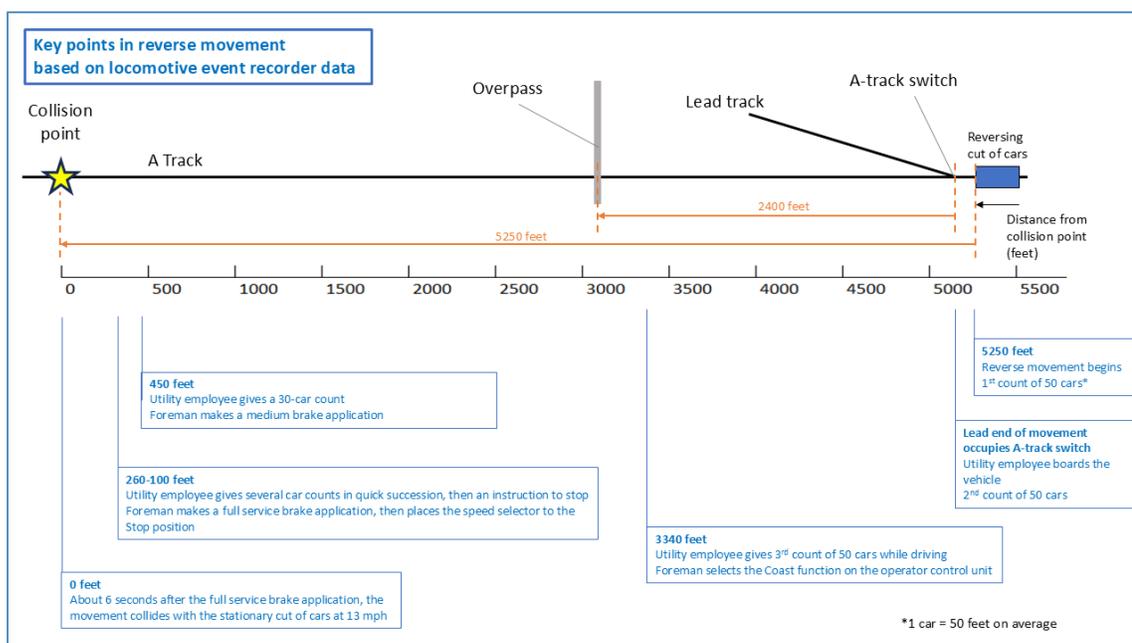
Figure 5. Key distances during the reverse move based on locomotive event recorder data (Source: TSB)

A review of the data from the locomotive event recorder revealed the following salient points (Figure 5):

- Between the 3<sup>rd</sup> count of 50 cars and the count of 30 cars, the movement reversed about 2890 feet.
- When the utility employee provided the count of 30 cars, the remaining distance to the cut of 79 stationary cars was about 450 feet (about 9 car lengths).
