AIR TRANSPORTATION SAFETY INVESTIGATION REPORT A23P0136

LIGHTNING STRIKE AND LOSS OF CONTROL

Helijet International Inc.
Sikorsky S-76C++ (helicopter), C-GXHJ
Sidney, British Columbia, 10 NM NE
24 October 2023

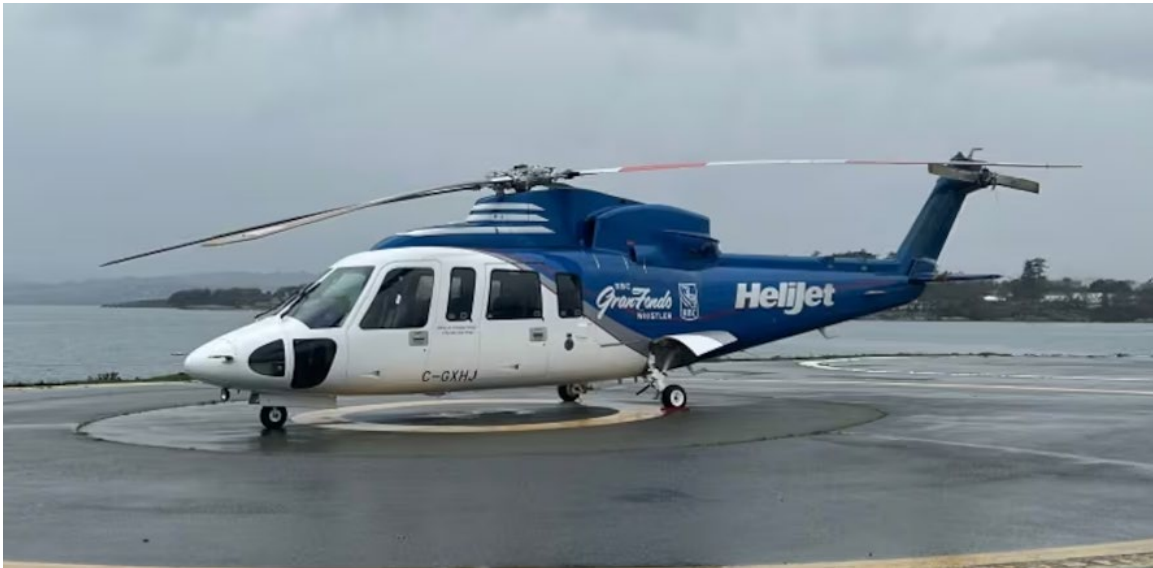
Figure 2. Occurrence helicopter at Victoria Harbour (Camel Point) Heliport (CBF7), following the occurrence (Source: CTV News)

The helicopter was substantially damaged. One tail rotor blade assembly separated from the helicopter in flight and contacted 3 main rotor blades, the left horizontal stabilizer, the left side of the tail boom, and the left engine cowl.

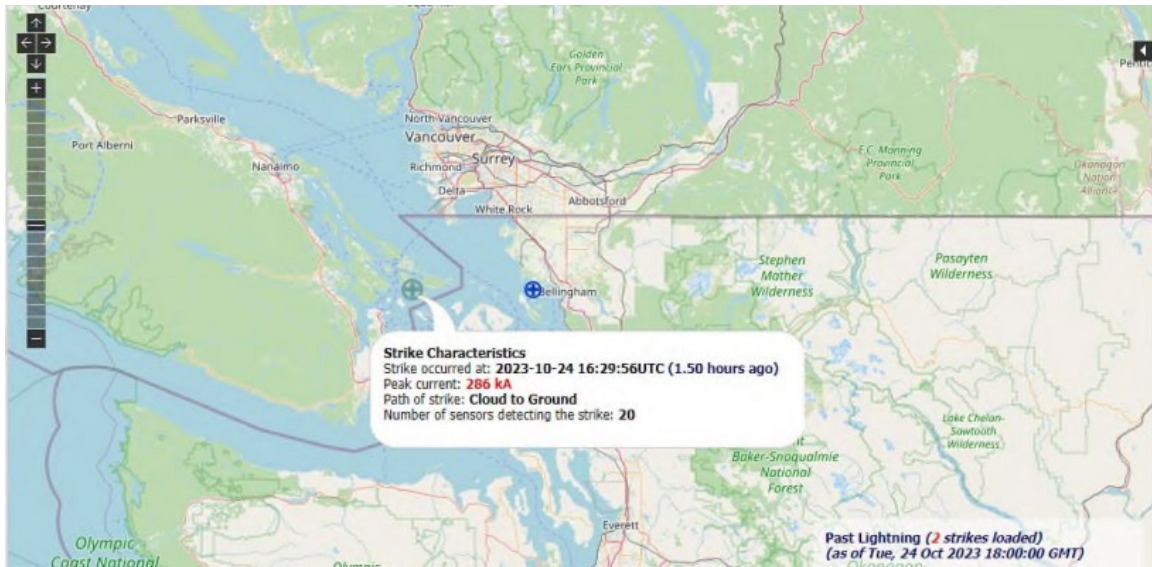
Figure 6. Canadian Lightning Detection Network real-time lightning parameters showing the characteristics of the lightning strike at 0929:56 Pacific Daylight Time over South Pender Island (Source: Canadian Lightning Detection Network of Environment and Climate Change Canada)

In this occurrence, the positive cloud-to-ground lightning strike produced 1 lightning stroke that transferred a large percentage of the charge to the aircraft. The peak current amplitude of the lightning stroke determines the explosive or shock wave effect of the stroke.⁴⁴ In addition, the current amplitude and duration determine the thermal effects of the stroke, which also contribute to physical damage.

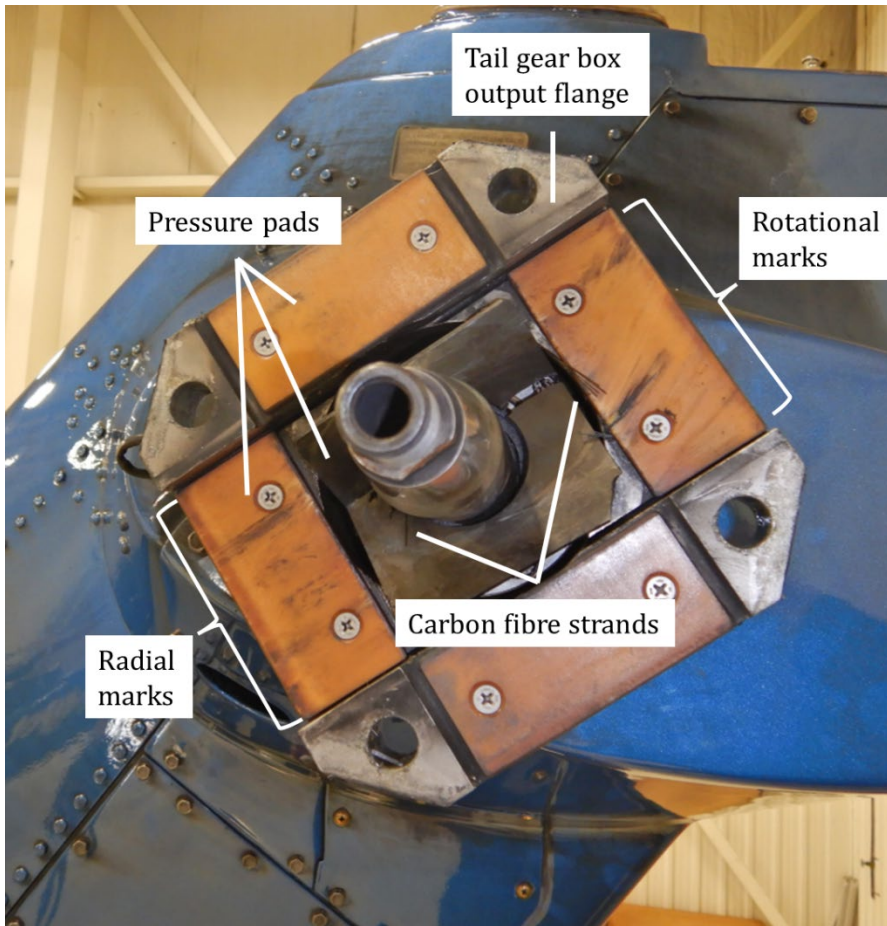
Figure 9. Occurrence helicopter tail gear box output flange highlighting the remaining carbon fibre strands and the marks on the pressure pads where the inboard tail rotor blade assembly was mounted (Source: TSB)

The pressure pads on the tail gear box output flange had radial and rotational marks where the inboard tail rotor blade assembly was mounted (Figure 9). One pressure pad had carbon fibre strands embedded in the pad. In addition, the pressure pad surrounding the pitch control shaft was broken in half with carbon fibre strands present.

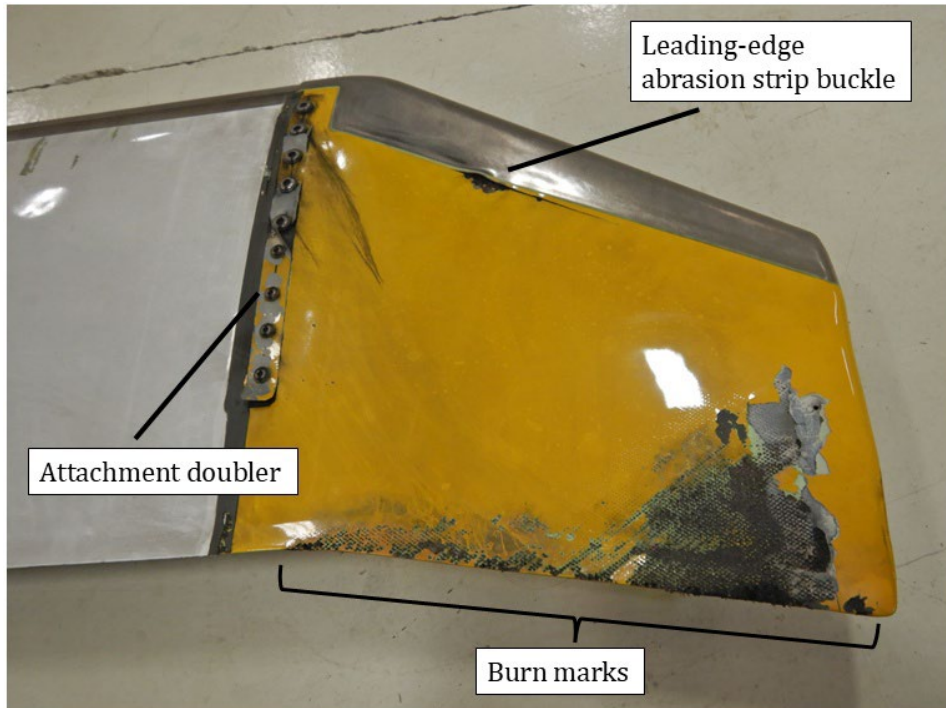
Figure 10. Top side of the blue main rotor blade tip cap with damage from lightning attachment (Source: TSB)

The occurrence helicopter's blue main rotor blade had burn marks on both sides of the tip cap that exposed the underlying Kevlar skin. The tip cap's leading-edge abrasion strip had buckled slightly on the upper (Figure 10) and lower aft edge as well as on the lower aft edge at the overlapping outboard seam, which is consistent with lightning attachment. The tip cap attachment doubler had buckled on the upper and lower skins.

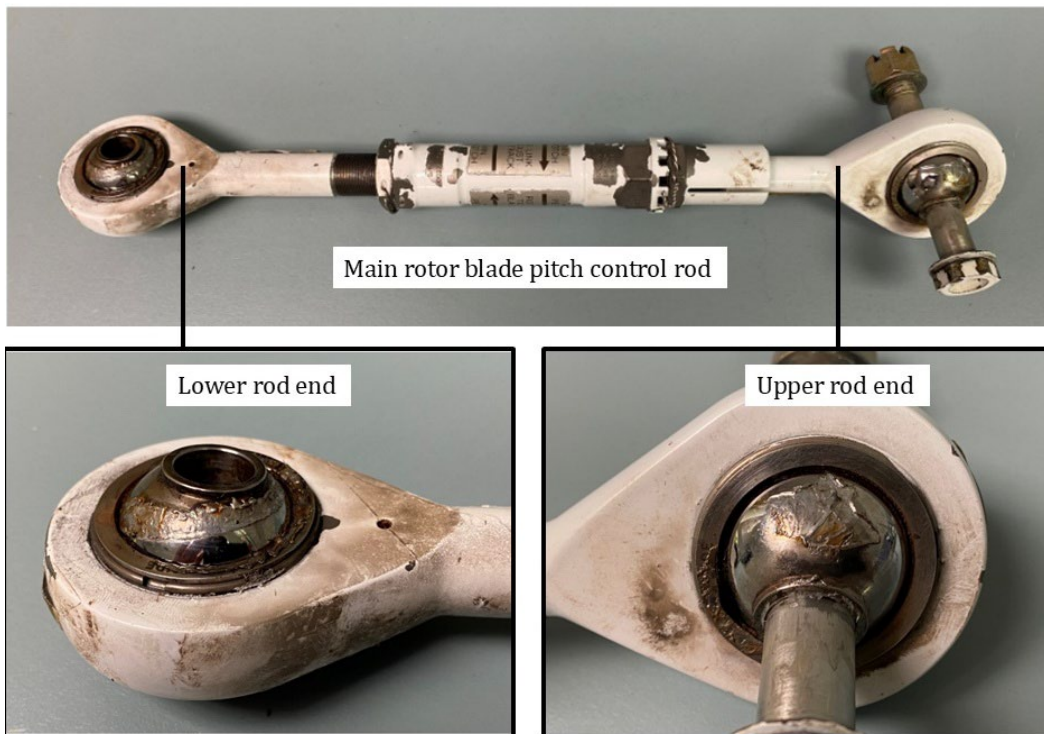
Figure 11. Occurrence helicopter’s blue main rotor blade pitch control rod with the spherical bearing damage highlighted (Source: TSB)

The blue main rotor blade damper, pitch control rod, and bonding jumper exhibited damage from the lightning strike. The damper inboard and outboard spherical bearings had minor pitting, flaking, and discoloration. The pitch control rod upper and lower spherical bearings and bearing races had significant discoloration with melted material over a portion of the bearing and bearing races (Figure 11).

The pitch control rod attachment points at the blade spindle and the swashplate also had indications of flashover.
