# MARINE TRANSPORTATION SAFETY INVESTIGATION REPORT M23A0169

## SUBMERSIBLE IMPLOSION AND LOSS OF LIFE

Submersible *Titan* and cargo vessel *Polar Prince*

18 June 2023

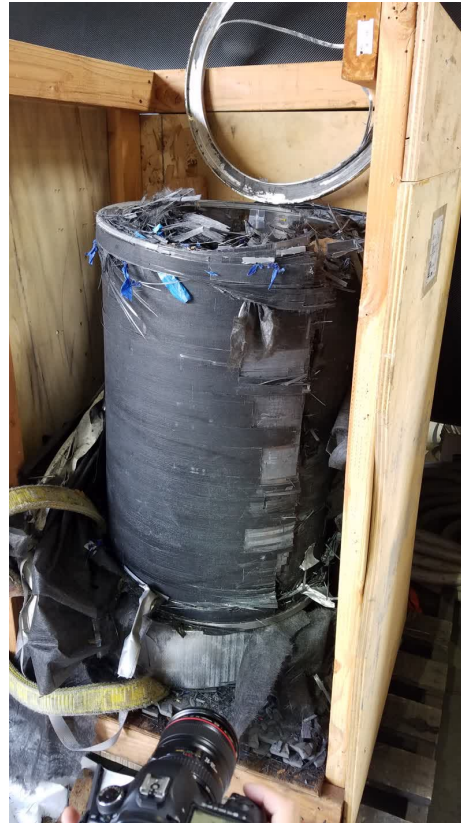
On 05 February 2016, OceanGate conducted a 2nd pressure test using the one-third scale model with aluminum plates on either end (Figure 9). The one-third scale model failed at a pressure equivalent to a depth of 4200 m (Figure 10). Strain gauges were used during this test.

Figure 10. Scale model after implosion (Source: Patrick Loomis)

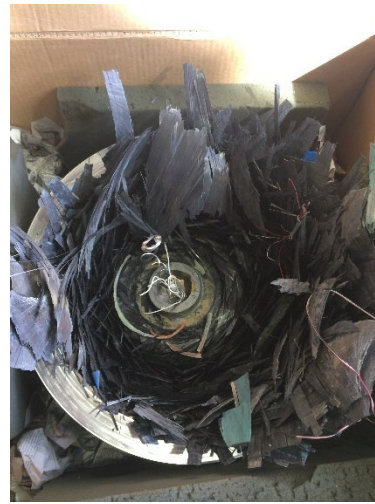
On 11 March 2016, OceanGate conducted a 3rd pressure test on a new one-third scale model, this one again with carbon fibre end domes (Figure 11). It failed at a pressure equivalent to a depth of 2754 m (Figure 12). This test was done with acoustic emission monitors to measure the effects of the pressure on the carbon fibre components.

Figure 12. Carbon fibre end dome after test  
(Source: Patrick Loomis)

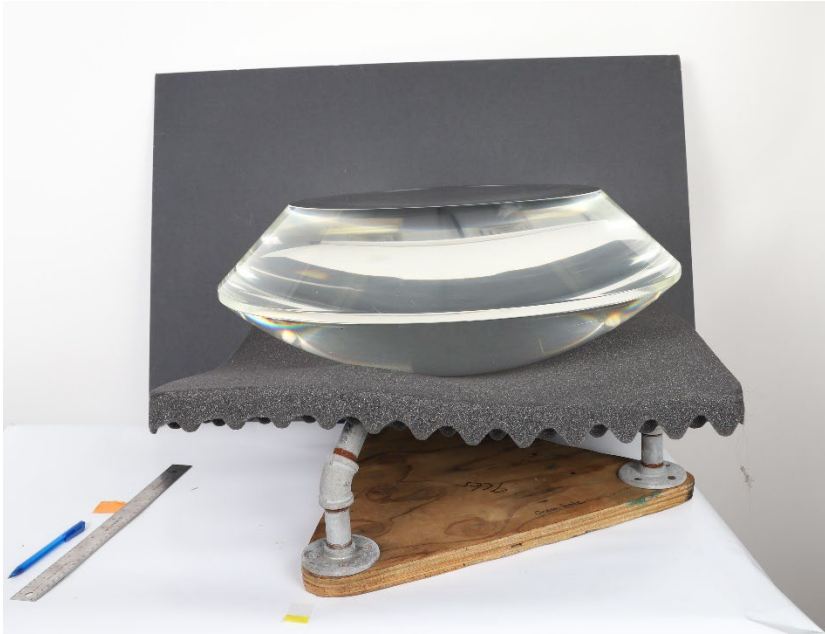
the *Titanic*, where the pressure is 40 MPa. The company also reiterated that OceanGate would need to do further testing on the viewport. OceanGate opted not to do further testing on the viewport before installing it in the submersible in order to save money.

Figure 14. Design of completed viewport rated to 6.516 MPa (Source: TSB).

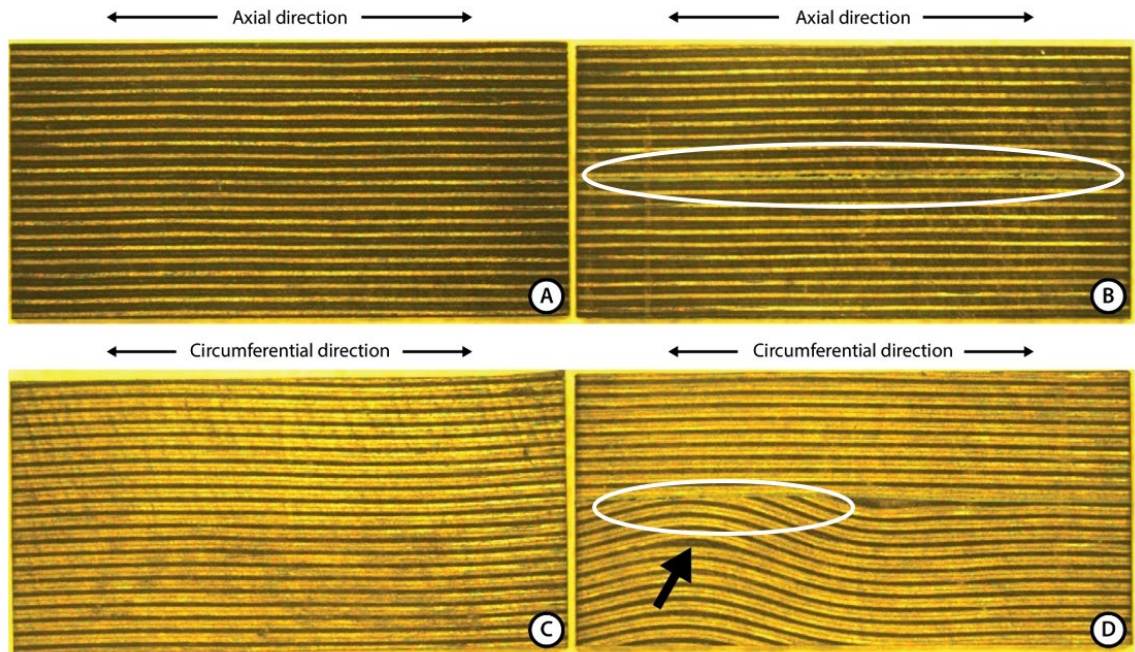
Figure 15. Photos of samples from the trimmed-off end piece of the Titan. Photos A and B show the plies in the axial direction, and photos C and D show the plies in the circumferential direction. Photo A shows no visible porosity, whereas Photo B shows visible porosity in the circled area. Photo C shows mild ply waviness. The black arrow in Photo D is pointing to the severe ply waviness, and the circled area in Photo D is pointing to an area that was ground down (Source: TSB).

The TSB Laboratory testing showed that the laminate composite material's allowable strength in the axial direction was sufficient, as evidenced by the calculated safety factor of 3.05, which was greater than the required 1.25. However, this was not the case for the allowable strength in the circumferential direction: the calculated safety factor was 1.11, which did not meet the required safety factor of 1.25.

Assuming that the test results from the samples are representative of the properties of the carbon fibre cylinder used in the *Titan*, the fact that the required safety factor for the strength in the circumferential direction was not met meant that it was unsafe for the *Titan* to have been repeatedly exposed to pressures equivalent to the depth of the *Titanic* or deeper (which occurred during pressure tests). This may explain why the *Titan* had 4 successful pressure tests at the Deep Ocean Test Facility and subsequent successful dives to depths at or near that of the *Titanic* but ultimately failed on its 14th dive to the *Titanic*.
