PIPELINE TRANSPORTATION SAFETY INVESTIGATION REPORT P25H0072

PIPELINE DAMAGE

Westcoast Energy Limited Partnership
16-inch Aitken Creek Lateral, Kilometre Post 3.338
Near Fort St. John, British Columbia
15 November 2025

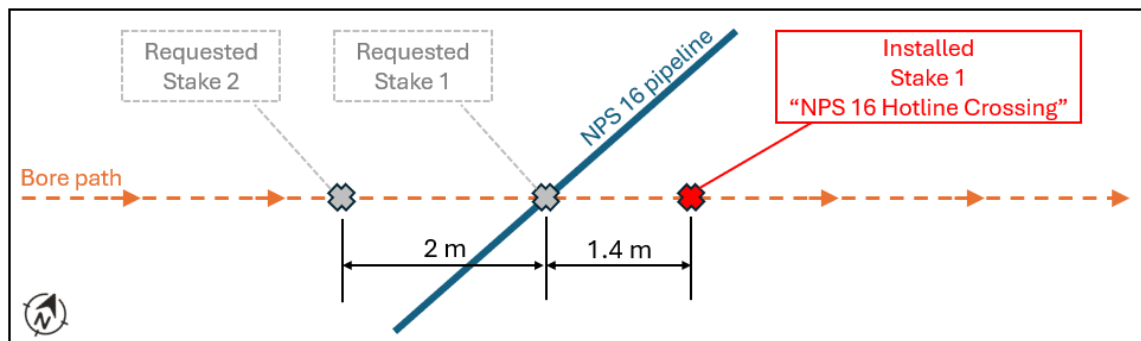
On 14 November 2025, the surveyor⁹ returned to the site to complete the staking. The surveyor noted that the 27 September 2025 coordinate, which reflected the location of the top of the NPS 16 pipeline at the crossing (i.e., Requested Stake 1), was now located in a mud hole that was being cleaned out. Consequently, the surveyor placed a stake (Installed Stake 1) at an offset, approximately 1.4 m east from the crossing, and labelled it "NPS 16 Hotline Crossing" (Figure 2). In selecting the location where the surveyor placed the stake, the surveyor relied on previously logged pipeline location data.

Figure 2. Schematic of requested and installed survey stakes (Source: TSB)

The construction crew was not made aware that Installed Stake 1 was offset east from the crossing. Therefore, as originally planned, they proceeded to create the observation hole approximately 2 m west of that stake to confirm the location of the microtunnel boring machine before it crossed underneath the NPS 16 pipeline.

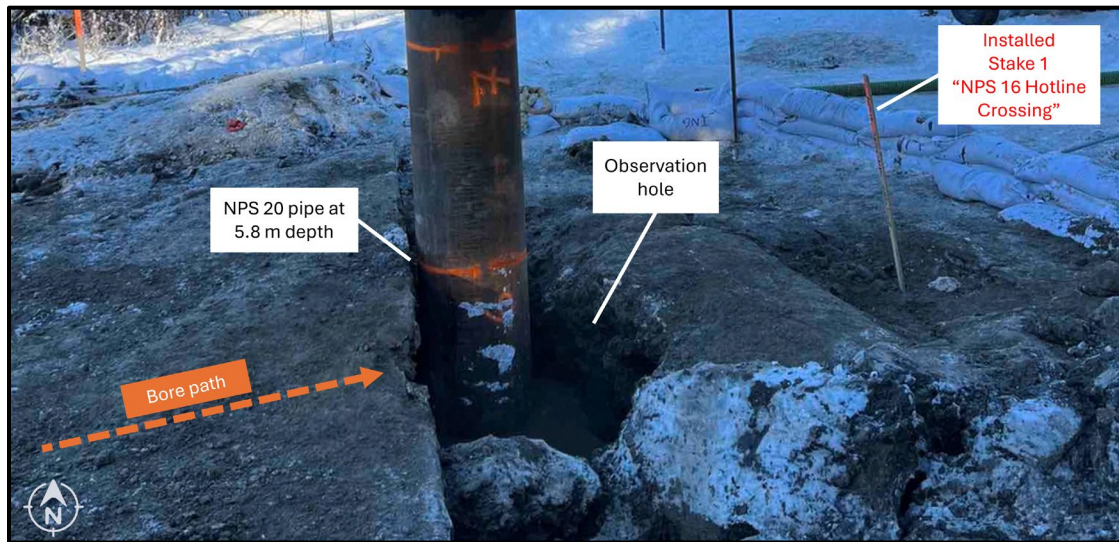
Due to unstable soil conditions that caused the hole's walls to collapse, and an obstruction encountered within the observation hole, the construction crew began installing an NPS 20 pipe vertically into the hole to act as shoring and break through the obstruction.

After reaching the obstruction at a depth of 5.8 m, an excavator bucket was used to push the NPS 20 pipe through the obstruction. Upon reaching 6 m deep, the crew members within the occurrence area smelled an odour that they interpreted as gas and observed water in the observation hole bubbling upwards approximately 1 to 2 m.

Prior to shoring the observation hole with the NPS 20 pipe, the construction crew unsuccessfully attempted to use a 20-inch metal corrugated culvert as shoring but encountered an obstruction at a depth of 5.8 m. Considering the obstruction to be wooden material,¹⁰ it was decided to use an NPS 20 pipe with bevelled ends to push through the obstruction and act as shoring (Figure 3).

Figure 3. NPS 20 pipe installed 5.8 m deep into observation hole on the day of the occurrence (Source: Westcoast, with TSB annotations)

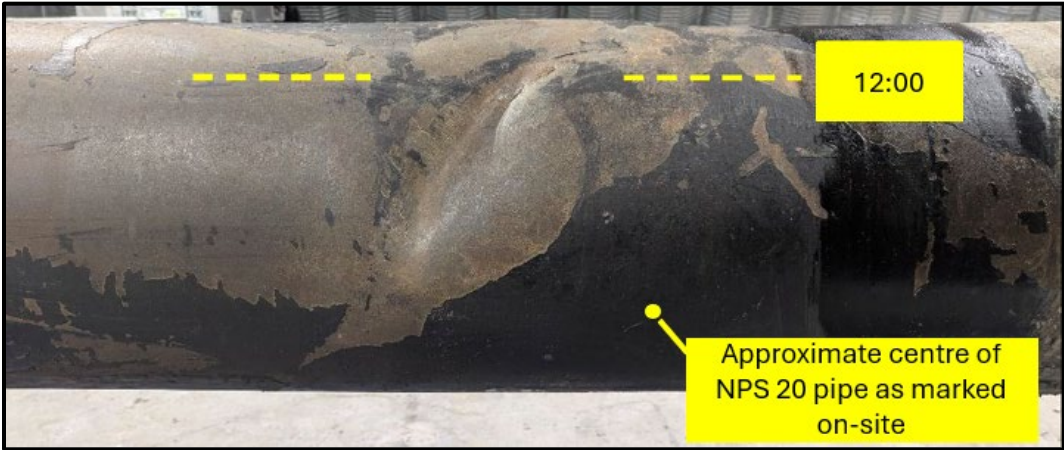
The NPS 16 line pipe had an outer black plastic rock guard wrap and a yellow extruded polyethylene coating, and its measured wall thickness ranged from 6.14 to 6.22 mm. The outer black rock guard wrap was damaged at the 12:00 position (top dead centre of the pipe). No wooden material was observed.

The damaged area of the NPS 16 line pipe was laser scanned and its damage appeared to be consistent with an impact by a solid object with an outside diameter of 20 inches (508 mm) (Figure 4 and Figure 5). A breach was noted in this area by a crack/tear that was approximately 61 mm long with a maximum width of 5 mm (Figure 6). There was significant deformation and presence of gouging and scrapes within this breached area. There was no evidence of corrosion or stress corrosion cracking at this location.

Figure 4. Mechanical damage visible on NPS 16 line pipe after pipe cleaning (Source: Acuren, with TSB annotations)

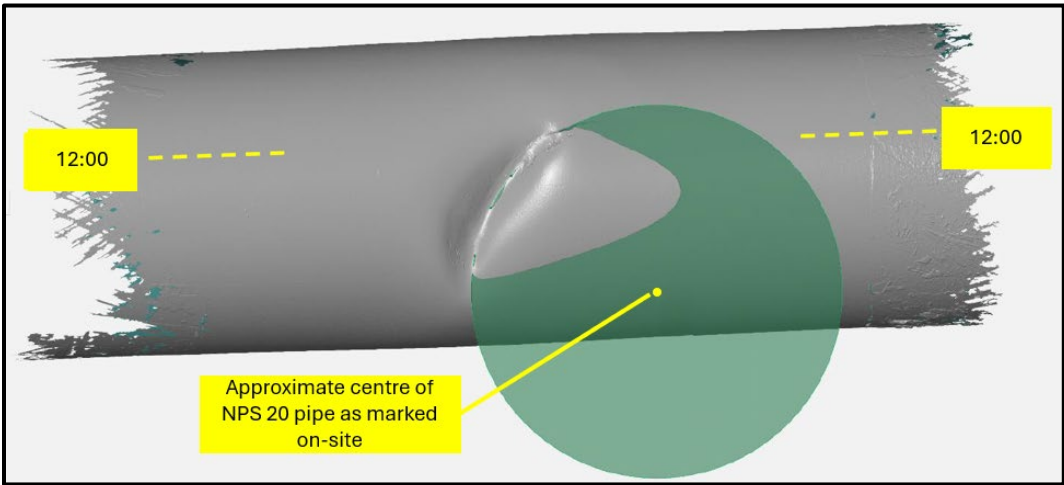
Figure 5. Laser scan correlating impact consistent with 20-inch-diameter pipe contact (Source: Acuren, with TSB annotations)

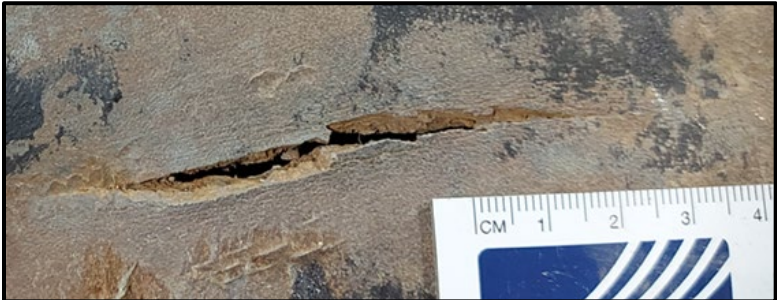
Figure 6. Breach point on NPS 16 line pipe (Source: Acuren)
