# RAIL TRANSPORTATION SAFETY INVESTIGATION REPORT R26Q0001

## MAIN-TRACK TRAIN COLLISION AND DERAILMENT

VIA Rail Canada Inc.  
Passenger train VIA 14  
Mile 11.73, Canadian National Railway Company  
Montmagny Subdivision  
Saint-Alexandre-de-Kamouraska, Quebec  
12 January 2026

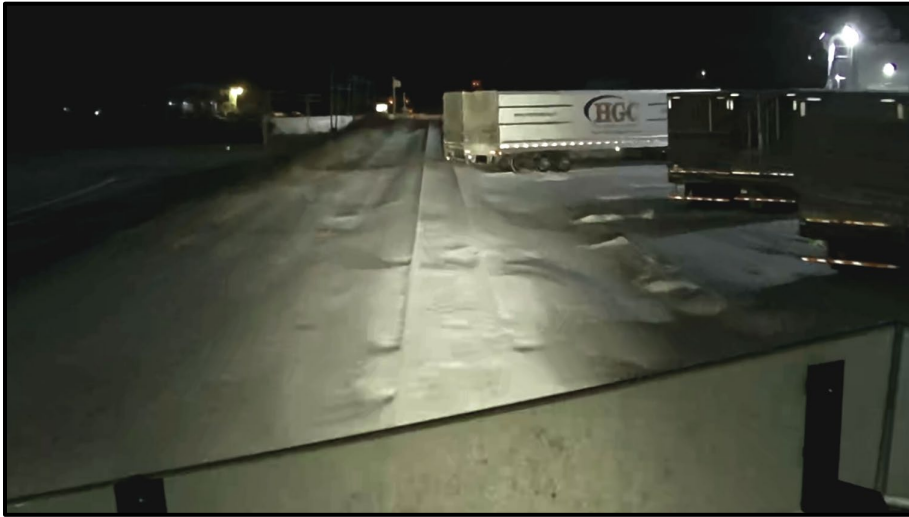
At around 0126,<sup>1</sup> at Mile 11.92, while the train was travelling at approximately 60 mph, the operating locomotive engineer noticed 2 tractor-trailers partially obstructing the tracks and made an emergency application of the train brakes. As the train's speed dropped to 40 mph, the lead locomotive (VIA 6435) struck the tractor-trailers that were parked adjacent to the track; the rear portions of the tractor-trailers were foul of the main track (Figure 2).

Figure 2. View from the lead locomotive before the collision, looking east (Source: VIA Rail Canada Inc.)

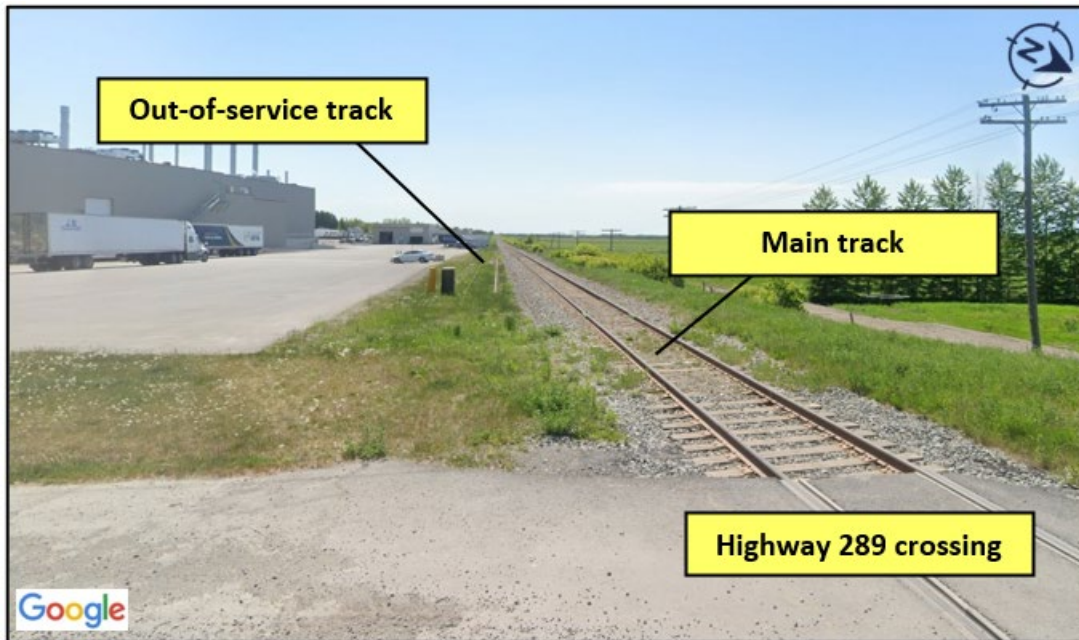
There was an old, out-of-service railway track running parallel to the main track, and there was no difference in elevation between the company lot and the south side of the out-of-service track.<sup>3</sup> The main track, however, was slightly elevated (Figure 3).

Figure 3. View of the railway tracks running alongside the company lot, looking west (Source: Google Maps Street View, with TSB annotations)

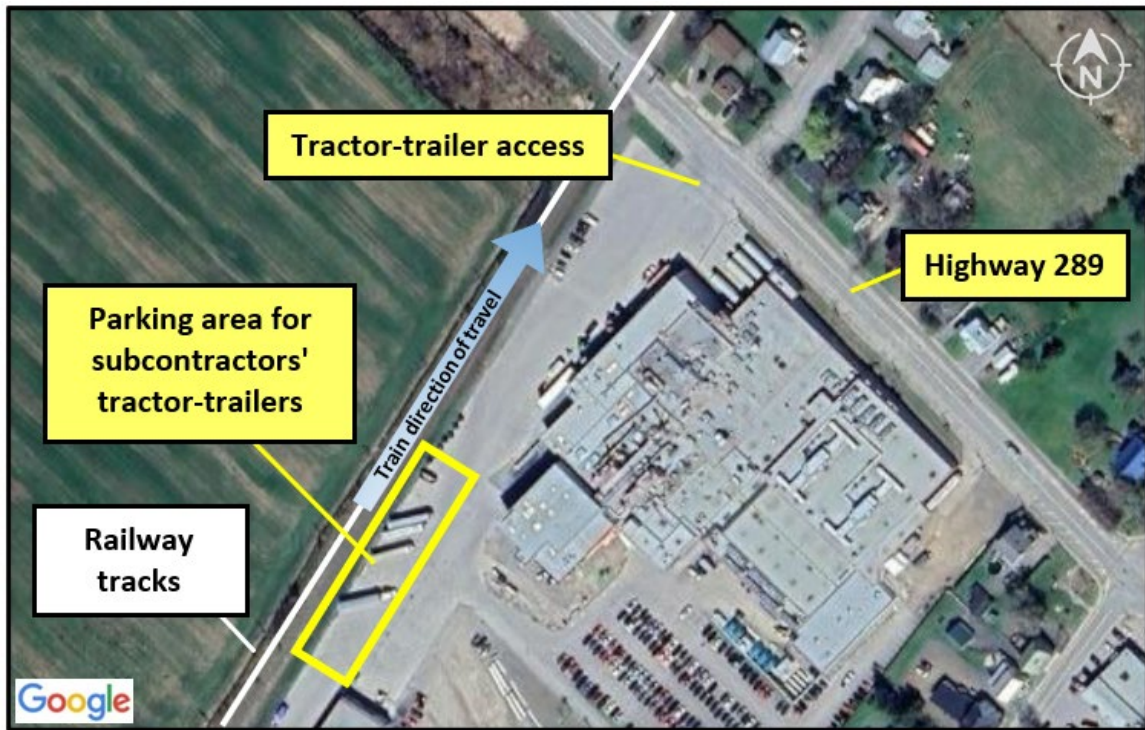
The company lot is directly accessible from Highway 289, and entry is unrestricted, with no security booth or access barrier. Transport trucks travel through the lot very frequently. Drivers for subcontracting carriers typically park their trucks at an angle in the section of the lot adjacent to the south side of the railway tracks (Figure 4).

At the time of the occurrence, there were no signs, fences, or other physical barriers in this area to delineate the parking area for subcontractors' trucks.

Figure 4. Parking lot normally used by subcontractors' trucks (Source: Google Maps, with TSB annotations)

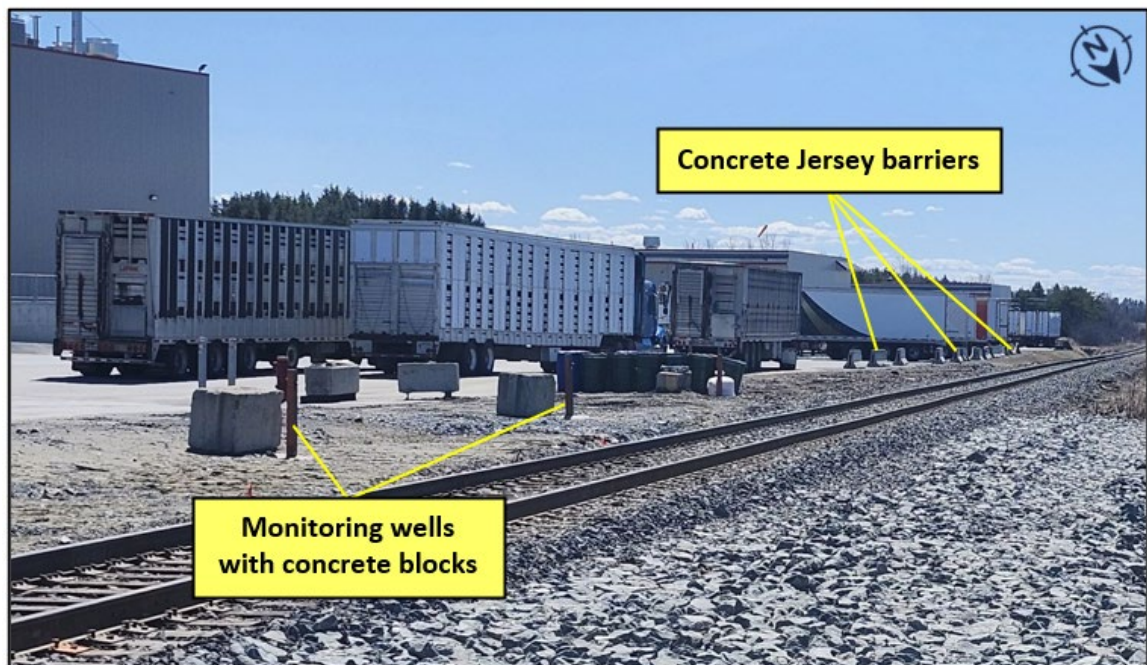
Figure 5. Temporary physical protection measures implemented following the occurrence (Source: TSB)

Approximately 1 week after the occurrence, the meat processing company temporarily placed 14 concrete Jersey barriers in the subcontractor truck parking area, between the parking lot and the railway track, and built a snow embankment there. At 27 April 2026, the temporary concrete barriers were still in place.

As part of the soil decontamination work undertaken at the site, 6 monitoring wells were installed on either side of the railway tracks. Concrete blocks were installed in front of each of the 6 wells located on the south side of the track (Figure 5).
