OPERATIONAL SERVICES BRANCH  
**ENGINEERING LABORATORY REPORT**

LP151/2013

Examination of Switch Frog

Montreal, Maine & Atlantic Railway, Train MMA-002

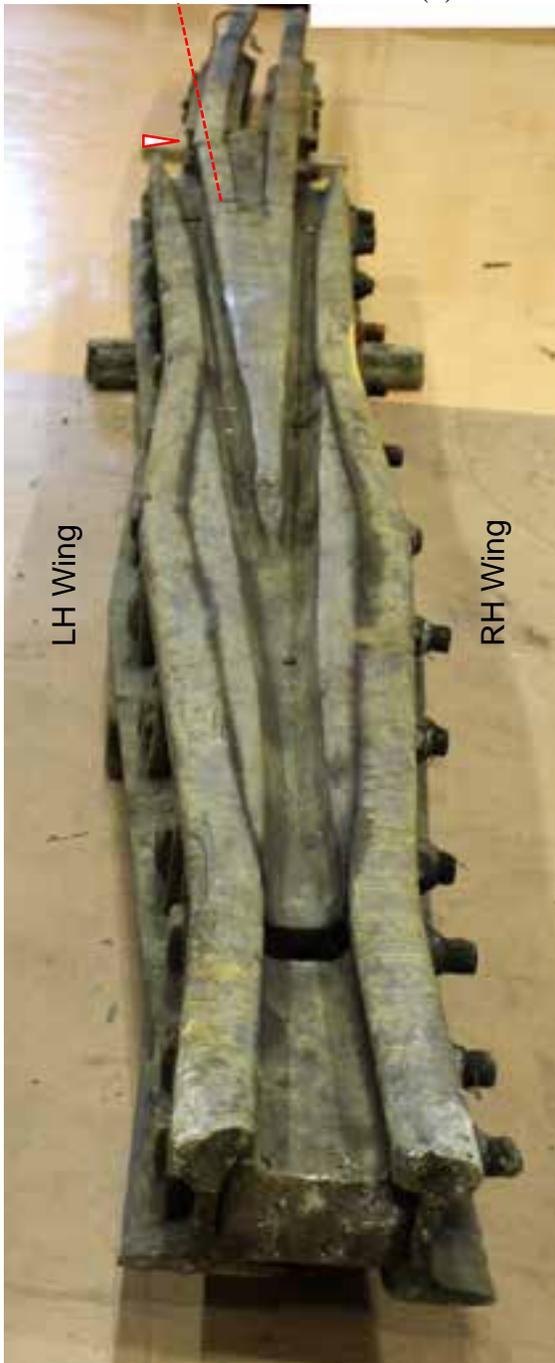
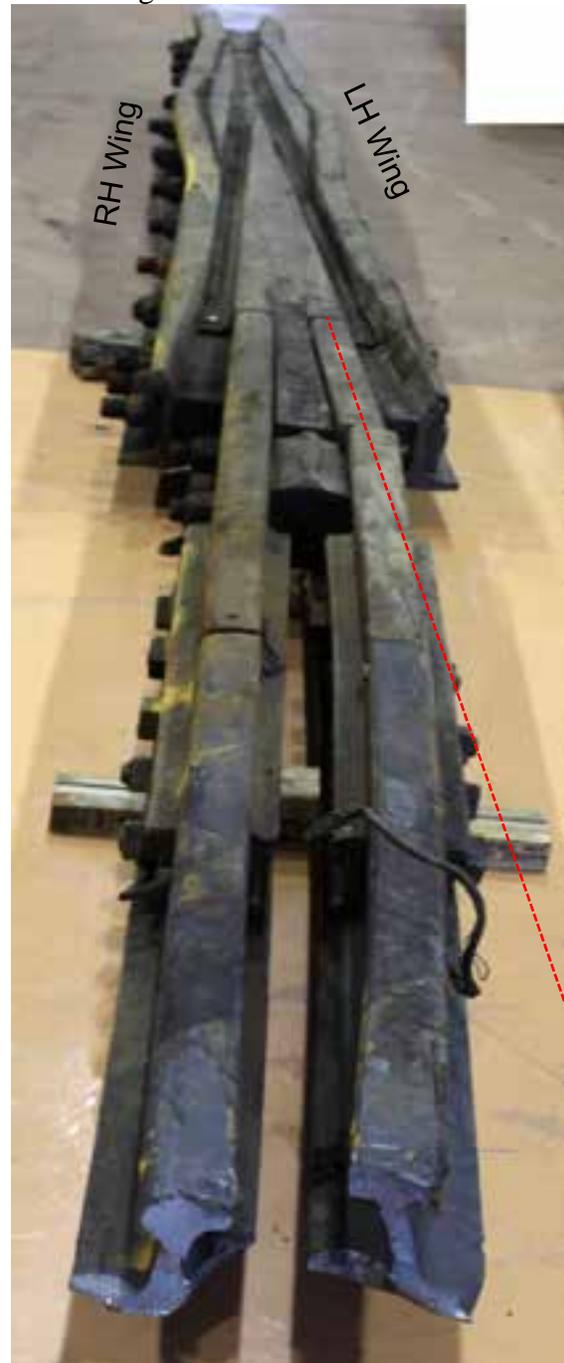
Figure 1: Frog, various views

- 2.3 The frog rails connected to the heel rails were cut at the occurrence site to facilitate transportation to the TSB laboratory (the cut ends are seen in the lower portion of Figure 1d).

- 2.4 The frog wing rails fractured during the occurrence at the location of the front end of the toe filler block (Figure 1c). A close-up photograph of the wing rails' fracture surfaces is shown in Figure 3. These fracture surfaces had a coarse texture typical for an overstress fracture mode. They were covered by oxide scale (as were most of the track components delivered for examination) due to exposure to the post-derailment fire. No pre-existing defects or fatigue cracks were observed on the fracture surfaces.

- 2.5 The left-hand (LH) heel rail had fractured at the location between the heel end of the frog core and the heel filler block (this location is indicated by the arrowheads in Figure 1b, 1c and Figure 2a). A close-up photograph of the mating fracture surfaces of this rail is shown in Figure 4. These fracture surfaces also had a coarse topography typical for overstress fractures and were damaged by fire. The crack in the thin portion of the heel filler block (arrowed in Figure 2c) likely occurred at the same time as the heel rail fracture. These fractures were apparently caused by a force applied to the rail from the LH side. As a result of this force, the LH heel

- rail along with the connecting frog rail was pushed inwards towards the right-hand (RH) rail (refer to Figure 1c and 1d where the normal orientation of the LH rails is indicated by the red dotted lines). This force also bent the joint bars connecting the heel and frog rails (Figure 5). Note that 1 bolt was missing; the corresponding hole is circled in Figure 1a. The extent of wear and corrosion on all the holes in these joint bars and the rails was similar, and there was no sign that some holes had been exposed to the elements longer than the others. Therefore, it is likely that the missing bolt was broken and lost during the present occurrence.

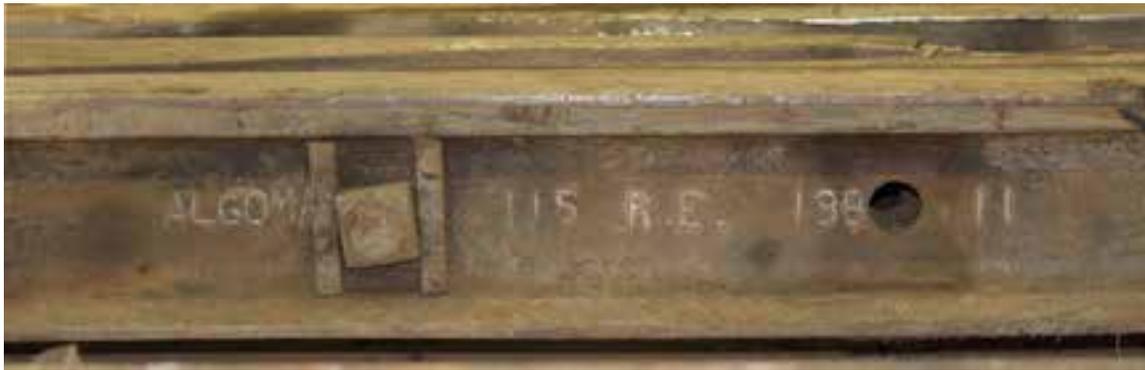
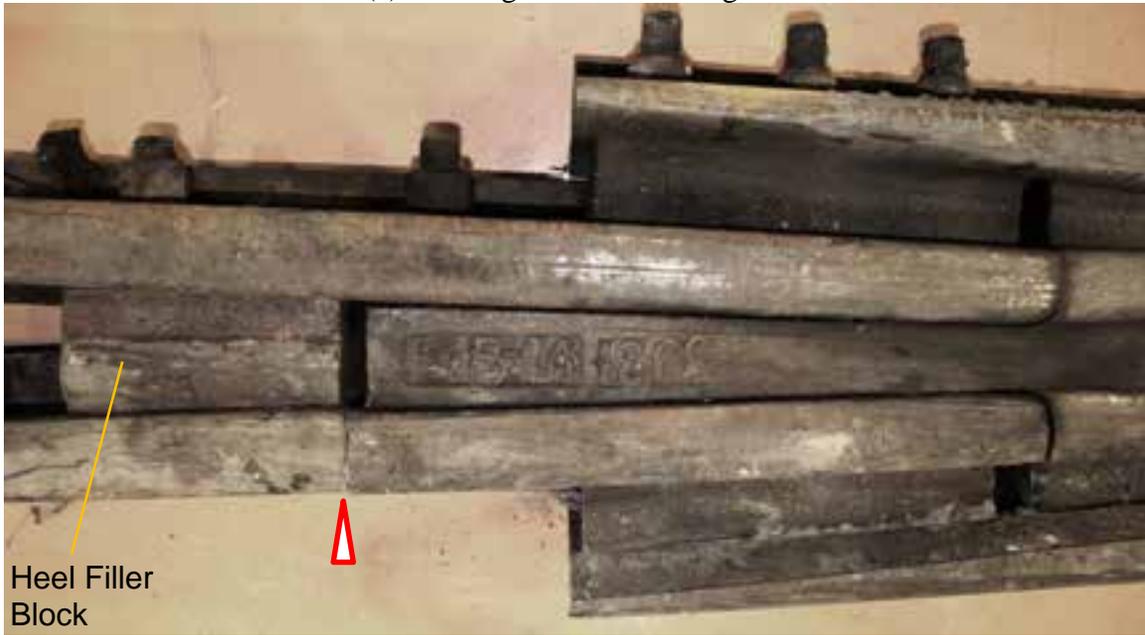
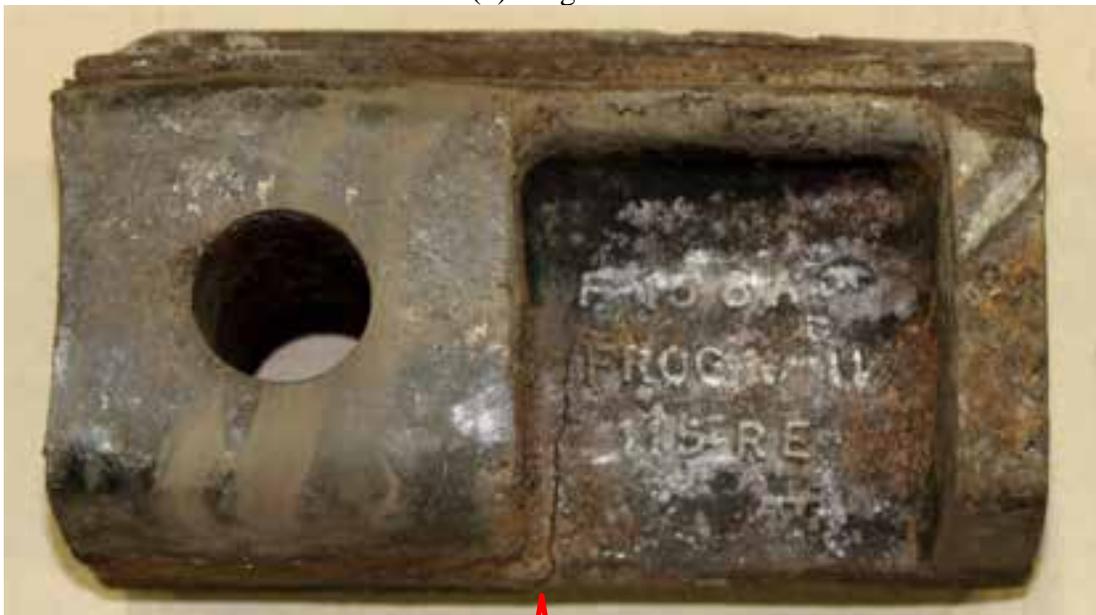
Figure 2: Frog identification markings

- 2.1 The frog is shown as received in Figure 1. Its overall design and dimensions suggested that it was a railbound manganese steel frog number 11. The identification markings on the frog components (Figure 2) confirmed this and indicated that the frog had been manufactured by Algoma for 115-pound RE rails. The last digit of the year stamp had been obliterated by the bolt hole (Figure 2a); however, the identification markings on the joint bars connecting the frog's heel rails to the track frog rails<sup>2</sup> indicated that they were produced by Algoma in 1981. Therefore, it is likely that the frog was manufactured in 1980 or 1981.

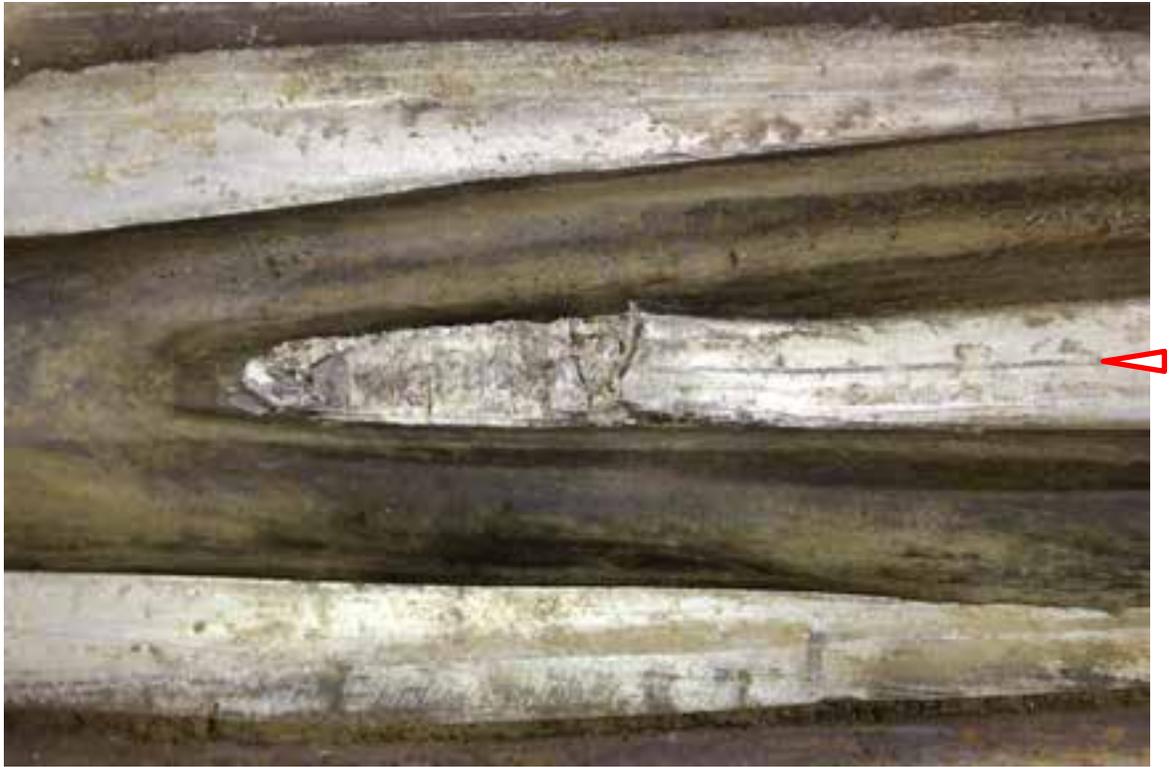
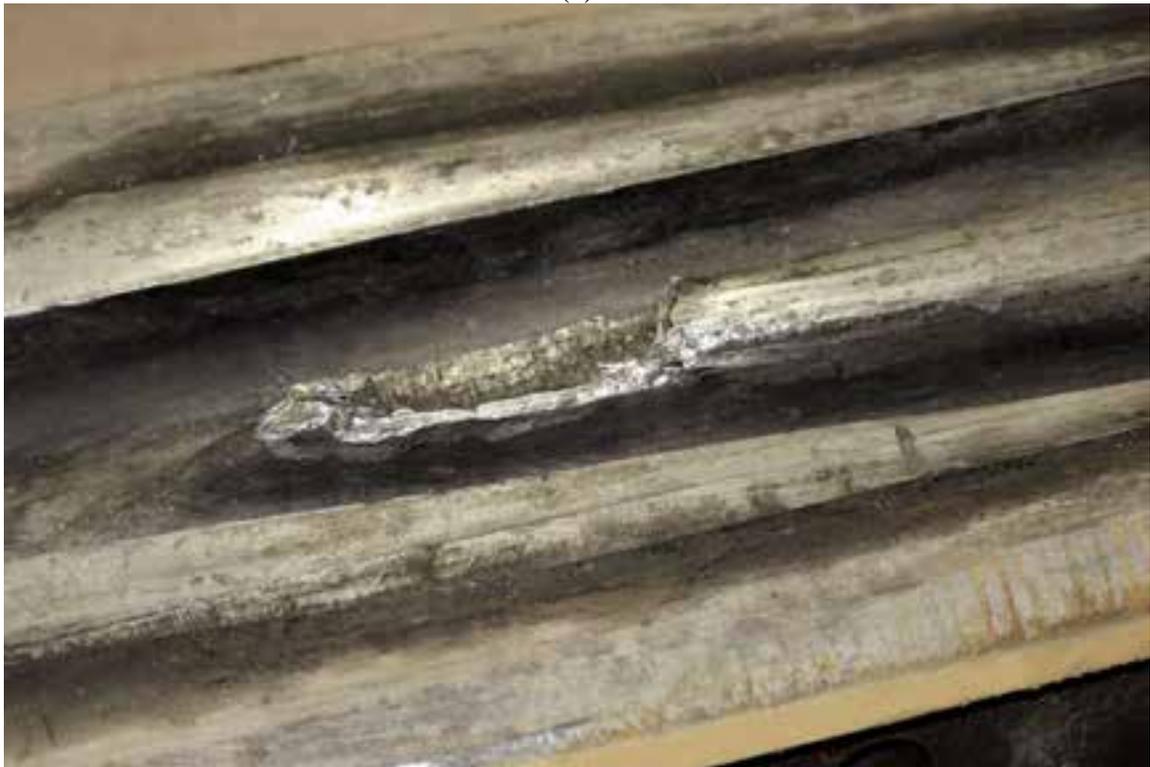
Figure 6: Close-up photographs of the frog point

- 2.6 Figure 6 displays close-up photographs of the frog point. The point was damaged – the missing portion was about 5 inches long and 0.5 inch thick. The horizontal portion of the separation surface has a wavy appearance, typical for the interface between a weld-repaired area and the base material. This suggests that the frog point had been previously weld-repaired. The approximately vertical portion of the separation surface (about 5 inches from the point tip) had features characteristic of overstress fracture. It is considered likely that the missing piece broke off during the present occurrence. If the separation of this piece had predated the derailment, multiple wheel marks would be expected on the separation surface. There were wheel flange contact marks on the RH edge of the damaged portion of the point (Figure 6), but no clear marks anywhere else. Note also a mark from a wheel rim on the top of the remaining upper surface of the point (arrowed in Figure 6a). There was no dent at the edge of the vertical fracture surface corresponding to this wheel mark which suggests that this mark had appeared while the missing piece of the point was still in place.

- 2.7 As mentioned in the previous paragraph, the frog point had likely been repaired by welding. Such repairs are allowed, and a frog should be repaired or removed when the wear reaches 0.5 inch from the top of the frog.<sup>3</sup> The missing portion of the frog point was about 0.5 inch thick, indicating that the point had been repaired when its wear approached the limit. There were also signs of repairs at other locations on the frog; an example is shown in Figure 7.

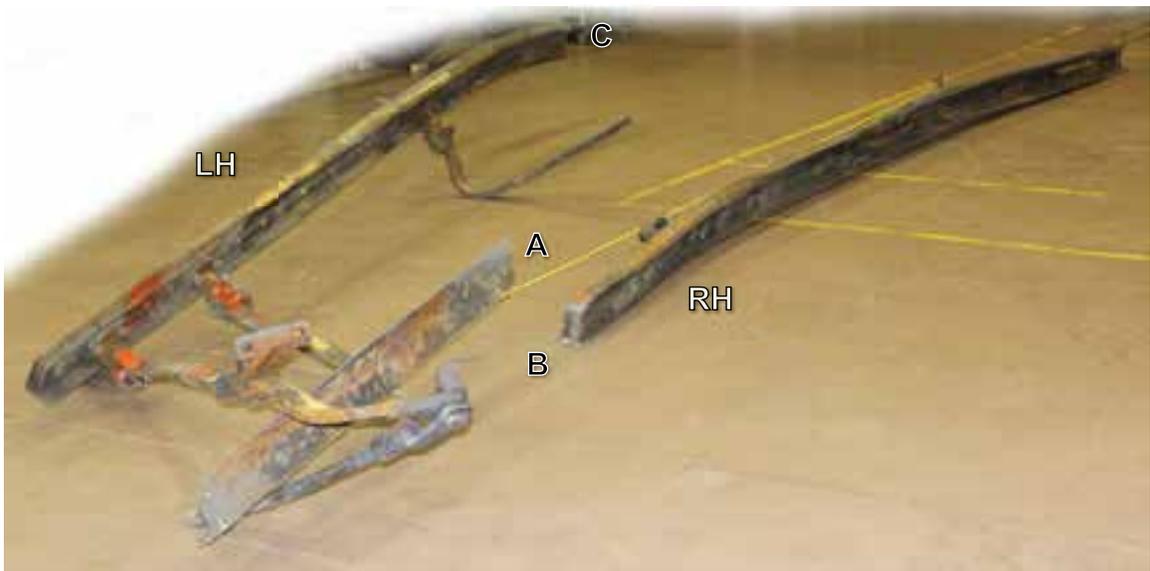
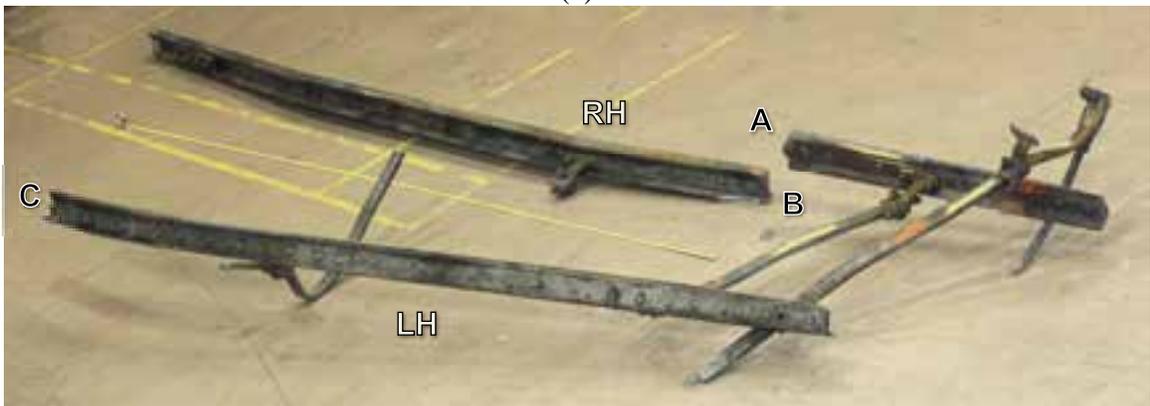
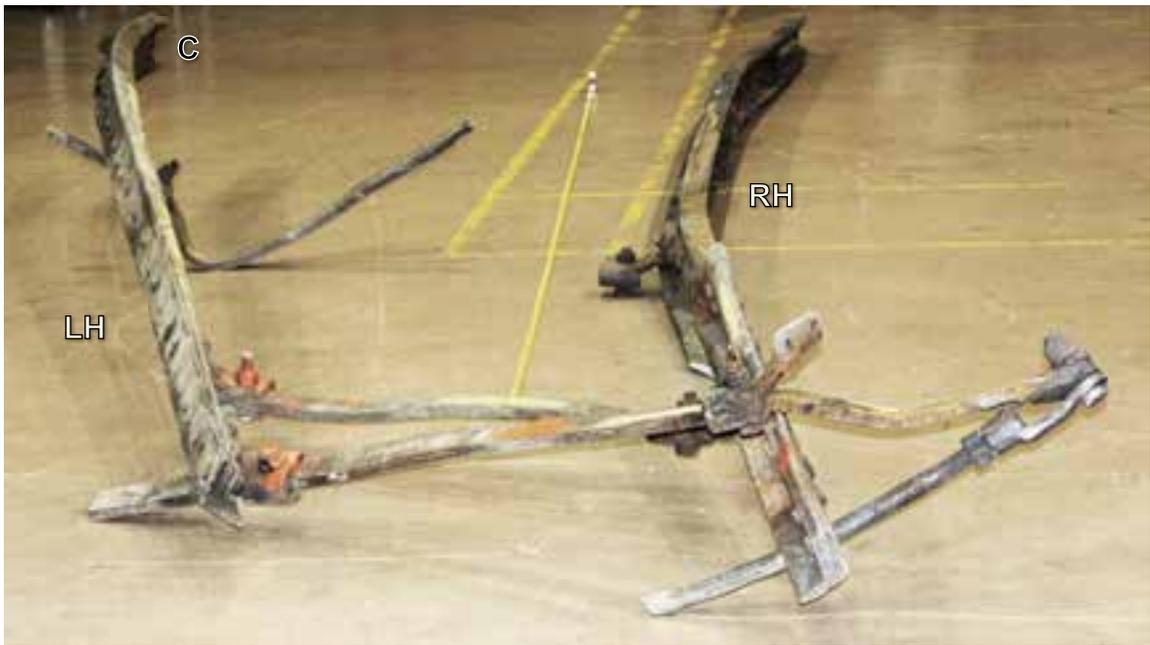
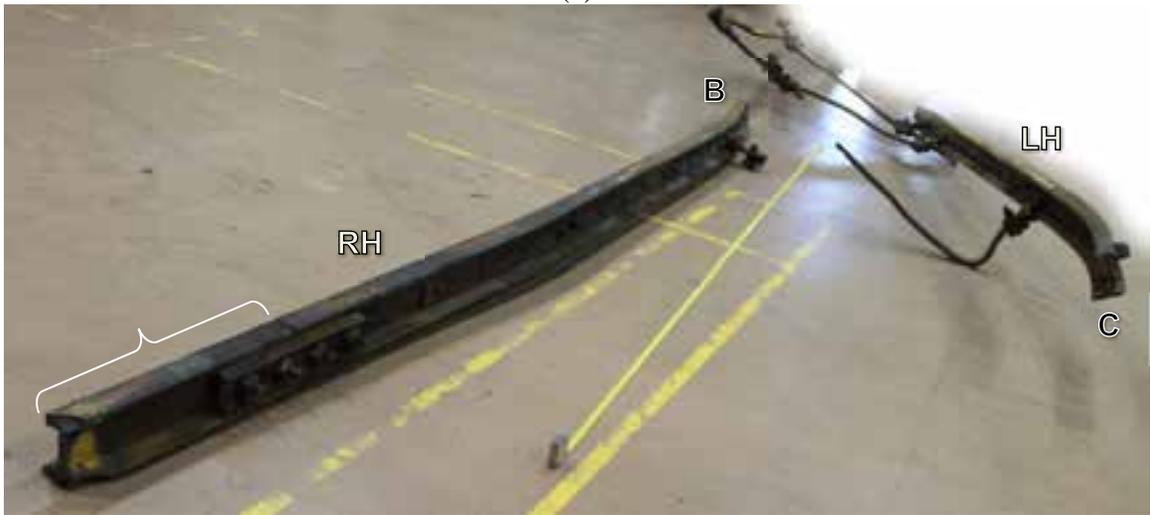
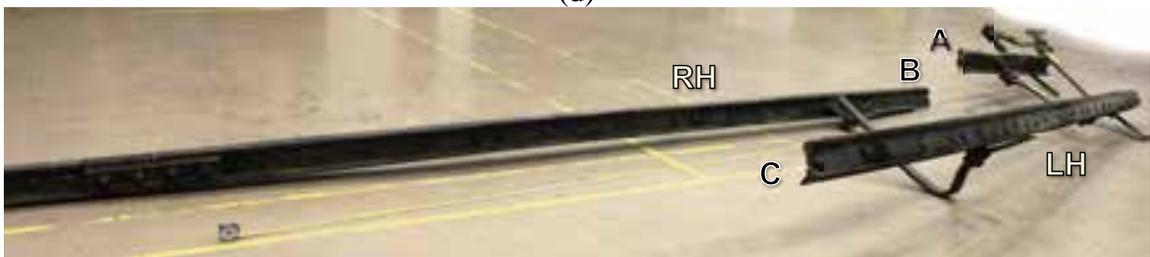
Figure 8: 22-foot switch point rails, various views

- ### 3.0 SWITCH POINTS
- 3.1 Three switch point rails were delivered for examination (Figure 8 and Figure 9). Their age was not determined.
- 3.2 The 2 rails shown in Figure 8 were from a single 22-foot straight split switch in the RH configuration. Both rails and the switch operation mechanism were severely damaged during the derailment. The rail tips were unremarkable except for a slight detachment of the side plate on the LH point (Figure 10). The rail wear was within the limits specified for 115-pound RE rail (see columns 5 to 7 of Table 1 and paragraph 2.2).

- 3.3 The RH switch point had a piece of stock rail about 2.5 feet long (indicated by the white bracket in Figure 8d) attached to it with joint bars. This stock rail had been cut at the occurrence site for ease of transportation to the TSB laboratory. Measurements of the rail length indicated that an approximately 1-foot section of rail, located about 5 feet from the tip, was missing (refer to A and B on Figure 8a and 8b). The fractures at locations A and B had occurred due to overstress with significant plastic deformation (Figure 11).

- 3.4 An approximately 8-foot long piece was missing from the heel of the LH switch point rail. The fracture surface at location C (Figure 8) was typical for an overstress fracture mode (Figure 12).

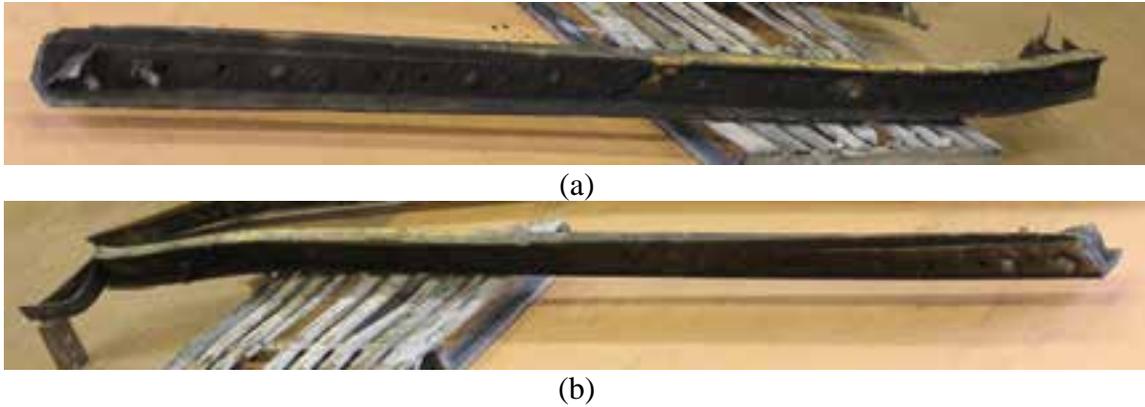
Figure 9: 16.5-foot switch point rail photographed from 2 sides

- 3.6 The other switch point rail (Figure 9) was from a 16.5-foot straight split switch. This rail was also deformed during the derailment. The rail fractured about 3 feet from the heel; the fracture surface was typical for overstress (Figure 13a). The switch point tip had nicks and burrs, and the side plate end was bent out (Figure 13b). The wear of this rail was not measured because the heel portion of rail was broken off. However, visually, the rail head did not appear worn. The railway operator reported that 16.5-foot yard switches had been recently installed in Lac-Mégantic with new rails.

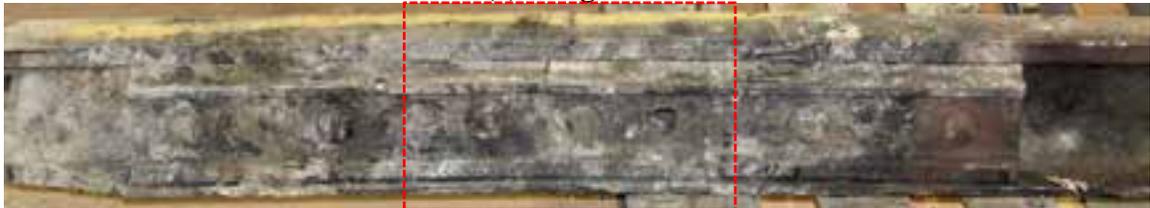
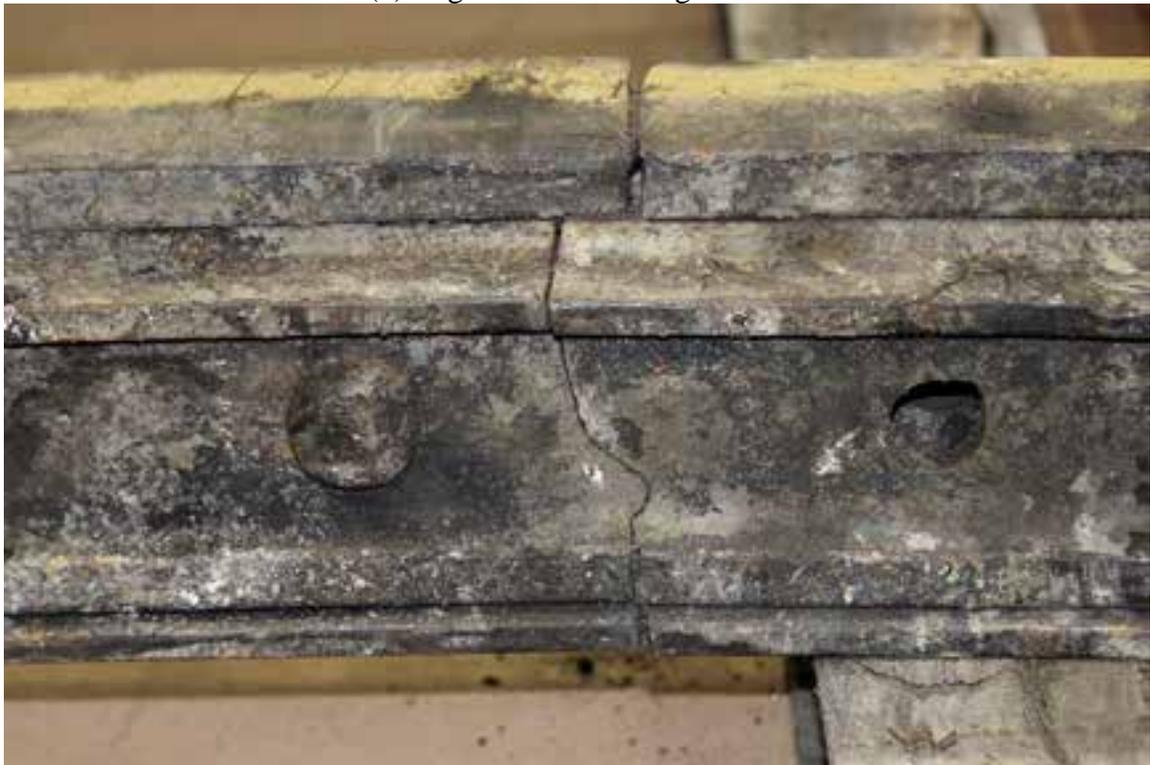
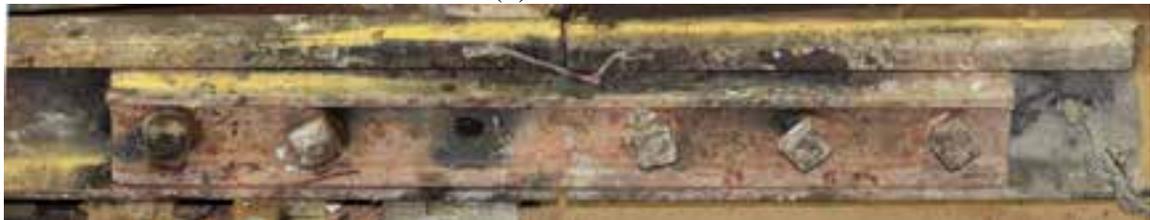
Figure 14: Rail joint, various views

- 4.1 The 2 joined rail pieces are shown as received in Figure 14. One piece was about 8 feet long, the other – about 2 feet long. The longer rail piece had identification markings: ALGOMA C.C. 115 LBS RE 1983. There were no markings on the shorter rail piece. The joint bar on the gauge side was marked ALGOMA C.C. 115 LBS RE 1987. The only discernible markings on the field side joint bar were ALGOMA ... 1975 ... PAT 1947.

- 4.3 There was a crack in the gauge-side joint bar (see Figure 14b and 14c). One of the bolts was missing; however, the extent of wear and corrosion on all the holes in the rails and the joint bars was similar, and there was no sign that some holes had been exposed to the elements longer than the others. Therefore, it is likely that the missing bolt was broken and lost during the present occurrence.

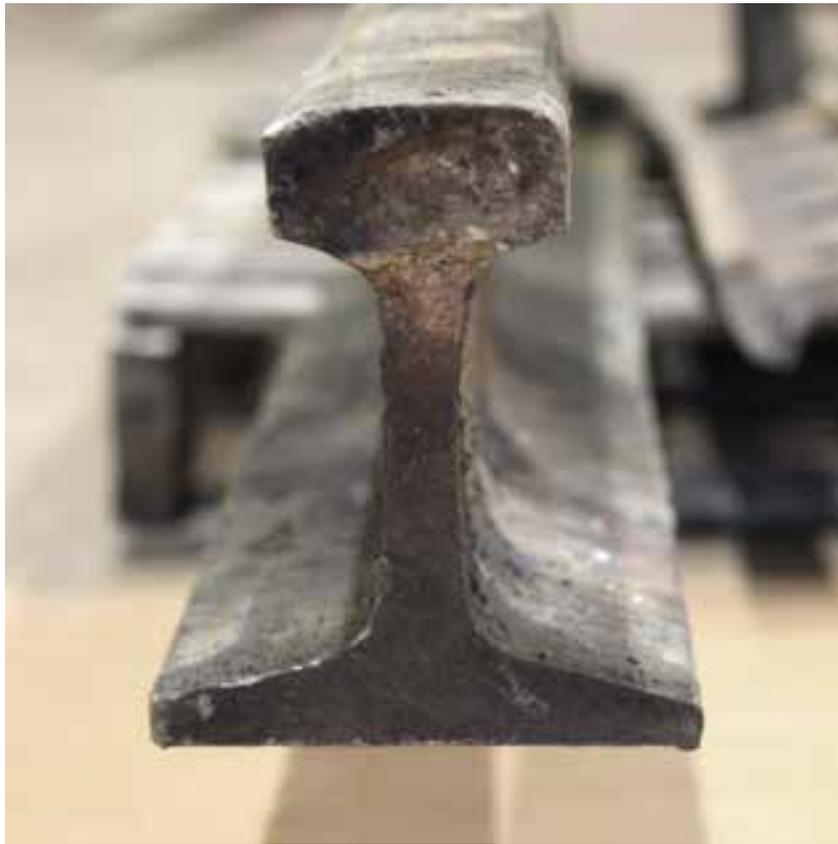
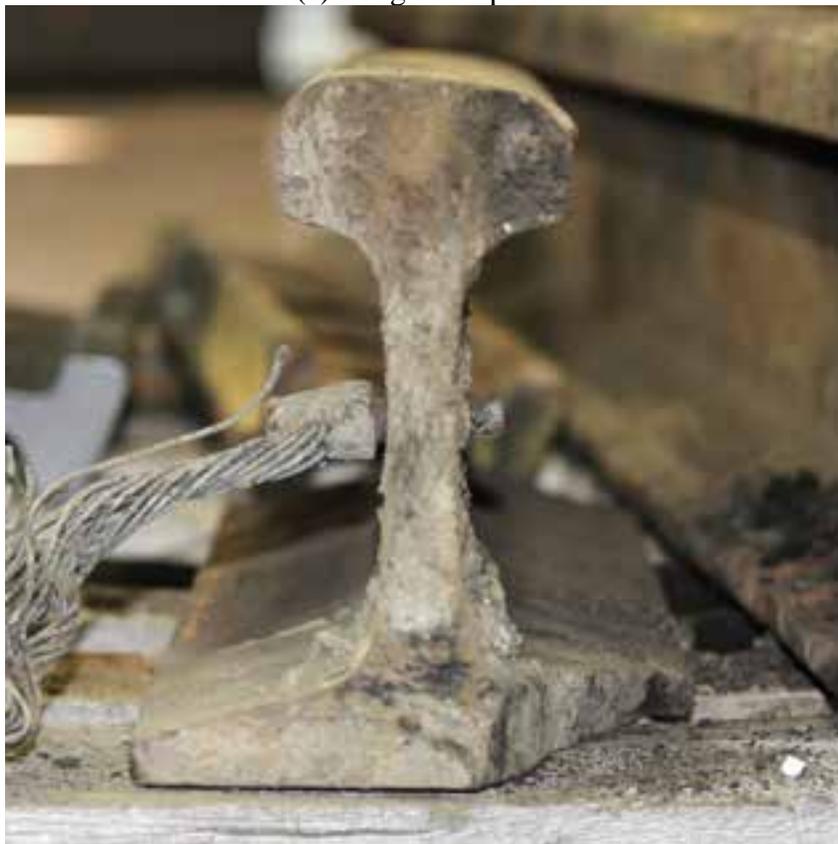
Figure 15: Close-up photographs of rail fracture surfaces

- 4.2 The rail head wear of both rails was small (see columns 8 and 9 of Table 1). The fractures of both rails had occurred due to overstress (Figure 15).

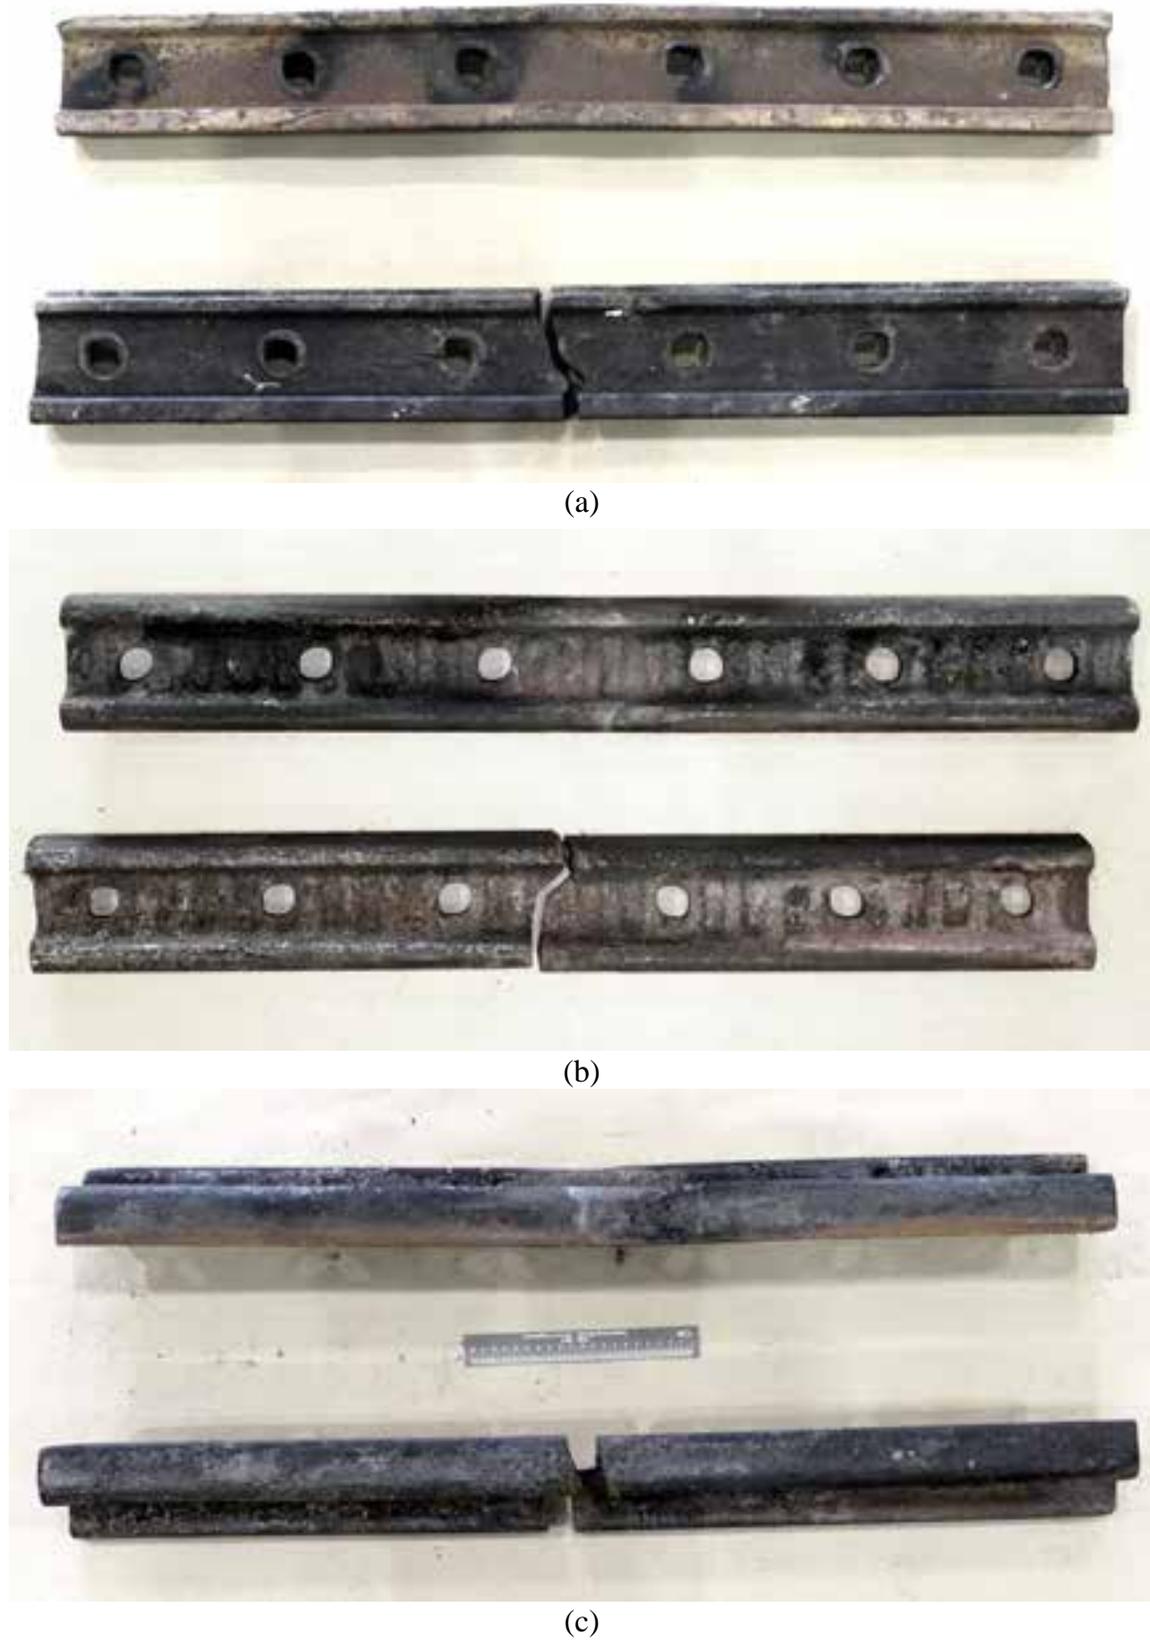
Figure 16: Disassembled joint bars, various views

- 4.4 The rail joint was disassembled in order to examine the joint bars (Figure 16). The field-side joint bar was bent, but no cracks were observed in it. Photographs of the fracture surfaces of the gauge-side joint bar are shown in Figure 17. A small fatigue crack is visible in the top corner (arrowed in Figure 17a and 17b and shown at higher magnification in Figure 17c and 17d); the rest of the fracture

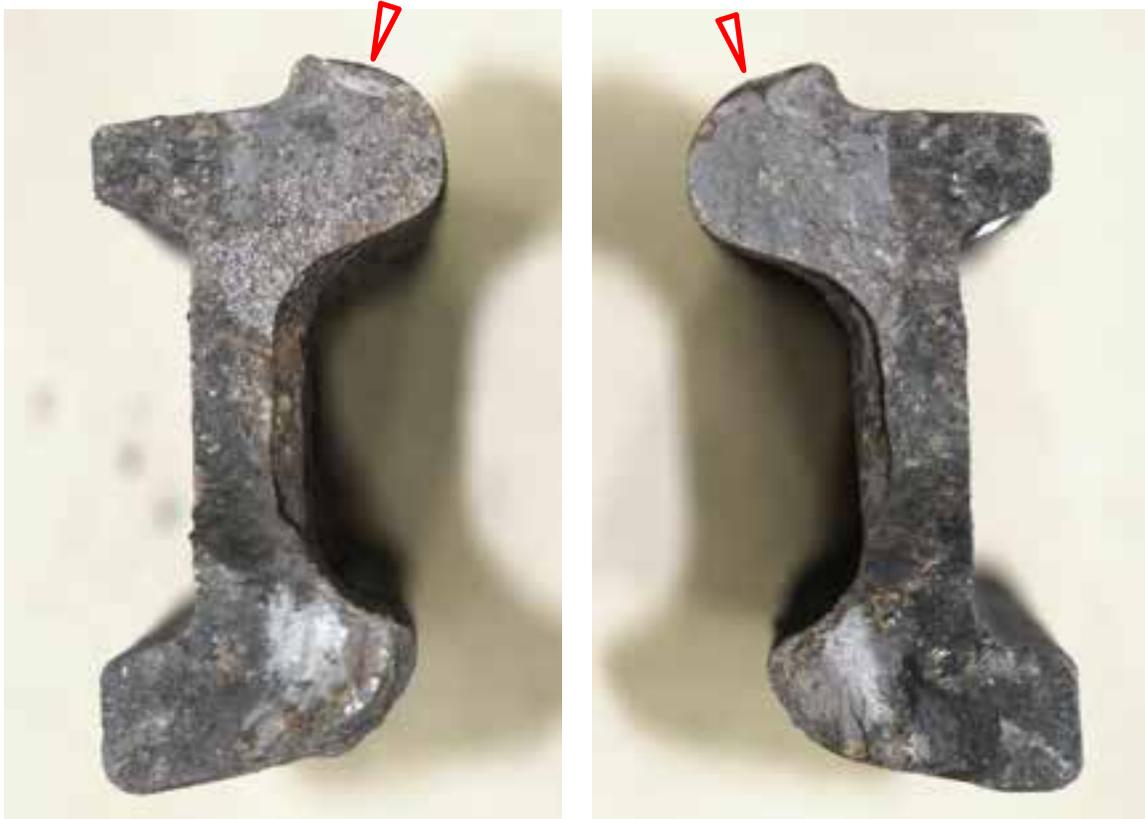
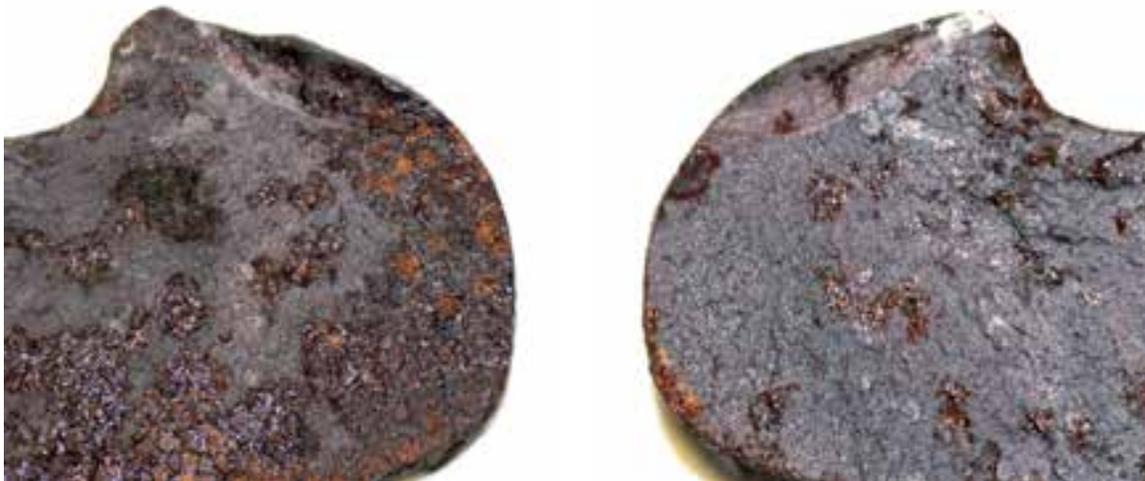
Figure 17: Close-up photographs of 2 mating fracture surfaces of the gauge-side joint bar

surface was typical for overstress. This edge of the joint bar was located in the under-head fillet of the rail, and the fatigue crack initiated at the location where the two rails met. Such fatigue cracks are rather common in joint bars.<sup>4</sup> Figure 18 displays representative examples of fatigue cracks in joint bars previously examined by the TSB laboratory. These joint bars fractured under normal operating conditions as a result of an overstress extension of fatigue cracks that had grown to a critical size. Note that the fatigue crack in the present occurrence was only about 25% of the size of fatigue cracks shown in Figure 18. Therefore, it is unlikely that this small fatigue crack would have caused this joint bar to break under normal operation loads. Thus, even though this fatigue crack was a precursor for overstress fracture, the latter was mostly caused by overload during the derailment. The same excessive load during the derailment apparently caused bending of the field-side joint bar.

- 4.5 To summarize the joint bar fracture examination: There was a small fatigue crack in the gauge-side joint bar. However, this fatigue crack had not yet grown to a critical size, and the complete fracture of the joint bar was a result of an overload during the derailment.
