ENGINEERING LABORATORY REPORT

LP182/2013

Examination of Locomotive Wheels and Brake Shoes

Montreal, Maine & Atlantic Railway, Train MMA-002

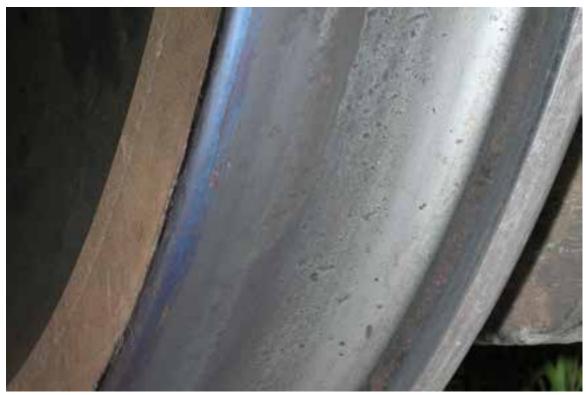
Figure 1: Representative example of wheel tread with ¼ blueing

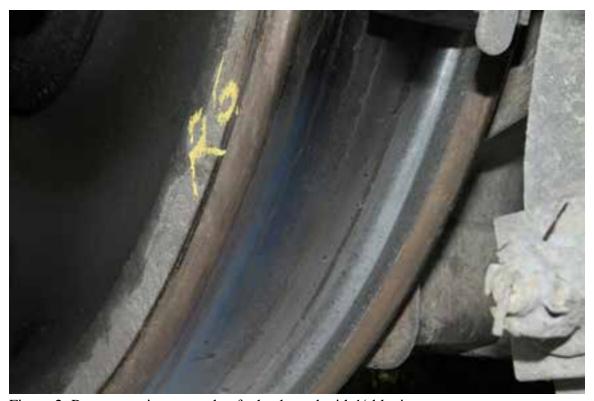
Figure 2: Representative example of wheel tread with ½ blueing

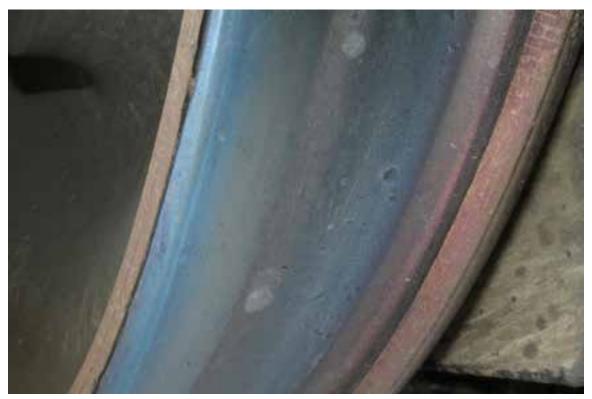
Figure 3: Representative example of wheel tread with ¾ blueing

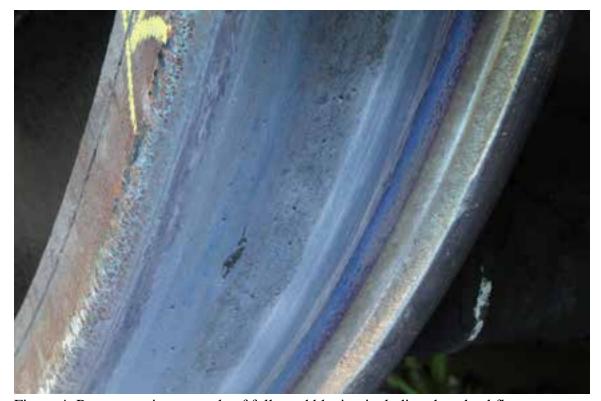
- 3.4 The data shows that MMA 5026 and CITX 3053, the second and third units, had the highest number of wheels with full blueing across the entire tread including the flange. The 9 brake shoes worn beyond the 5.5 mm limit were under these same 2 units. Combining the brake shoe wear results with the tread blueing results reveals that the third unit, CITX 3053, generated the greatest retarding force.

Figure 4: Representative example of full tread blueing including the wheel flange

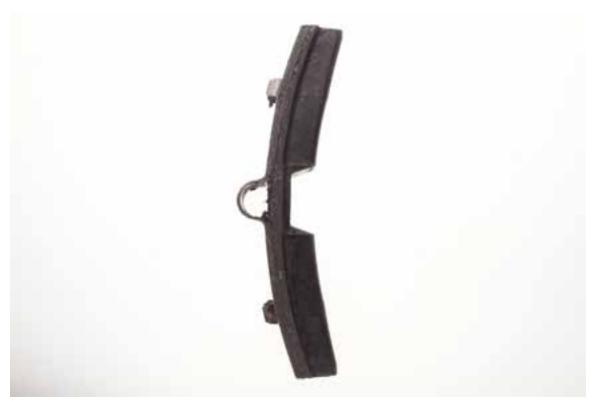
Figure 5: Representative new brake shoe

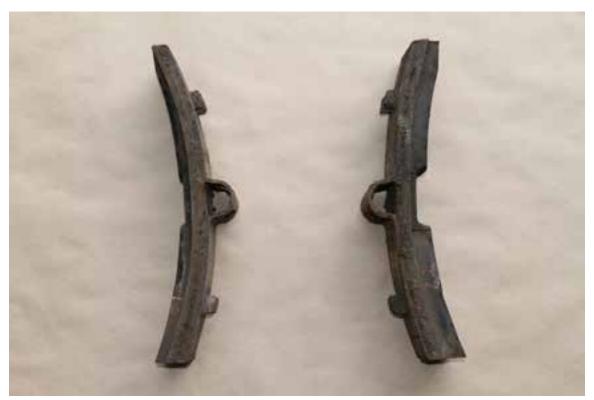
Figure 6: Representative brake shoes showing asymmetric wear

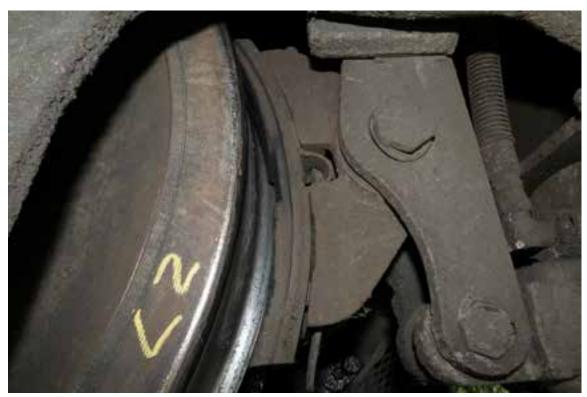
Figure 7: Brake shoe installed showing asymmetric wear

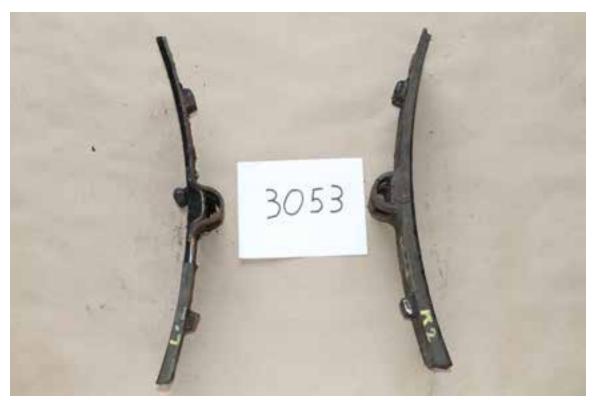
- 3.3 The data indicates that 9 of the 68 brake shoes (13%) had a lining thickness of 5.5 mm or less (Appendix A, grey shaded cells). Only 2 of these (11%) were at one of the wheel locations equipped with a handbrake. Had the handbrakes on the subject locomotives all been securely applied, it would be expected that the brake shoe lining wear would have been greatest at wheels acted upon by a handbrake.

Figure 8: Example of brake shoes with little lining remaining

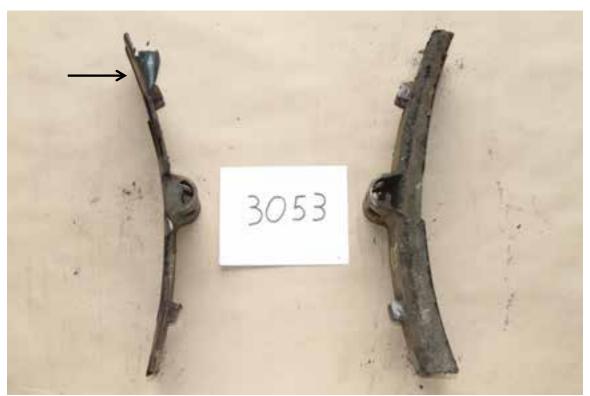
- 4.1 All of the locomotive and car wheels exceeded the applicable minimum allowable rim thicknesses.
- 4.2 The original condition of the brake shoe linings before the occurrence was not known. Therefore the extent of brake shoe thickness loss due to the runaway is not known.
- 4.3 Some of the brake shoes had worn through the lining to the backing plate.

Figure 9: Example of brake shoe with lining worn away to backing plate (arrowed)

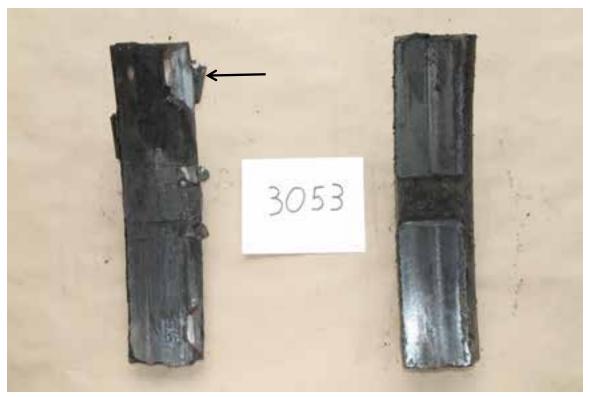
Figure 10: Tread side view of brake shoe lining worn away to backing plate (arrowed)
