OPERATIONAL SERVICES BRANCH
ENGINEERING LABORATORY REPORT

LP184/2013

Examination of Knuckle and Pin

Montreal, Maine & Atlantic Railway, Train MMA-002

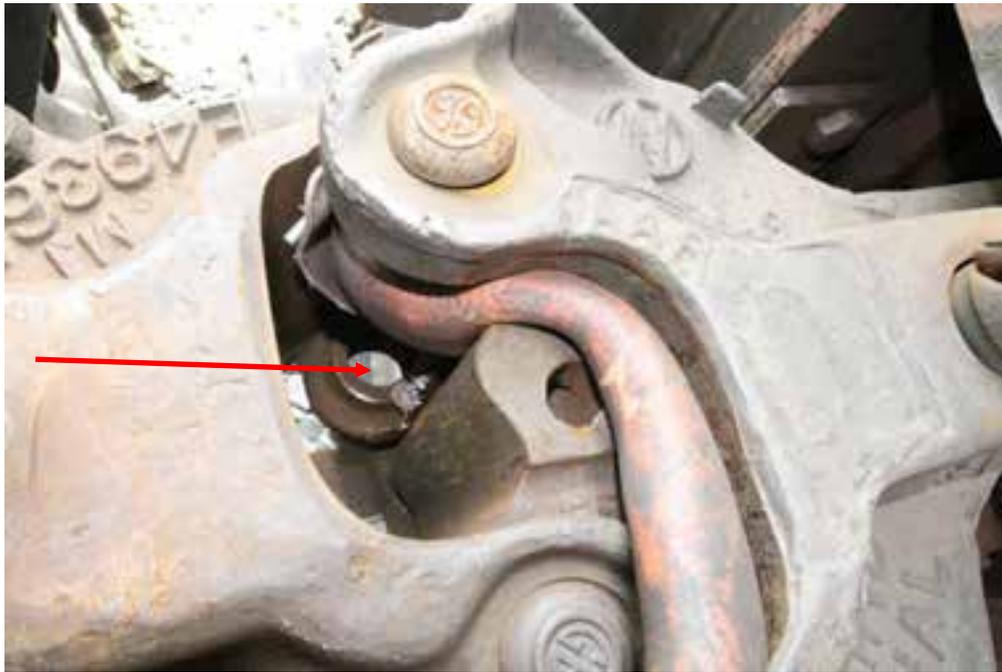
- 1.2 During the field investigation it was noted that the knuckle and pin from the aft end of the number 2 locomotive (MMA 5026) had failed (Figure 1). The knuckle on the forward end of the box car (CIBX 172032) had also failed (Figure 2). The 2 knuckles were sent to the Transportation Safety Board of Canada (TSB) Engineering Laboratory to determine the possible cause of the failures.

Figure 1: Photograph showing the fractured knuckle from the aft end of locomotive MMA 5026. Note the missing portions of the knuckle and knuckle pin (red arrow).

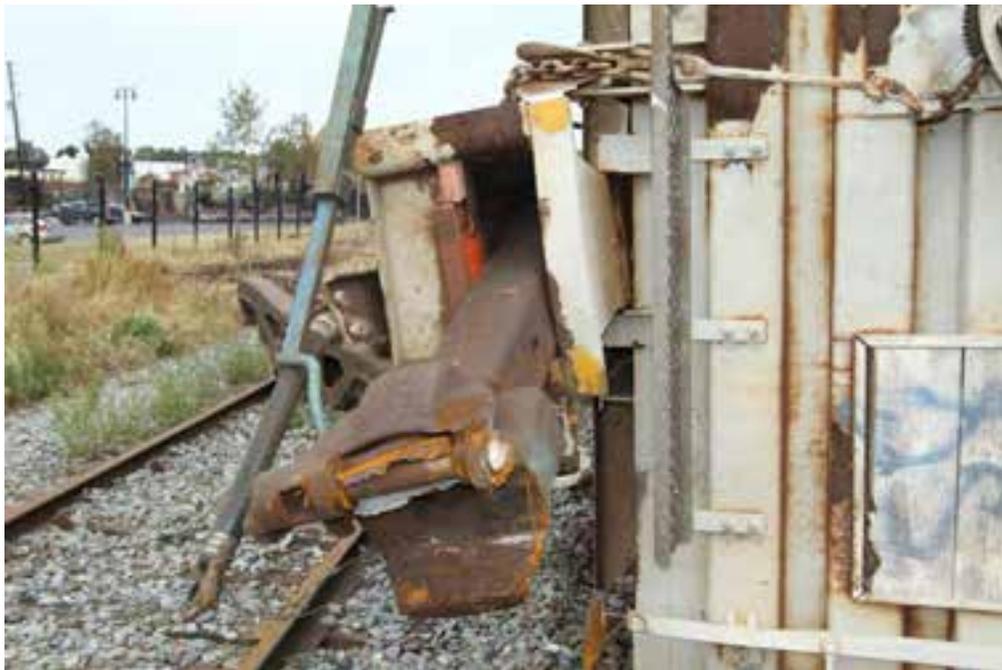
Figure 2: Photograph showing the fractured knuckle on the forward end of the box car (CIBX 172032).

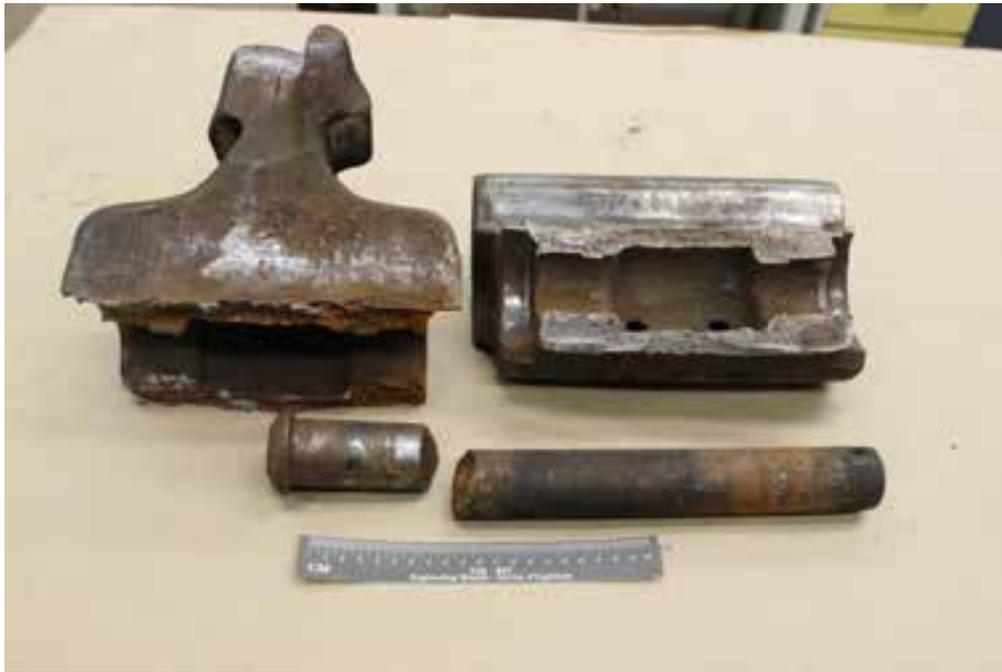
Figure 3: The locomotive knuckle and pin as received.

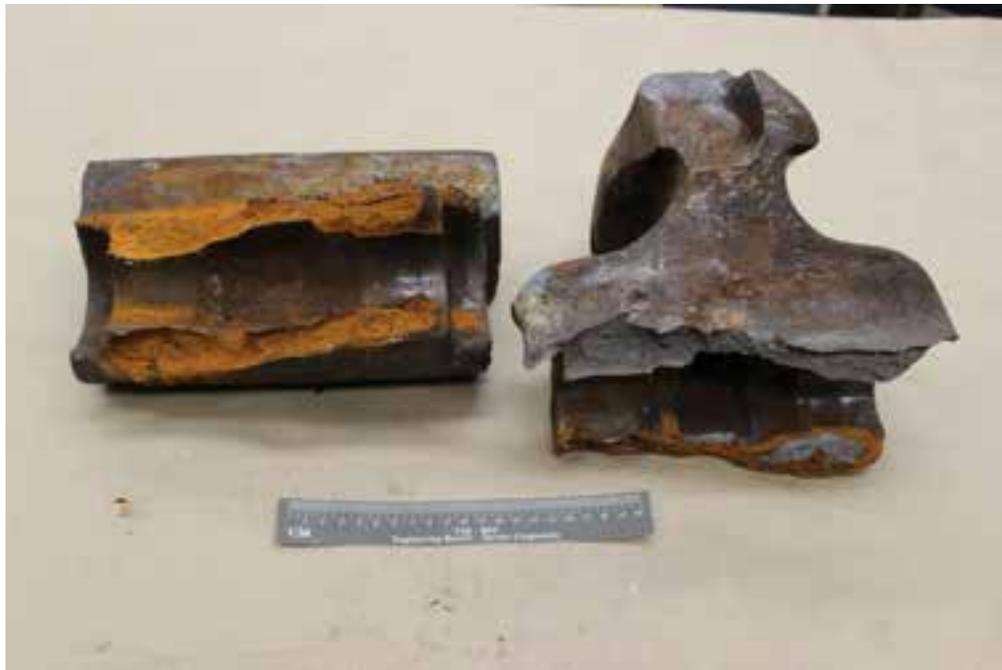
Figure 4: The box car knuckle as received.

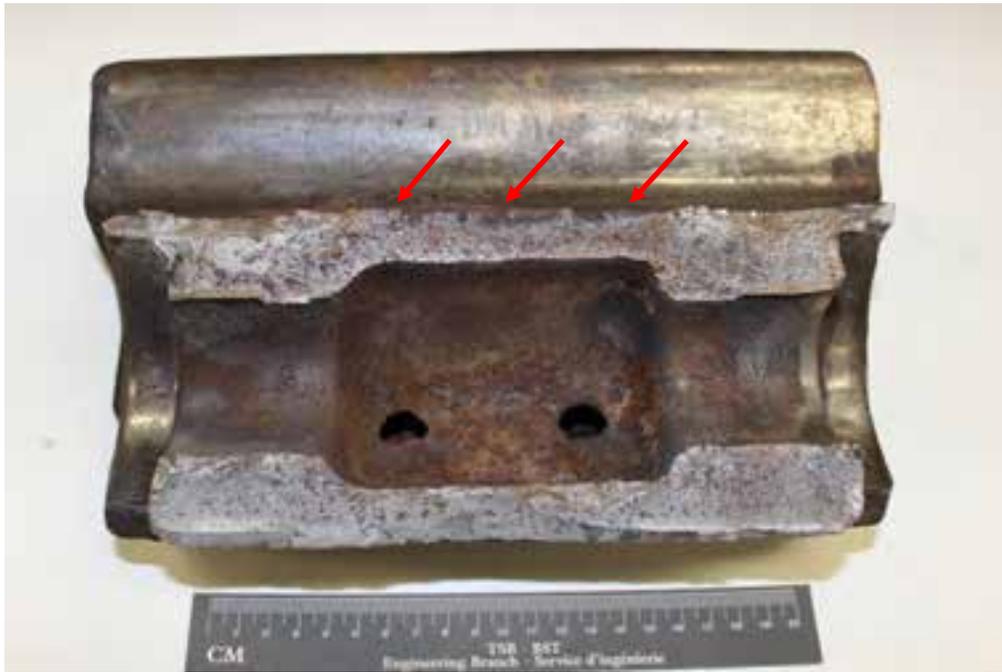
- 2.2 Locomotive Knuckle and Pin
- 2.2.1 The knuckle and pin were cleaned for examination. The fracture surfaces from the locomotive knuckle and pin are shown in Figure 5 and 6, respectively. Figure 7 is a close-up of the area adjacent to the inner radius of the knuckle where fatigue cracks were visible on the fracture surface. The fatigue cracks had a dark rusty appearance suggesting they had been present for some time. The remaining fracture surface had a rough appearance consistent with an overstress mode of failure. Shear lips on the side opposite to the fatigue region and the orientation of ridges on the fracture surface indicate the direction of failure from the inner to the outer radius (refer to arrows on Figure 8), consistent with a tensile load acting on the knuckle.

- 4.1 The locomotive knuckle failed in a tensile overstress mode initiating at a pre-existing fatigue crack on the inner radius of the knuckle. This fatigue crack merely acted as a location site for the failure of the knuckle.

Figure 5: The fracture surface of the locomotive knuckle. Red arrows point to the pre-existing fatigue cracks on the inner radius.

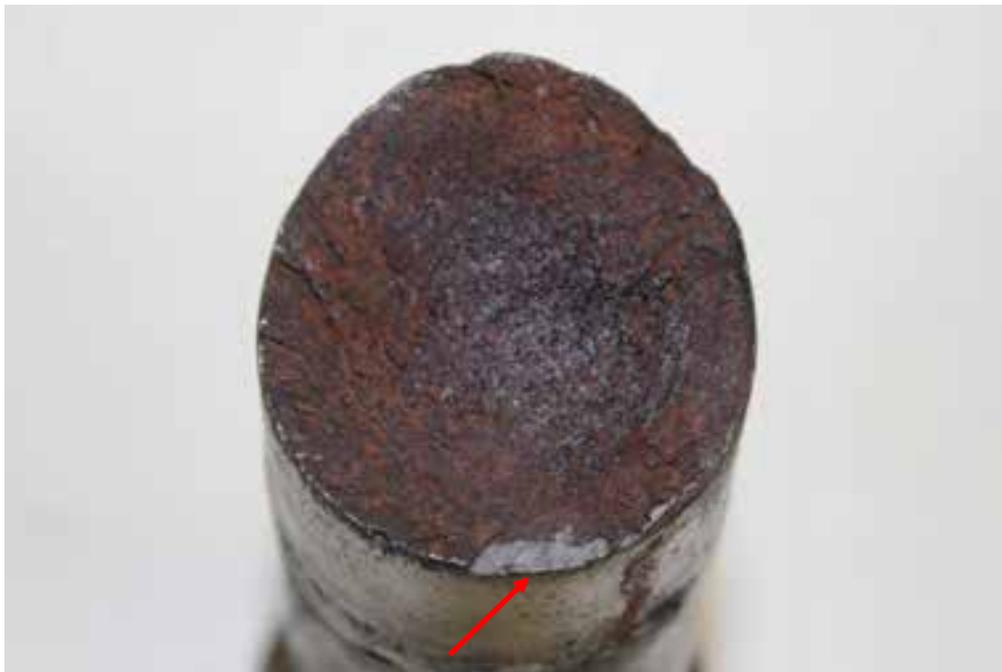
- 2.2.3 The knuckle pin had a total shank length of 13 ½ inches and it had fractured 3 inches below the head (Figure 6). The fracture surface of the pin contained a small pre-existing fatigue crack approximately 10 mm wide by 4 mm deep. The remaining fracture surface exhibited a rough appearance with ridges originating from the small fatigue crack, consistent with overstress caused by a bending load. The fatigue crack most likely acted as a location site for the failure of the pin.

- 4.3 The locomotive knuckle material met the applicable AAR requirements.
- 4.4 The locomotive knuckle pin failed in a bending overstress mode which initiated at a pre-existing fatigue crack. This fatigue crack merely acted as a location for the failure and had the appearance that it was present for some time.

Figure 6: The fracture surface of the locomotive knuckle pin. The red arrow points to the pre-existing fatigue crack.

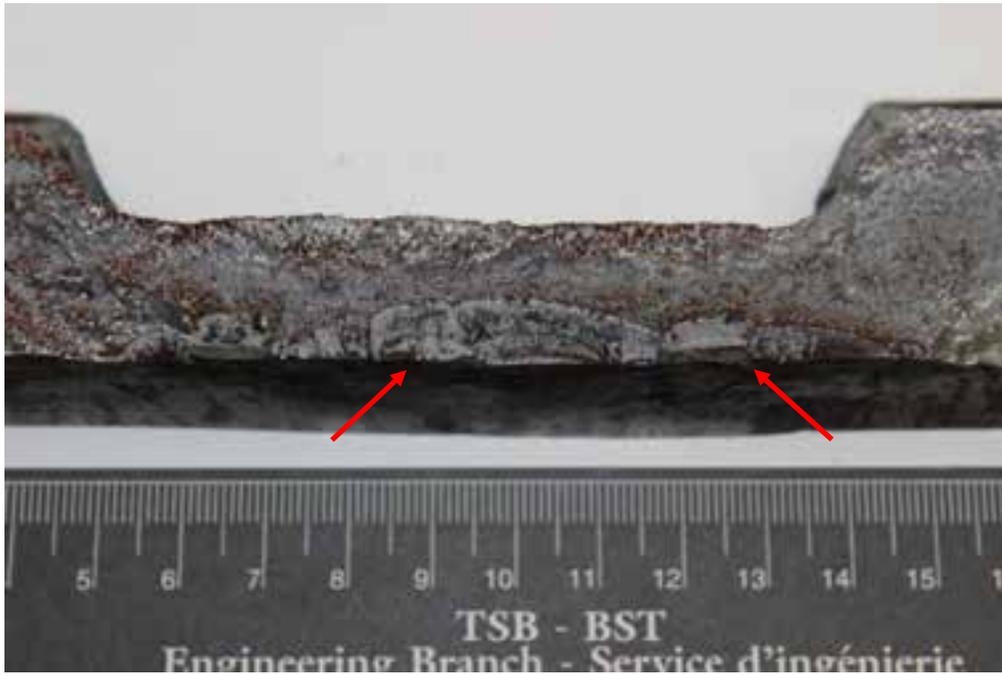
Figure 7: The area on the locomotive knuckle fracture surface with the pre-existing fatigue cracks (red arrows).

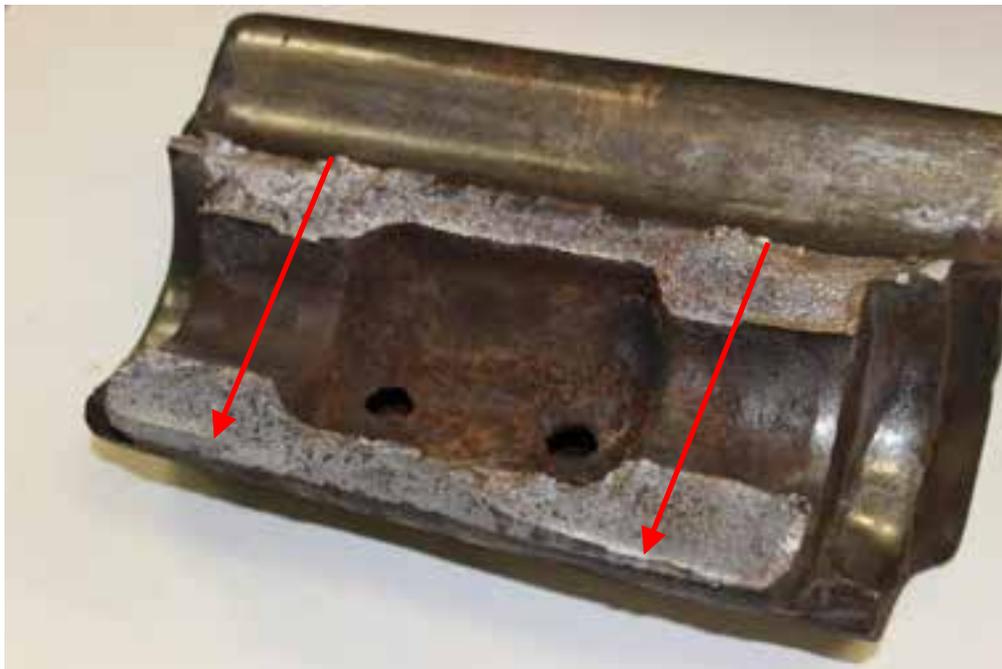
Figure 8: The fracture surface of the locomotive knuckle - red arrows show the direction of the tensile overstress failure.

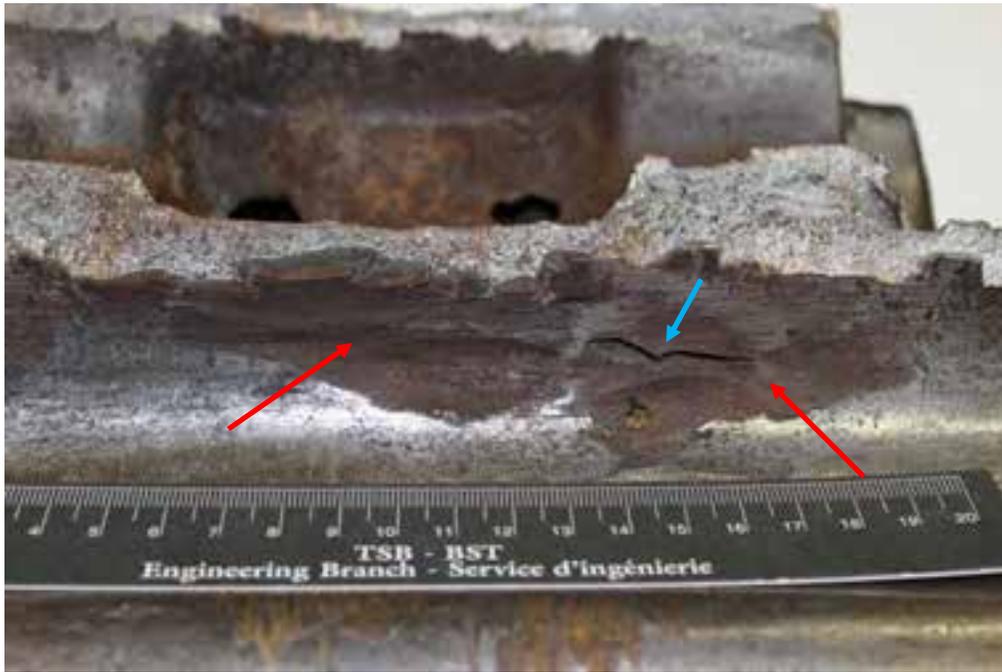
- 2.2.2 Mechanical damage, parallel scoring and secondary cracks were noted on the inner radius adjacent to the fatigue region (Figure 9). The appearance of the

scoring damage was consistent with grinder marks. The secondary cracks likely opened as a result of the tensile loads that caused the knuckle failure.

- 4.2 The fatigue crack observed on the locomotive knuckle was most likely present for some time and may have initiated from the mechanical damage observed on the inner radius of the knuckle. This mechanical damage was most likely caused by grinding.

Figure 9: The inner radius of the locomotive knuckle. Red arrows point to mechanical damage most likely caused by a grinder. Note the crack that opened during the fracture of the knuckle (blue arrow).

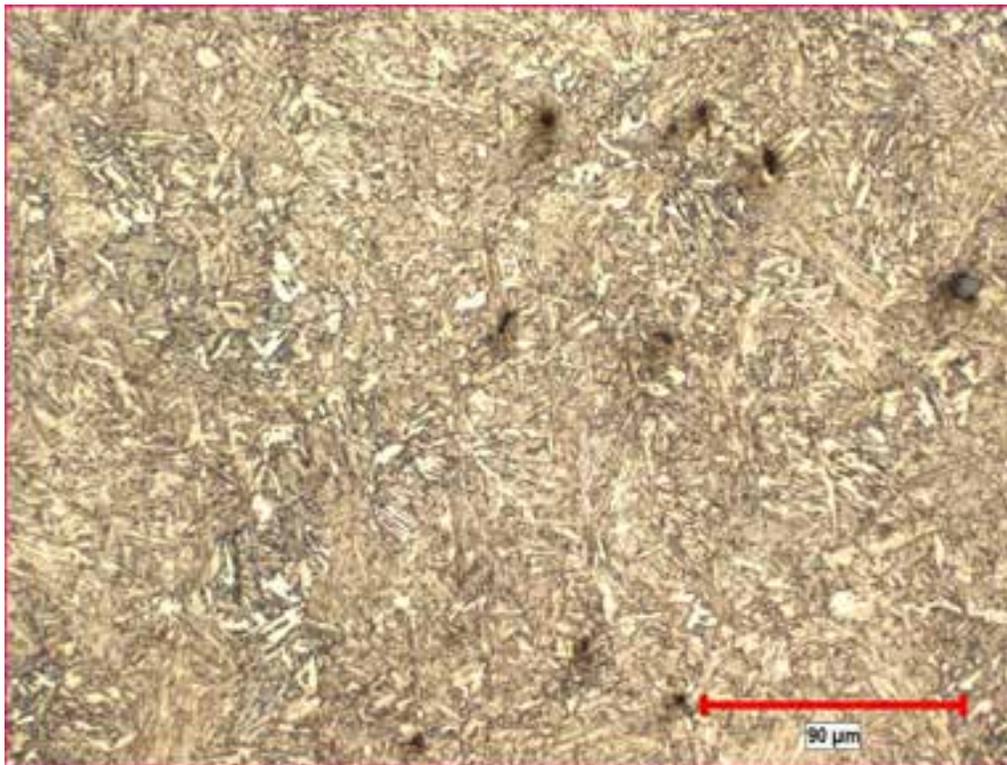
- 2.2.4 A metallurgical section was taken through the fatigue crack in the inner radius of the knuckle. Chemical etching in a 2% Nital solution revealed a quenched and tempered martensite microstructure (Figure 10). The metallurgical cross-section also exhibited small secondary cracks at the inner radius surface of the knuckle (a representative example is shown in Figure 11). There was no sign of a transformed microstructure that might be indicative of thermal damage caused by grinding.

Figure 10: Micrograph showing the quenched and tempered martensite microstructure of the locomotive knuckle.

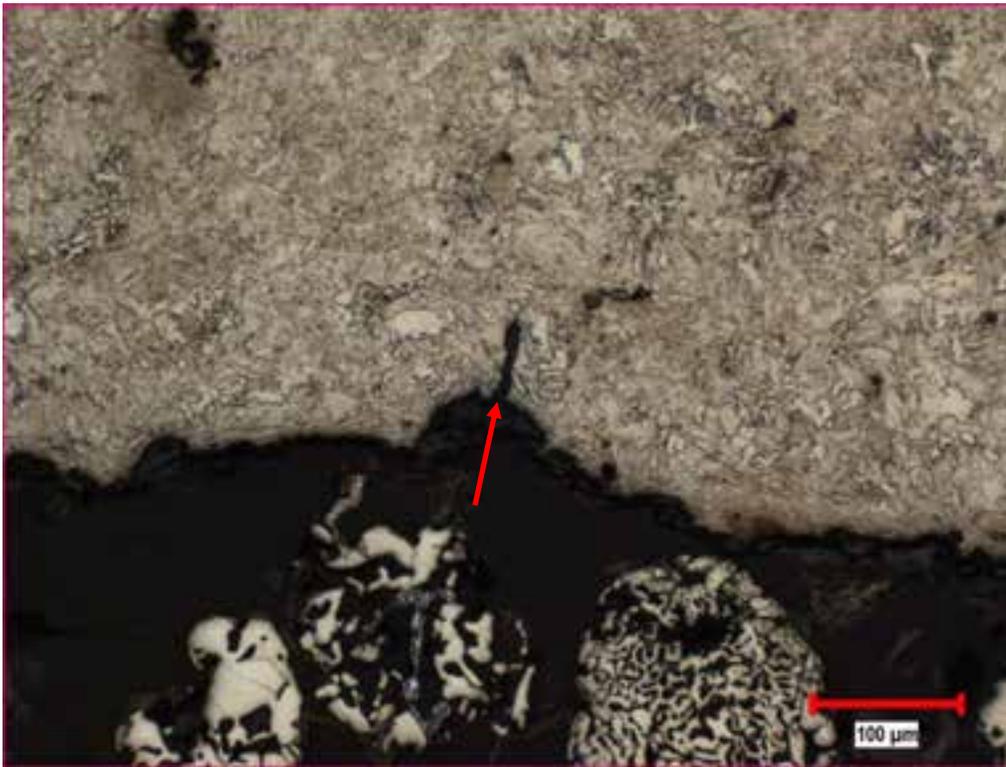
Figure 11: Micrograph showing a crack (red arrow) on the inner radius of the locomotive knuckle adjacent to the fatigue crack.

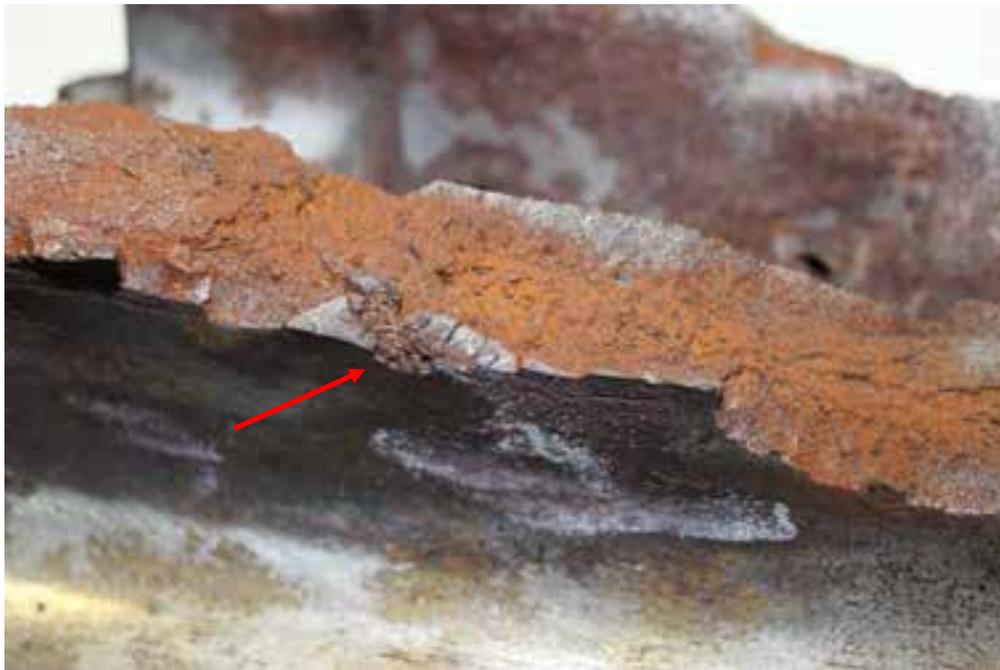
- 2.3.1 The fracture surfaces of the box car knuckle were cleaned for examination. A small area adjacent to the inner radius of this knuckle had a porous granular appearance consistent with a casting flaw (Figure 12). A small fatigue crack was associated with this casting flaw. The remaining fracture surface was overstress in nature (Figure 13). The orientation of the shear lips on the inner and outer sides of the fracture surface indicates that the knuckle failed from a torsional load (refer to arrows on Figure 13). The knuckle had an impact mark on the portion that engages with the mating knuckle (Figure 14). This impact mark was offset in the upward direction. The direction of the torsional load indicated by the shear lips and the location of the impact mark are consistent with the box car leaning to the left side as it was derailed and finally coming to rest on its left side.

- 4.5 The box car knuckle failed from a torsional overstress mode. A small pre-existing casting flaw and fatigue crack likely acted as an initiation site for the failure.

Figure 12: The casting flaw and fatigue crack on the fracture surface of the box car knuckle (red arrow).

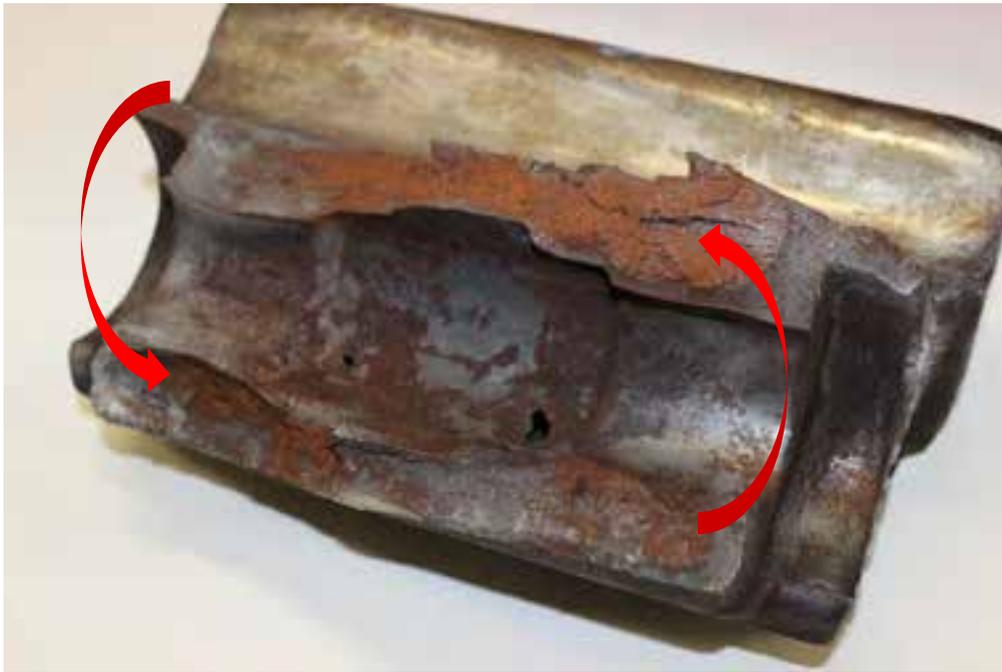
- 3.2 The orientation of the shear lips and location of the impact mark on the box car knuckle indicate that this failure occurred under a torsional load when the box car derailed and landed on its left side. It is considered most probable that due to their small size, the pre-existing casting flaw and fatigue crack observed in the knuckle did not affect its load-bearing capacity and merely acted to locate the fracture.

Figure 13: The red arrows indicate the direction of the torsional overstress failure on the fracture surface of the box car knuckle.

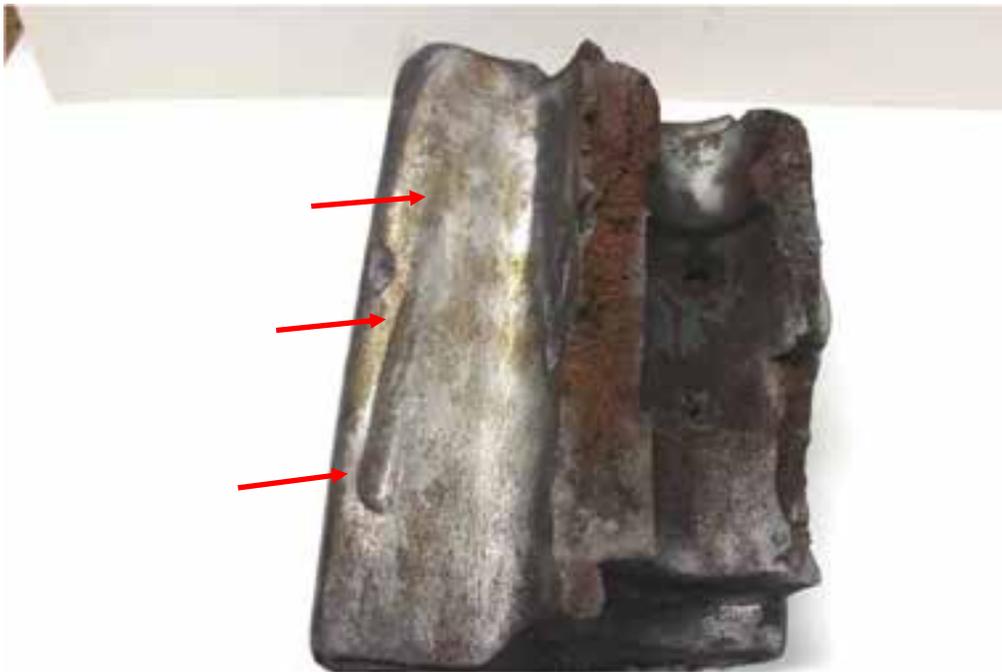
Figure 14: Red arrows points to the impact mark on the box car knuckle.

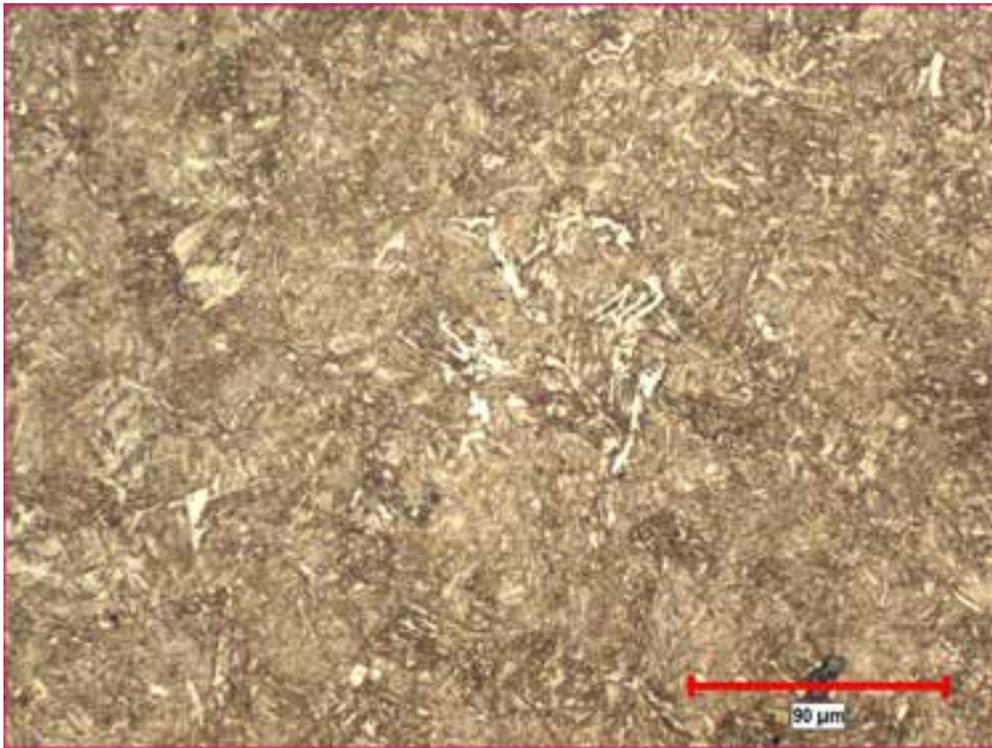
- 2.3.2 A metallurgical section was taken adjacent to the area of fatigue. Chemical etching in 2% Nital solution revealed a quenched and tempered martensite microstructure (Figure 15).

Figure 15: Micrograph showing the quenched and tempered martensite microstructure of the box car knuckle.
