AVIATION INVESTIGATION REPORT

A00P0210

LOSS OF POWER AND COLLISION WITH WATER

de HAVILLAND DHC-6 (TWIN OTTER) C-GGAW

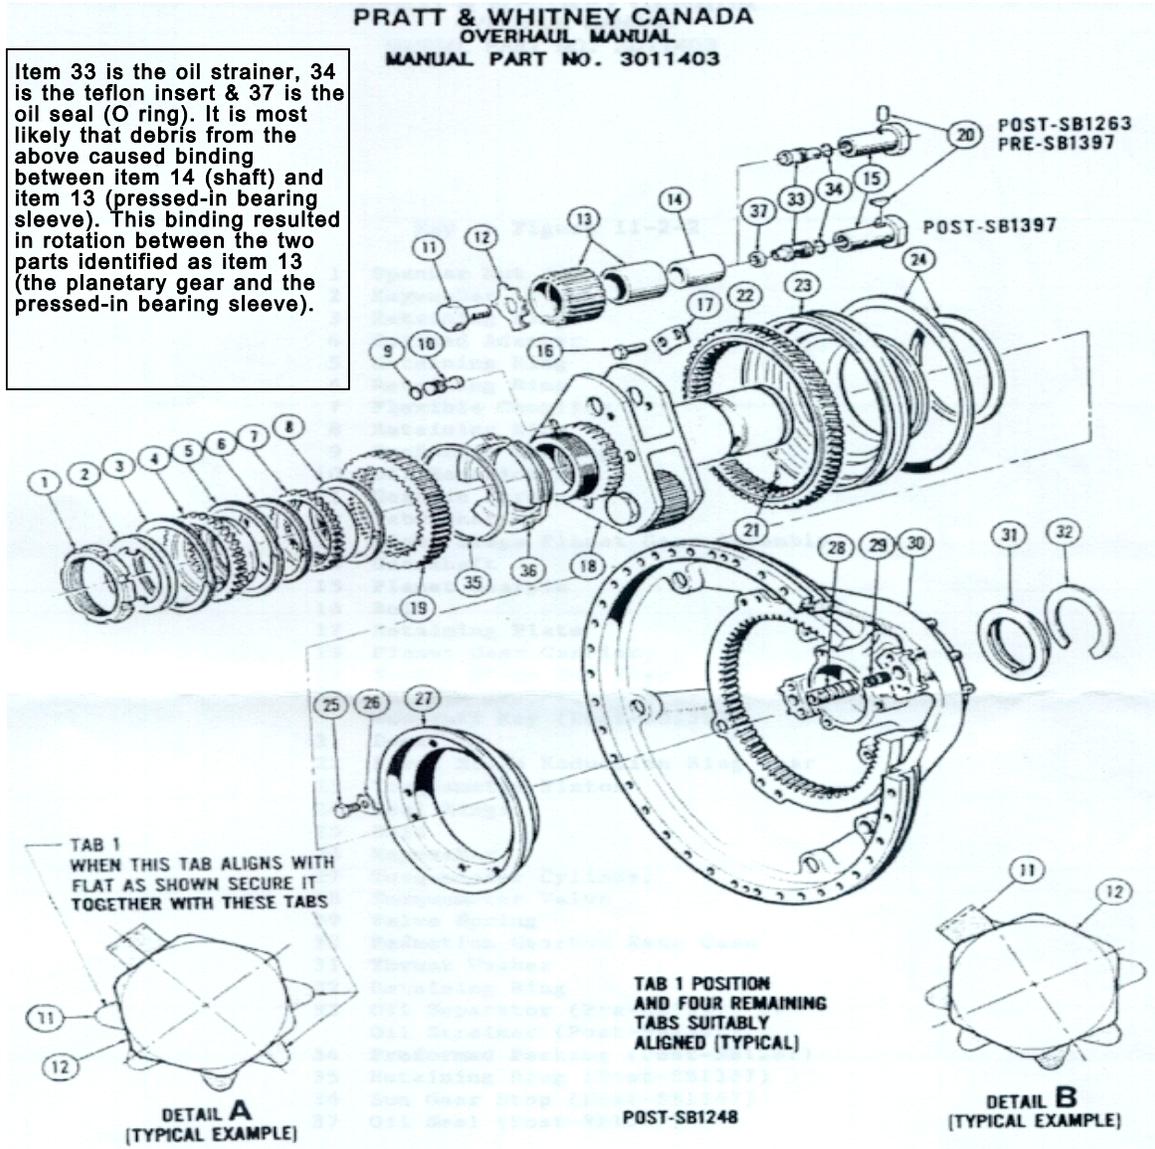
Appendix A1—Reduction Gearbox Rear Case Assembly

The planet gear oil strainer screen exhibited a deformed Teflon insert, pinched “O” ring, bent “neck” and fretting of the strainer housing suggesting an improper installation of the strainer within the pin. The screen beneath the outer screen exhibited fractures in the braze and wires. The wires fractured by fatigue. Some wire fracture surfaces were smeared and corroded suggesting the fractures were not recent, and as a result, the fracture of the strainer is believed to be a consequence of the installation. The release of wire fragments and debris may have subsequently initiated or contributed to the distress of the bearing sleeve.

Power loss of the No. 2 engine was a consequence of the installation of the planetary gear oil strainer at overhaul. This is believed to have been a sporadic occurrence, however, P&WC has recognized possible installation problems of the strainer. As such, the applicable Overhaul Manual was revised in 1998 to clarify the installation procedure of the strainer screen. The subject engine was overhauled in 1993 prior to the change in the manuals. Even though fractures in the planet gear oil strainer screen are not believed to have been a recent or sudden event, an unsafe condition existed. The West Coast Air maintenance procedure in effect prior to the accident exceeded the requirements of the de Havilland EMMA program. In spite of additional precautions, an unsafe condition developed during the unmonitored period between inspections.

Pratt & Whitney Canada has confirmed that the Overhaul Manual applicable to the P&WC PT6-20 series engine RGB was revised in 1998 to clarify the installation procedure of the planetary gear oil strainer screens.
